RISK MANAGEMENT THERMOGRAPHIC INSPECTION FOR:

TI THERMAL IMAGING LTD

**UNIT 8 WEYBRIDGE BUSINESS CENTRE
66 YORK ROAD
WEYBRIDGE
SURREY
KT13 9DY**

25/08/11

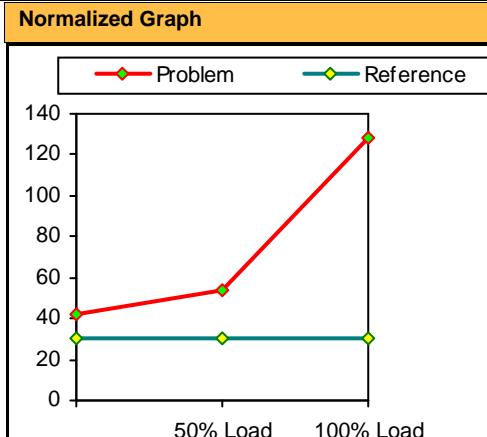
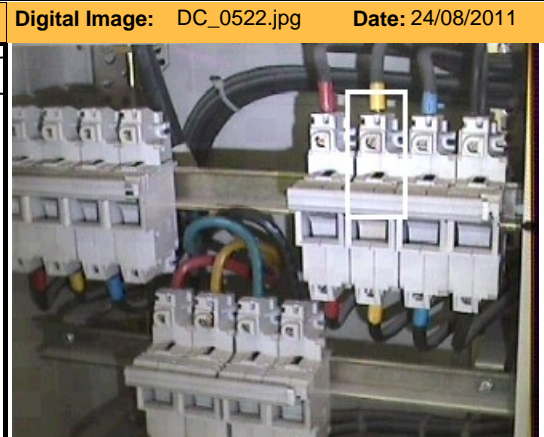
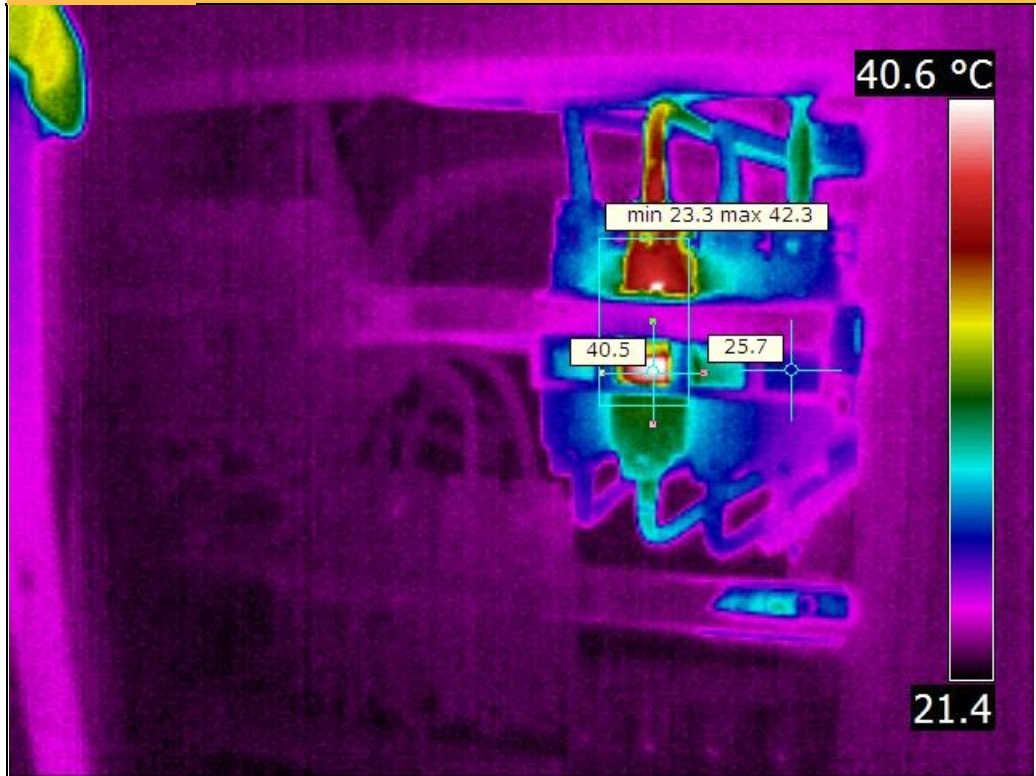
Infrared Image: IR_0521A.jpg Date: 24/08/2011

Location / Equipment Information	
Work Order	NOT ISSUED
Equipment ID	DB T41
Location	RISER E
Description	DB T41
Severity	3-Important
Anomaly	B phase line side connection indicates higher temperature than expected on 100A - 3 Pole Circuit Breaker
Possible Root Cause	Suspected loose/deteriorated line side connection
Recommendation	Check, clean and re-make line side connection(s)

Current Prob No: T/D Electrical/1	
Operation Priority:	Critical to operation
Max Component Temperature - Ar1 Max Temperature	42 C
Reference Temperature or SP2 Temperature	30 C
Temperature Rise Above Reference	12 C
Maximum allowable Temperature British Standard Reference	75 C
British Standard Reference - BS7671

Temperature Information	
Cubicle ambient:	21 C
Emissivity:	0.96
Environment:	Indoors
Adjusted Temperature Rise above reference:	12 C
Estimated Temp Rise over reference @ 50% Load: (See * 1)	24 C
Estimated Temp Rise over reference @ 100% Load: (See * 2)	98 C

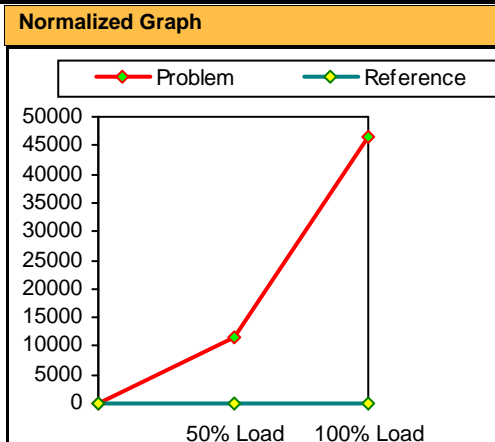
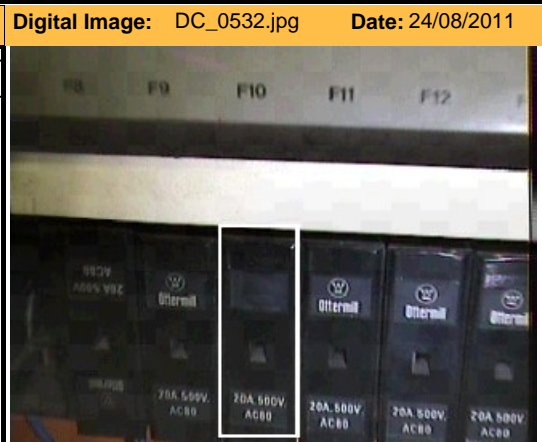
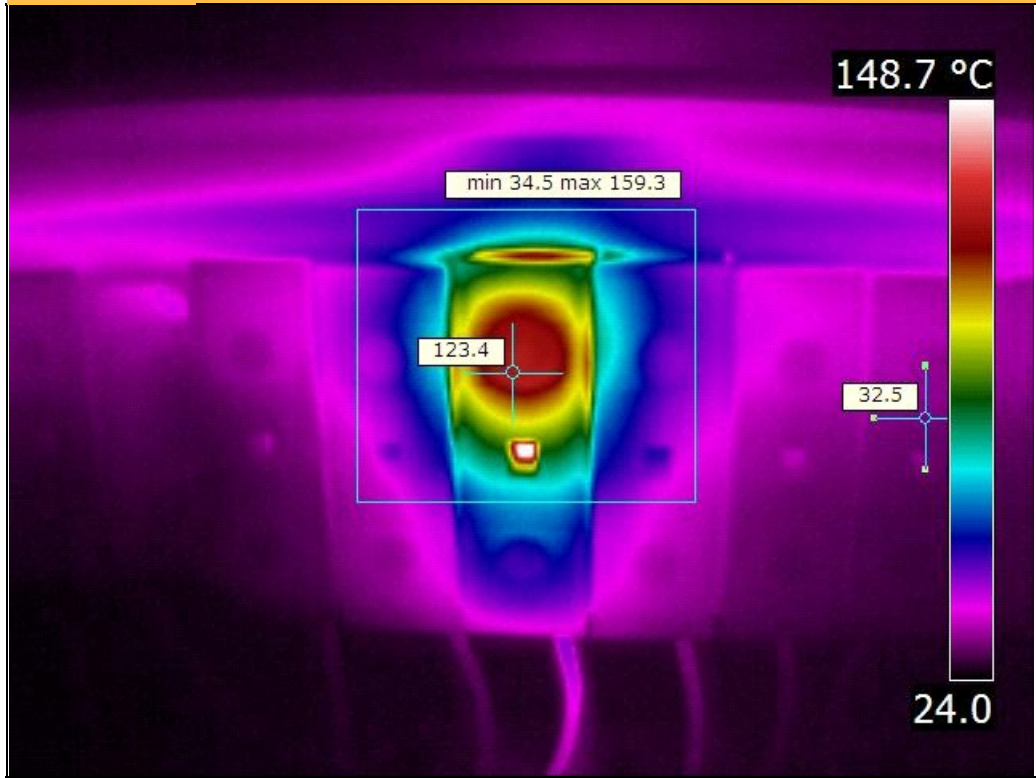
Infrared Image: IR_0531A.jpg Date: 24/08/2011

Location / Equipment Information	
Work Order	1830172
Equipment ID	MCC
Location	BALFOUR PLANTROOM
Description	F10
Severity	1-Critical
Anomaly	Indicates higher temperature than expected on 20A - Fuse
Possible Root Cause	Suspected internal problem
Recommendation	Either replace or investigate internal connections to determine source of temp anomaly

Current Prob No: T/D Electrical/2	
Operation Priority:	Critical to operation
Max Component Temperature - Ar1 Max Temperature	159 C
Reference Temperature or SP2 Temperature	43 C
Temperature Rise Above Reference	116 C
Maximum allowable Temperature British Standard Reference	75 C
British Standard Reference - BS7671

Temperature Information	
Cubicle ambient:	23 C
Emissivity:	0.96
Environment:	Indoors
Adjusted Temperature Rise above reference:	116 C
Estimated Temp Rise over reference @ 50% Load: (See * 1)	11600 C
Estimated Temp Rise over reference @ 100% Load: (See * 2)	46400 C

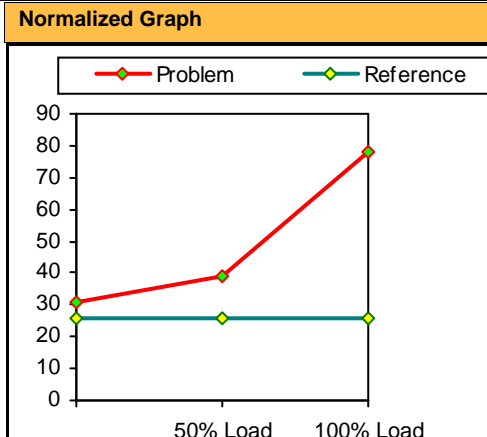
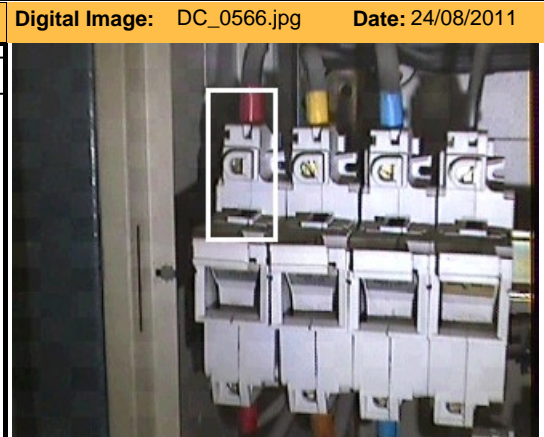
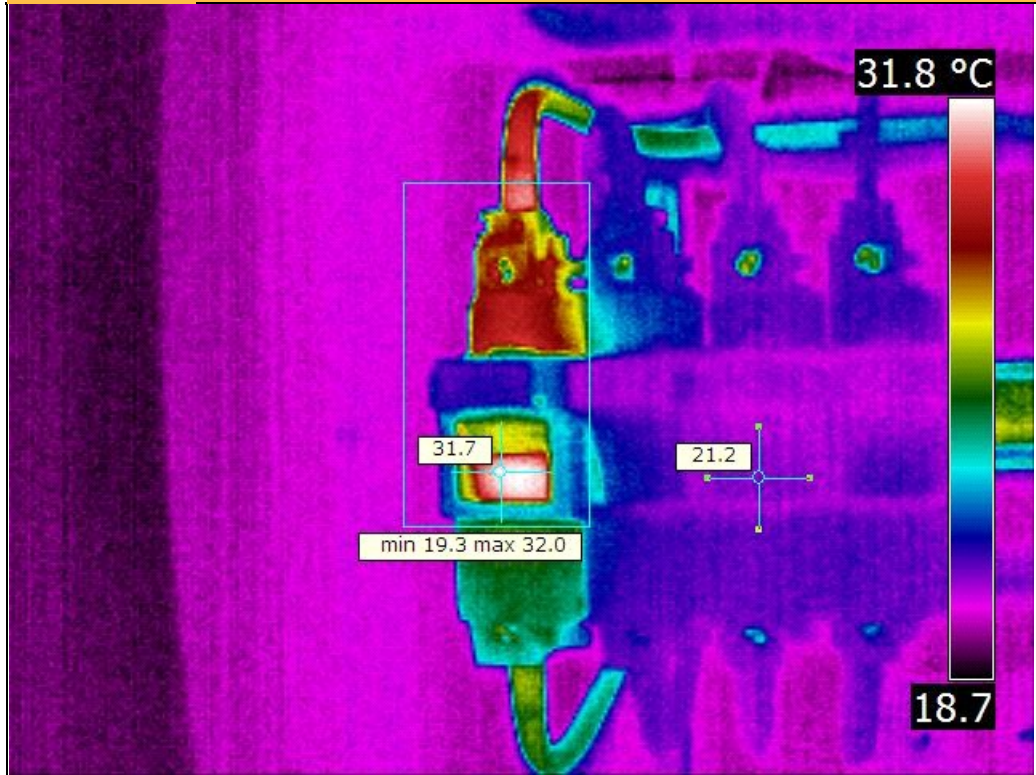
Infrared Image: IR_0565A.jpg Date: 24/08/2011

Location / Equipment Information	
Work Order	NOT ISSUED
Equipment ID	DB T12-15
Location	RISER B
Description	RYB1-4
Severity	4-Minor
Anomaly	A phase line side connection indicates higher temperature than expected on 100A - 3 Pole Circuit Breaker
Possible Root Cause	Suspected loose/deteriorated line side connection
Recommendation	Check, clean and re-make line side connection(s)

Current Prob No: T/D Electrical/3	
Operation Priority:	Critical to operation
Max Component Temperature - Ar1 Max Temperature	31 C
Reference Temperature or SP2 Temperature	26 C
Temperature Rise Above Reference	5 C
Maximum allowable Temperature British Standard Reference	75 C
British Standard Reference - BS7671

Temperature Information	
Cubicle ambient:	19 C
Emissivity:	0.96
Environment:	Indoors
Adjusted Temperature Rise above reference:	5 C
Estimated Temp Rise over reference @ 50% Load: (See * 1)	13 C
Estimated Temp Rise over reference @ 100% Load: (See * 2)	52 C

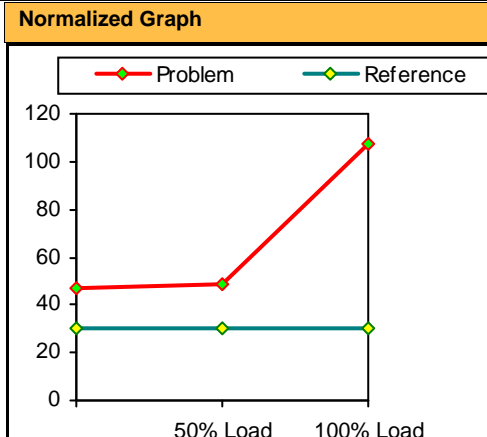
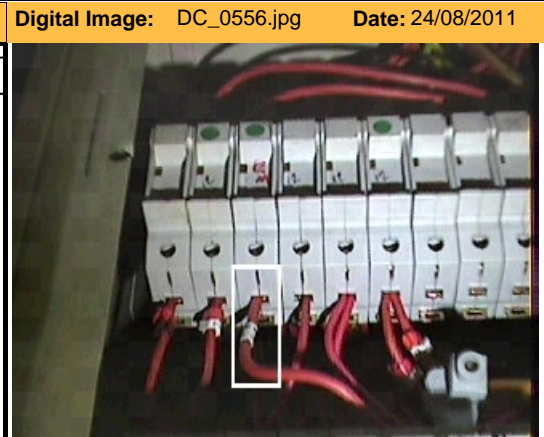
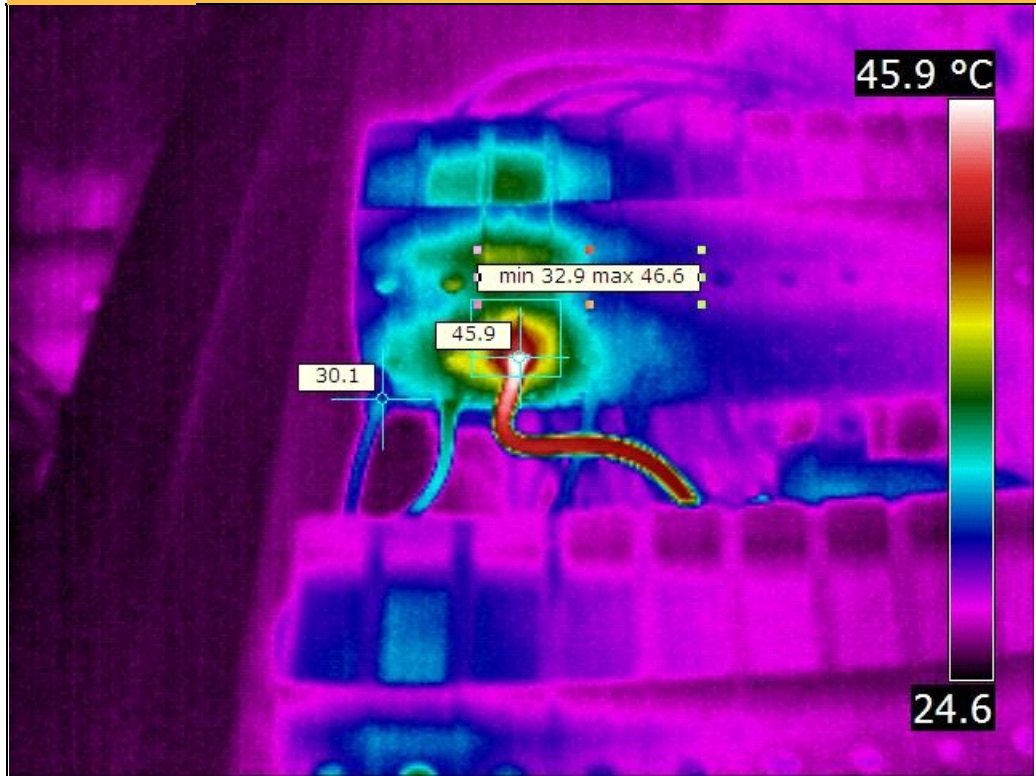
Infrared Image: IR_0555A.jpg Date: 24/08/2011

Location / Equipment Information	
Work Order	1830173
Equipment ID	DB T20 R3
Location	RISER A
Description	DB T20 R3
Severity	2-Serious
Anomaly	Load side connection indicates higher temperature than expected on 32A - 1 Pole Mini Circuit Breaker
Possible Root Cause	Suspected loose/deteriorated load side connection
Recommendation	Check, clean and remake load side connection(s)

Current Prob No: T/D Electrical/4	
Operation Priority:	Critical to operation
Max Component Temperature - Ar1 Max Temperature	47 C
Reference Temperature or SP2 Temperature	30 C
Temperature Rise Above Reference	17 C
Maximum allowable Temperature British Standard Reference	75 C
British Standard Reference - BS7671

Temperature Information	
Cubicle ambient:	21 C
Emissivity:	0.96
Environment:	Indoors
Adjusted Temperature Rise above reference:	17 C
Estimated Temp Rise over reference @ 50% Load: (See * 1)	19 C
Estimated Temp Rise over reference @ 100% Load: (See * 2)	77 C

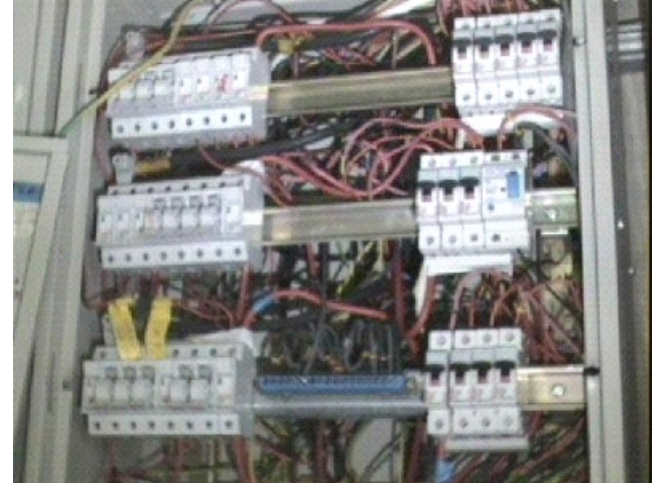
File:	Date:	Time:
File: DC_0506.jpg	Date:	Time:

Classification: Electrical
Observations: Broken door hinge causing an access and possible security issue
What is the Cause: Physical damage
Recommendations: Repair or replace

Work Order#: NOT ISSUED	
Current Prob No: Visual/1	
Is Chronic:	No
Operation Priority:	Critical to operation
Repair Priority:	3-Important

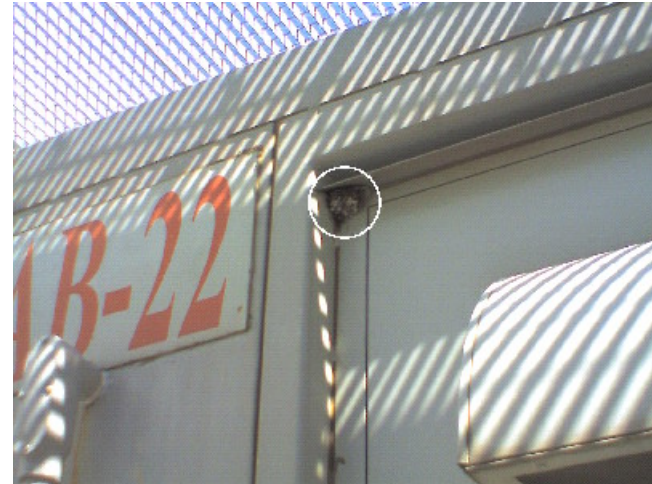
File:	Date:	Time:
File: DC_4276.jpg	Date: 06/08/2009	Time: 12:34 PM

Classification: Electrical
Observations: Insect infestation causing an unsafe working environment and access restriction
What is the Cause: Insect nest by access door
Recommendations: Insect repellent procedure required

Current Prob No: Visual/2	
Is Chronic:	No
Operation Priority:	Critical to operation
Repair Priority:	1-Critical

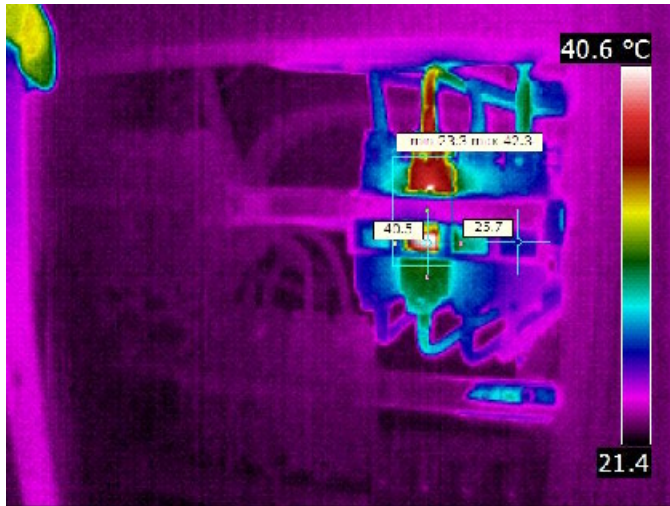
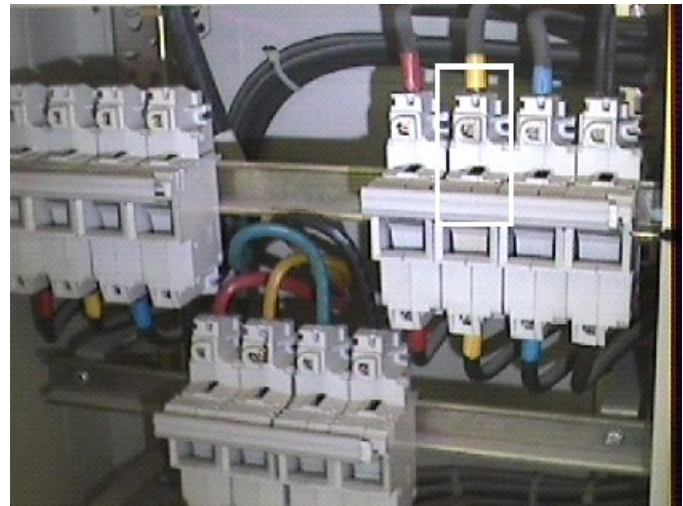
IR File: IR_0521A.jpg

Thermal Information	
Operation Priority:	Critical to operation
Repair Priority:	3-Important
Ambient:	21 C Enviroment: Indoors
Component Temperature On B phase line si	42 C
B phase load side Reference Temperature:	30 C
Temperature Rise Above Reference:	12 C
ANSI/EEE/NEMA Max Allowable Temp @ 100% Load:	75 C
Est Temp Rise over reference @ 50% Load:	24
Est Temp Rise over reference @ 100% Load:	98

Repair Information	PLEASE FAX BACK AFTER REPAIR TO:		Loss to Production	
	0871 900 4978 OR		<input type="checkbox"/> Yes	<input type="checkbox"/> No
	INFO@THERMALIMAGING.CO.UK		<input checked="" type="checkbox"/> Unknown	
	Consequences of Failure:	Repair Date:	Repaired By: <input type="text"/>	
	Loss of DB T41	Root Cause:	<input type="text"/>	
Parts Req. Before Failure:	Repair Procedure:	<input type="text"/>		
Parts Req. After Failure:	Repair Action:	<input type="text"/>		
Repair Recommendation:	Check, clean and re-make line side connection(s)

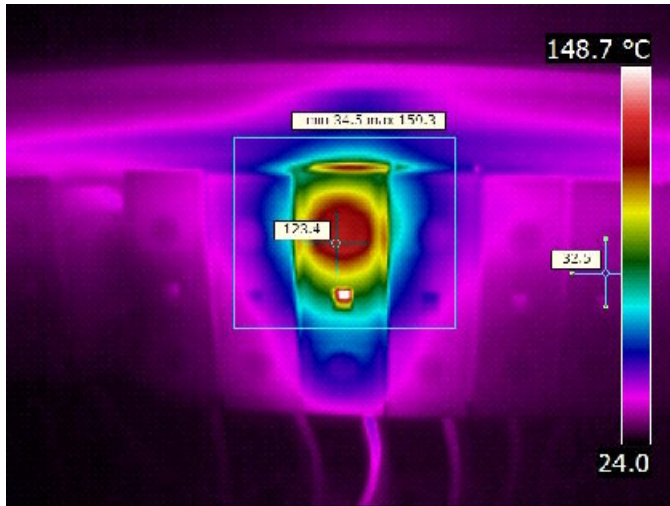
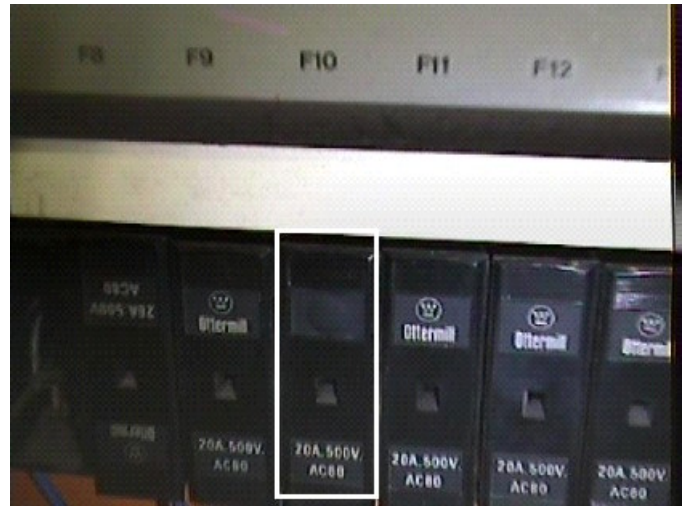
IR File: IR_0531A.jpg

Thermal Information	
Operation Priority:	Critical to operation
Repair Priority:	1-Critical
Ambient:	23 C Enviroment: Indoors
Component Temperature On -:	159 C
- Reference Temperature:	43 C
Temperature Rise Above Reference:	116 C
ANSI/EEE/NEMA Max Allowable Temp @ 100% Load:	75 C
Est Temp Rise over reference @ 50% Load:	11600
Est Temp Rise over reference @ 100% Load:	46400

Repair Information	PLEASE FAX BACK AFTER REPAIR TO:		Loss to Production	
	0871 900 4978 OR		<input type="checkbox"/> Yes	<input type="checkbox"/> No
	INFO@THERMALIMAGING.CO.UK		<input checked="" type="checkbox"/> Unknown	
	Consequences of Failure:	Repair Date:	Repaired By: <input type="text"/>	
	Loss of F10	Root Cause:	<input type="text"/>	
Parts Req. Before Failure:	Repair Procedure:	<input type="text"/>		
Parts Req. After Failure:	Repair Action:	<input type="text"/>		
Repair Recommendation:	Either replace or investigate internal connections to determine source of temp anomaly

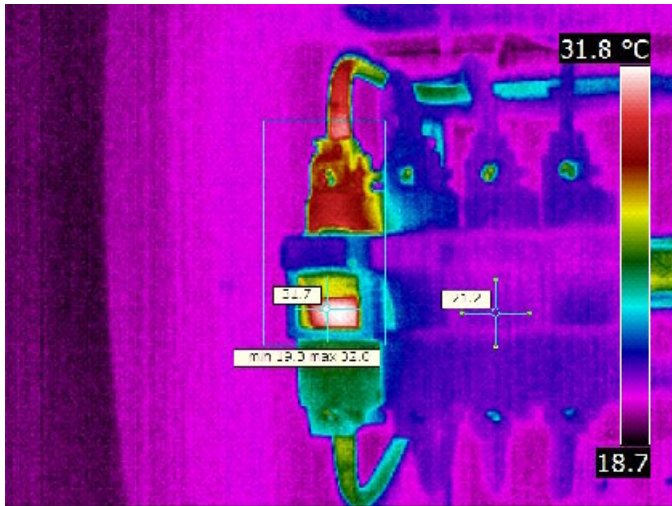
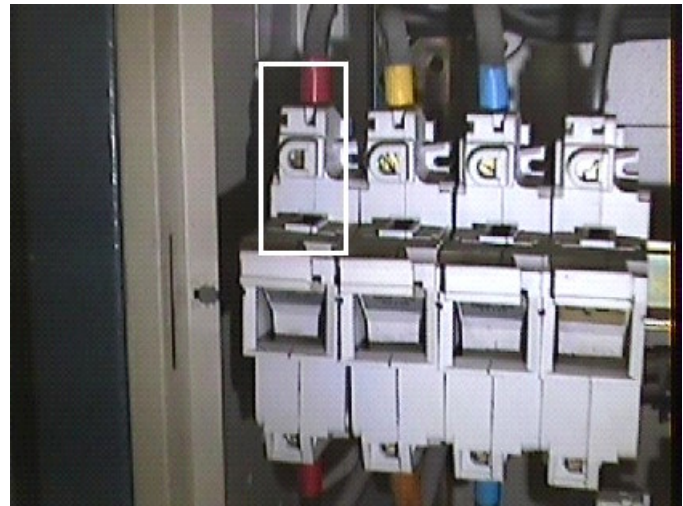
IR File: IR_0565A.jpg

Thermal Information	
Operation Priority:	Critical to operation
Repair Priority:	4-Minor
Ambient:	19 C Enviroment: Indoors
Component Temperature On A phase line si	31 C
A phase load side Reference Temperature:	26 C
Temperature Rise Above Reference:	5 C
ANSI/EEE/NEMA Max Allowable Temp @ 100% Load:	75 C
Est Temp Rise over reference @ 50% Load:	13
Est Temp Rise over reference @ 100% Load:	52

Repair Information	PLEASE FAX BACK AFTER REPAIR TO:		Loss to Production	
	0871 900 4978 OR		<input type="checkbox"/> Yes	<input type="checkbox"/> No
	INFO@THERMALIMAGING.CO.UK		<input checked="" type="checkbox"/> Unknown	
	Consequences of Failure:	Repair Date:	Repaired By: <input type="text"/>	
	Loss of RYB1-4	Root Cause:	<input type="text"/>	
Parts Req. Before Failure:	Repair Procedure:	<input type="text"/>		
Parts Req. After Failure:	Repair Action:	<input type="text"/>		
Repair Recommendation:	Check, clean and re-make line side connection(s)

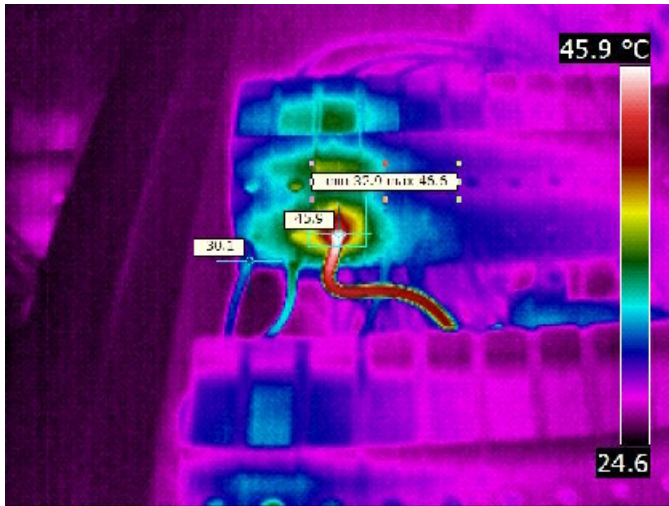
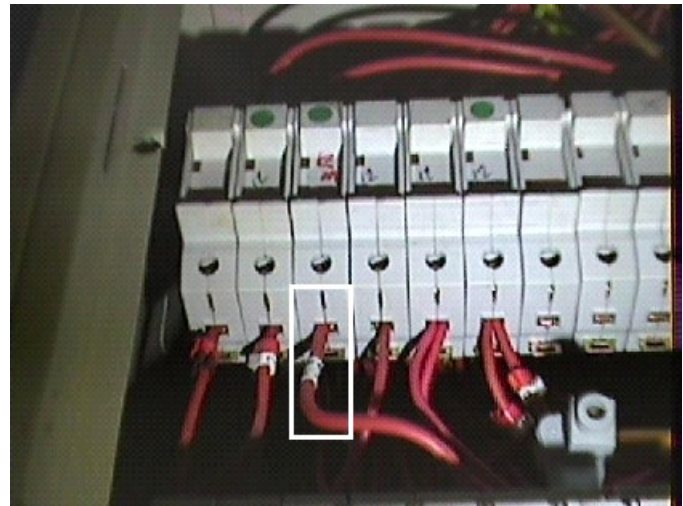
IR File: IR_0555A.jpg

Thermal Information	
Operation Priority:	Critical to operation
Repair Priority:	2-Serious
Ambient:	21 C Enviroment: Indoors
Component Temperature On Load side:	47 C
Line side Reference Temperature:	30 C
Temperature Rise Above Reference:	17 C
ANSI/EEE/NEMA Max Allowable Temp @ 100% Load:	75 C
Est Temp Rise over reference @ 50% Load:	19
Est Temp Rise over reference @ 100% Load:	77

Repair Information	PLEASE FAX BACK AFTER REPAIR TO:		Loss to Production	
	0871 900 4978 OR		<input type="checkbox"/> Yes	<input type="checkbox"/> No
	INFO@THERMALIMAGING.CO.UK		<input checked="" type="checkbox"/> Unknown	
	Consequences of Failure:		Repair Date:	Repaired By:
	Loss of DB T20 R3			
Parts Req. Before Failure:		Root Cause:		
Parts Req. After Failure:		Repair Procedure:		
Repair Recommendation:		Repair Action:		
Check, clean and remake load side connection(s)

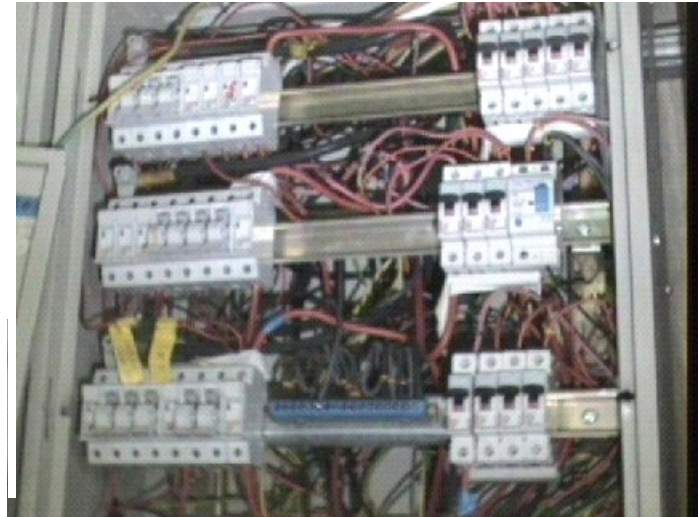
Operation Priority:	Critical to operation
Repair Priority:	3-Important
Hazard Type:	Visual
Hazard Classification:	Electrical
Hazard Group:	Broken door hinge
Hazard Issue:	causing an access and possible security issue
Observations:	Broken door hinge causing an access and possible security issue
What is the Cause:	Physical damage

Repair Information	PLEASE FAX BACK AFTER REPAIR TO: 0871 900 4978 OR INFO@THERMALIMAGING.CO.UK		Loss to Production		
	Consequences of Failure:		<input type="checkbox"/> Yes <input type="checkbox"/> No <input checked="" type="checkbox"/> Unknown		
	Parts Req. Before Failure:		Repair Date:	Repaired By:	
	Parts Req. After Failure:		Root Cause:		
	Repair Recommendation:		Repair Procedure:	Repair or replace	
Repair or replace		Repair Notes:

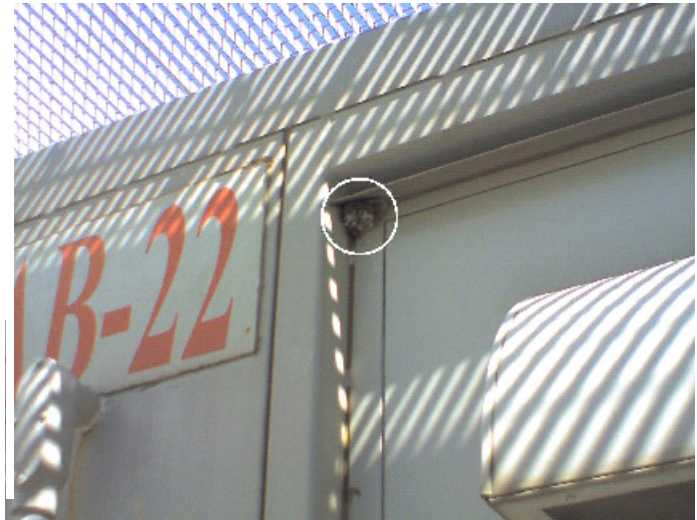
Operation Priority:	Critical to operation
Repair Priority:	1-Critical
Hazard Type:	Visual
Hazard Classification:	Electrical
Hazard Group:	Insect infestation
Hazard Issue:	causing an unsafe working environment and access restriction
Observations:	Insect infestation causing an unsafe working environment and access restriction
What is the Cause:	Insect nest by access door

Repair Information		PLEASE FAX BACK AFTER REPAIR TO:		Loss to Production	
		0871 900 4978 OR		<input type="checkbox"/> Yes <input type="checkbox"/> No <input checked="" type="checkbox"/> Unknown	
Consequences of Failure:		INFO@THERMALIMAGING.CO.UK		Repaired By: <input type="text"/>	
<input type="text"/>		Repair Date: <input type="text"/>		Root Cause: <input type="text"/>	
Parts Req. Before Failure:		Repair Procedure: <input type="text"/>		Repair Notes: <input type="text"/>	
<input type="text"/>		Repair Notes: <input type="text"/>			
Parts Req. After Failure:					
<input type="text"/>					
Repair Recommendation:					
<input type="text"/>					
<input type="text"/>
