## **THERMOGRAPHIC INSPECTION FOR:**

**FLOWLINE T-PIECES  
304/306**

**TI-14055**

**TI , TI Site 5 Process**

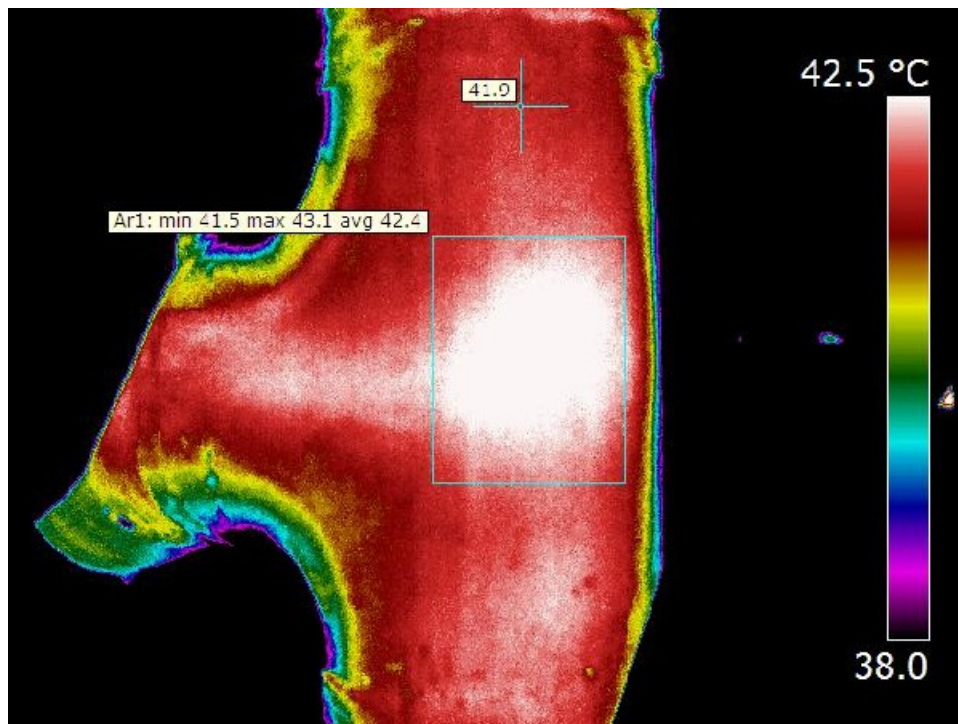
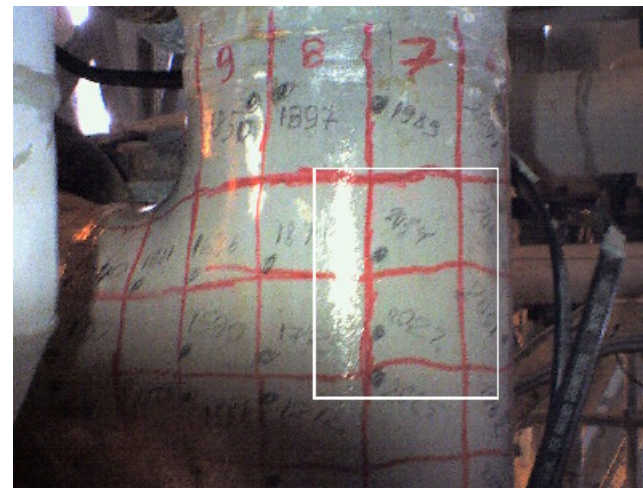
### Current Prob No: Visual/1

Observations: Increased external surface temperature at AR1

What is the Cause: Suspected wall thickness loss through internal erosion

Is Chronic: No  
Operation Priority: Critical to operation  
Repair Priority: 2-Serious

Recommendations: Continue to monitor external surface temperature for further increase in temperature

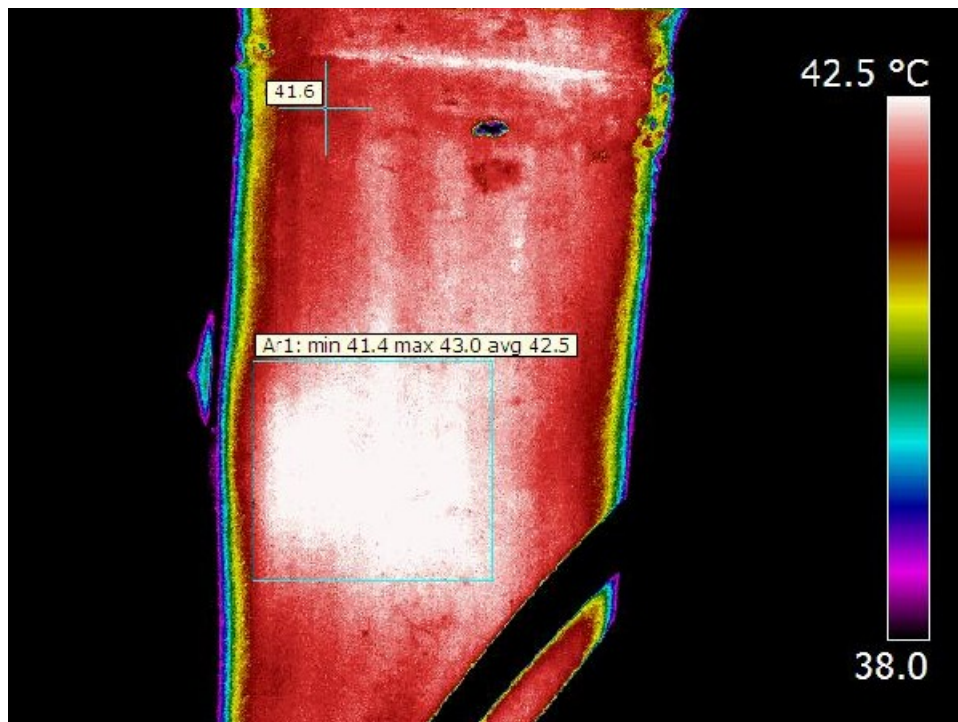
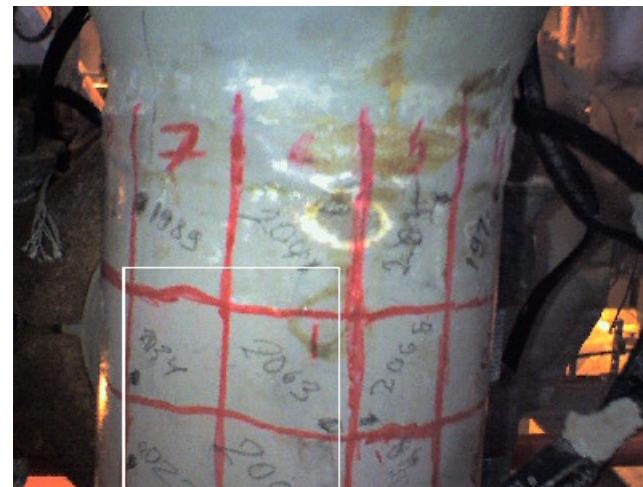
**Current Prob No: Visual/2**

Is Chronic:	<b>No</b>
Operation Priority:	<b>Critical to operation</b>
Repair Priority:	<b>2-Serious</b>

<b>Classification:</b>	Oil and Gas Pipework
<b>Observations:</b>	Increased external surface temperature at AR1
<b>What is the Cause:</b>	Suspected wall thickness loss through internal erosion
<b>Recommendations:</b>	Continue to monitor external surface temperature for further increase in temperature

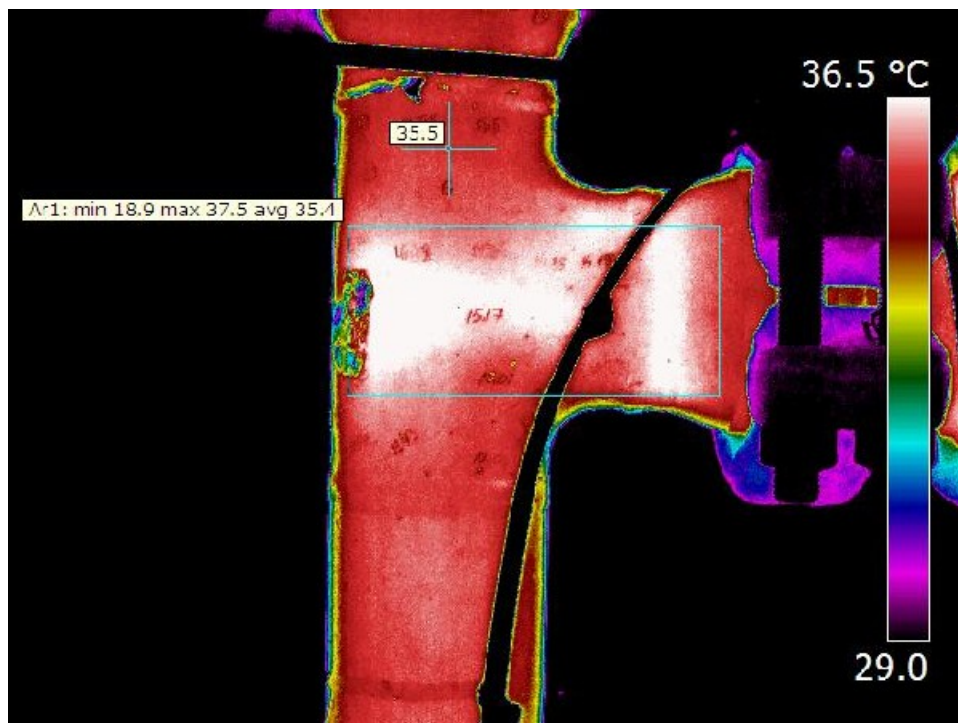
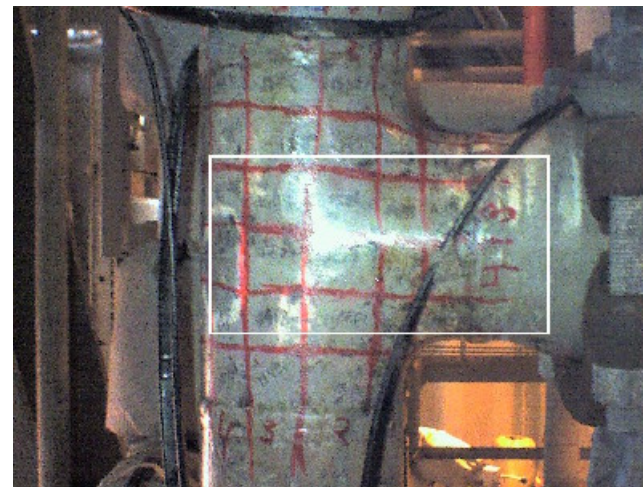
### Current Prob No: Visual/3

Is Chronic: No  
Operation Priority: Critical to operation  
Repair Priority: 2-Serious

Observations: Increased external surface temperature at AR1

What is the Cause: Suspected wall thickness loss through internal erosion

Recommendations: Continue to monitor external surface temperature for further increase in temperature

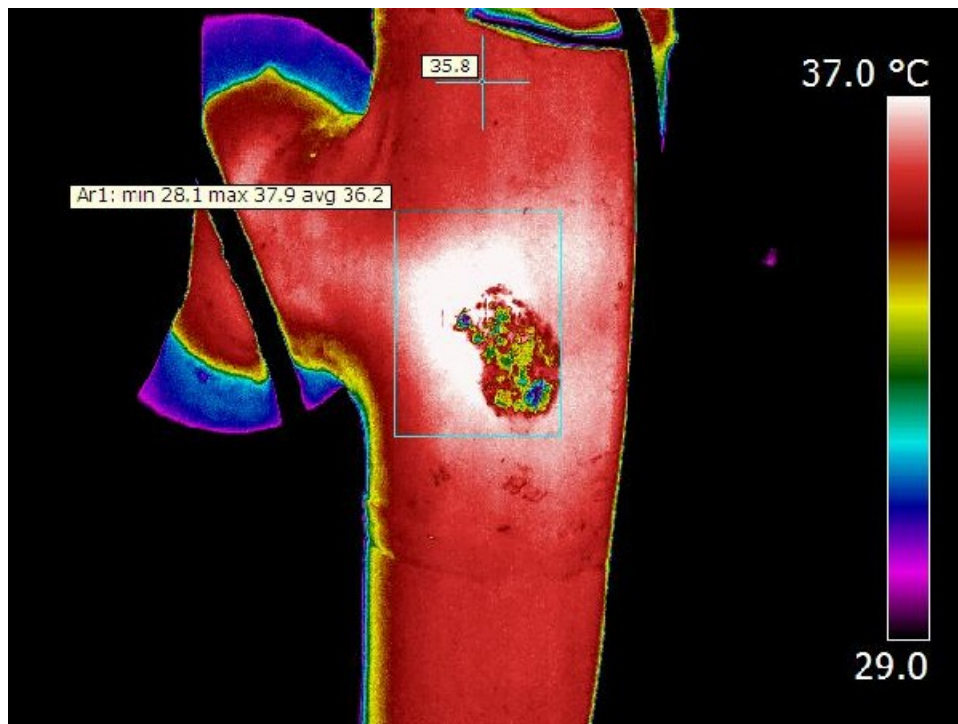
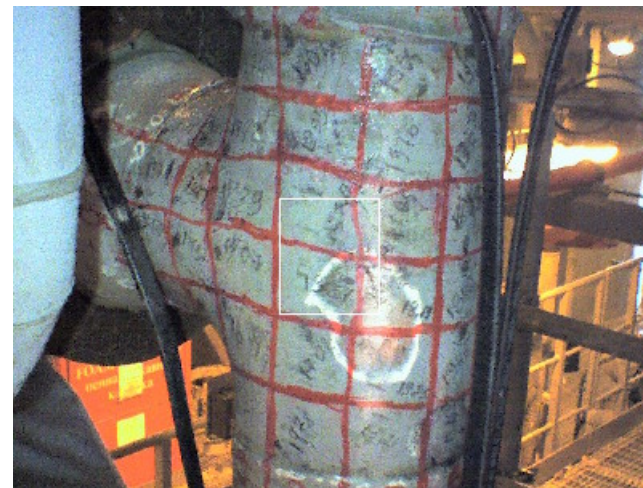
### Current Prob No: Visual/4

Observations: Increased external surface temperature at AR1

What is the Cause: Suspected wall thickness loss through internal erosion

Is Chronic: No  
Operation Priority: Critical to operation  
Repair Priority: 2-Serious

Recommendations: Continue to monitor external surface temperature for further increase in temperature
