PART L2 and BRE 176 BUILDING THERMOGRAPHIC INSPECTION FOR:

SAMPLE

Introduction to your Ti Thermal Imaging LTD internal building inspection

INFRARED THERMOGRAPHIC INSPECTION
OF
VISUAL PROBLEMS

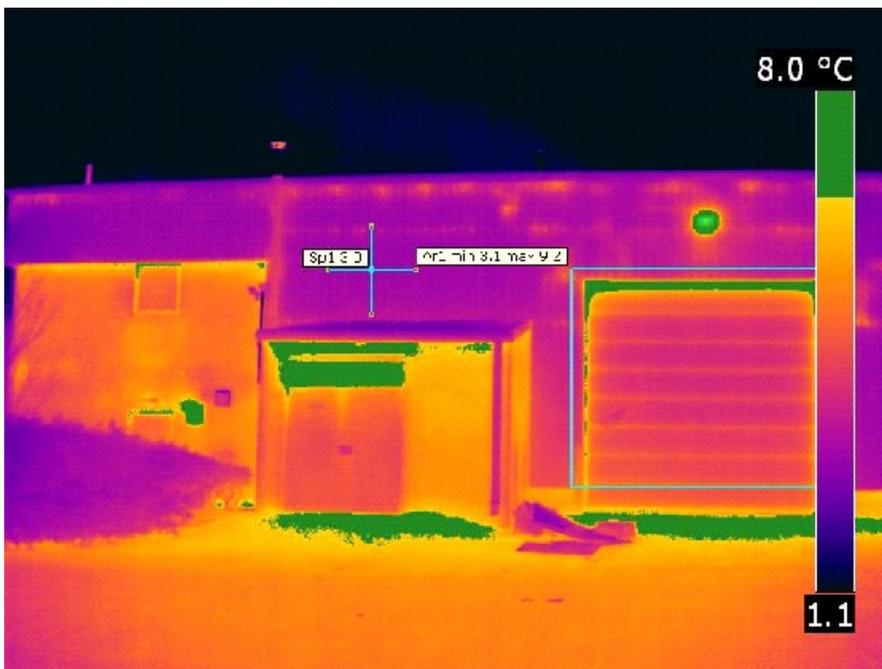
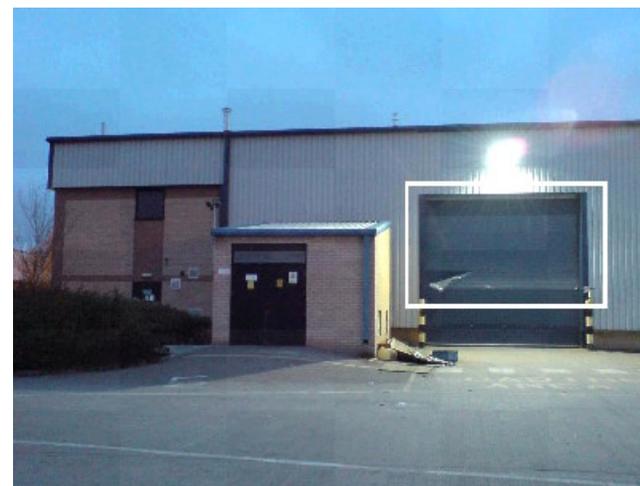
File: IR_1379A.jpg	Date: 23/04/2012
File: DC_1378.jpg	Date: 23/04/2012

Current Prob No: Visual/1	
Is Chronic:	No
Operation Priority:	Critical to operation
Repair Priority:	4-Minor

Classification: Buildings
 Observations: Elevated temperature at AR1
 What is the Cause: Suspected air leakage
 Recommendations: Check seals and repair or replace where necessary

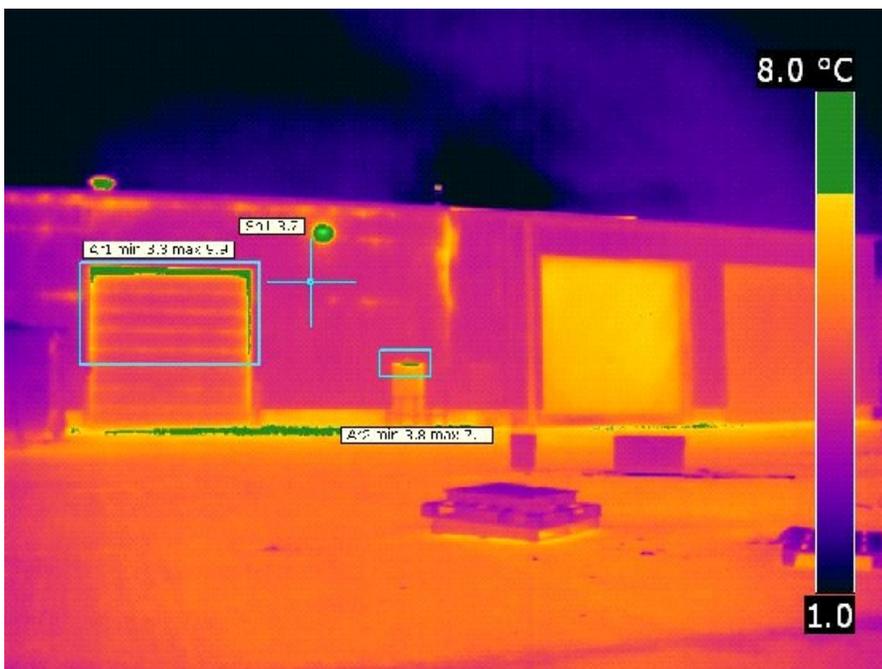
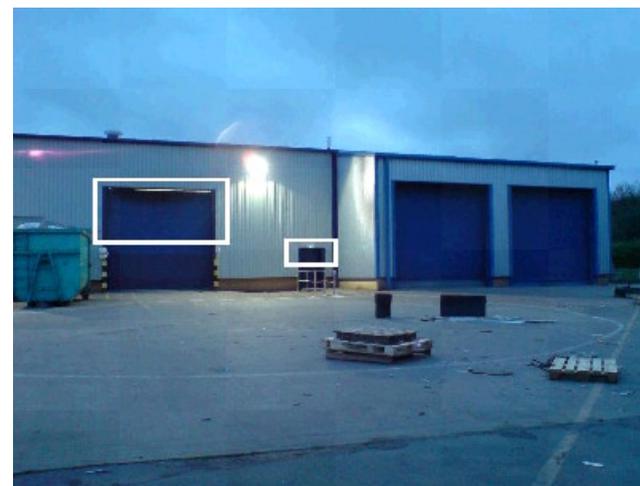
File: IR_1383A.jpg	Date: 23/04/2012
File: DC_1384.jpg	Date: 23/04/2012

Current Prob No: Visual/2	
Is Chronic:	No
Operation Priority:	Critical to operation
Repair Priority:	4-Minor

Classification: Buildings
Observations: Elevated temperature at AR1 and AR2
What is the Cause: Suspected air leakage
Recommendations: Check seals and repair or replace where necessary

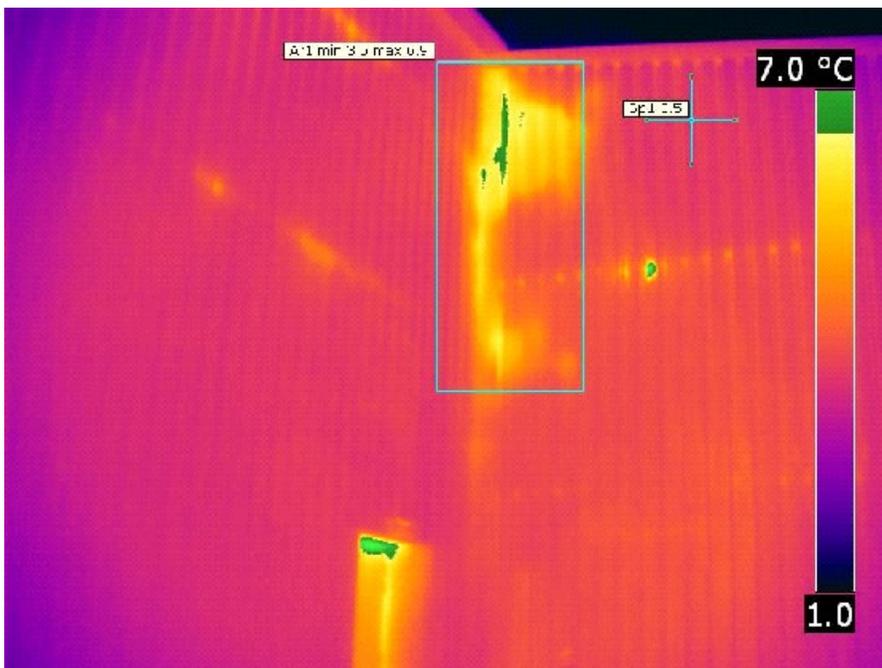
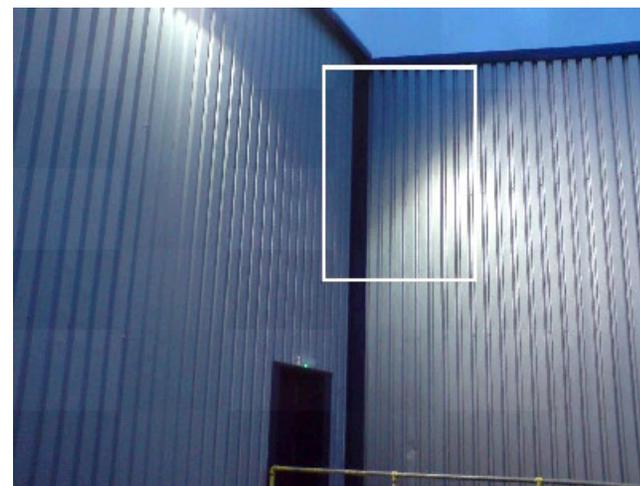
File: IR_1385A.jpg	Date: 23/04/2012
File: DC_1386.jpg	Date: 23/04/2012

Current Prob No: Visual/3	
Is Chronic:	No
Operation Priority:	Critical to operation
Repair Priority:	4-Minor

Classification: Buildings
 Observations: Elevated temperature at AR1
 What is the Cause: Suspected insulation incontinuity
 Recommendations: Repair, add or replace insulation as necessary

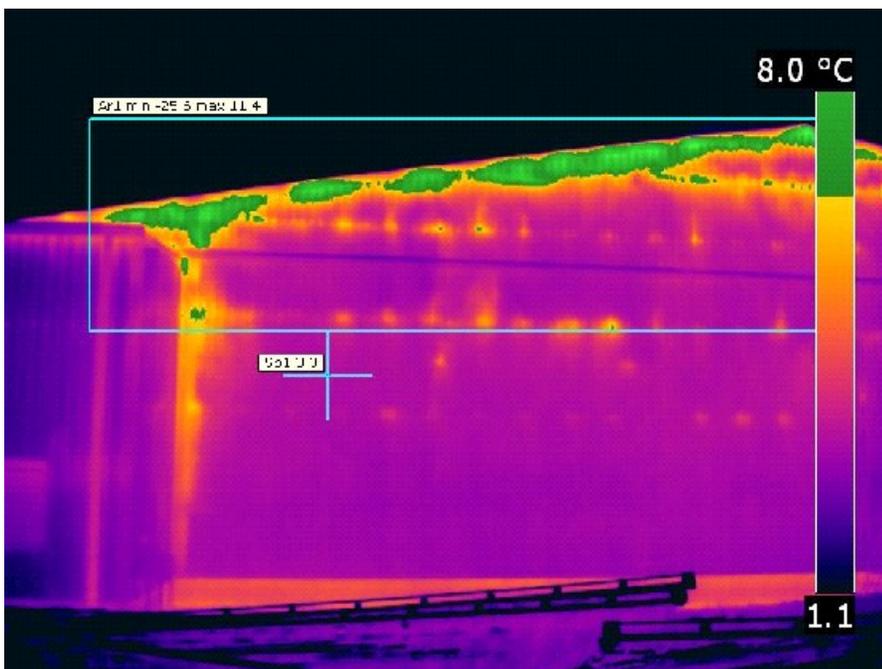
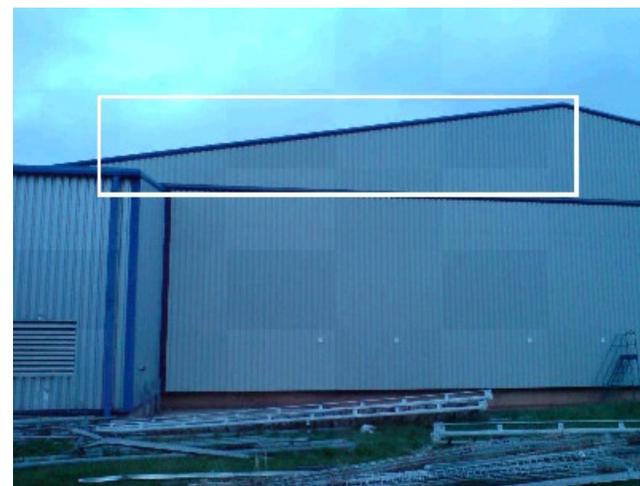
File: IR_1389A.jpg	Date: 23/04/2012
File: DC_1390.jpg	Date: 23/04/2012

Current Prob No: Visual/4	
Is Chronic:	No
Operation Priority:	Critical to operation
Repair Priority:	3-Important

What is the Cause: Insulation suspected of damp due to poor panel seals

Recommendations: Repair or replace panel seals to prevent water ingress

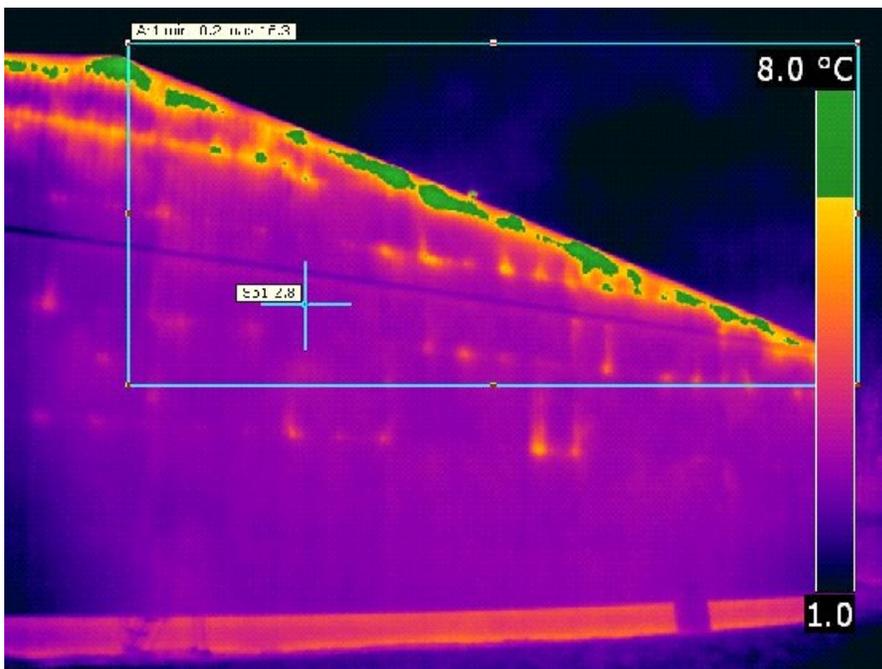
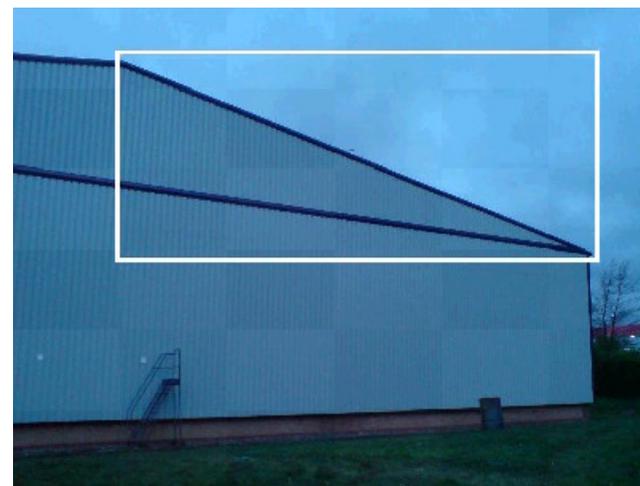
File: IR_1391A.jpg	Date: 23/04/2012
File: DC_1392.jpg	Date: 23/04/2012

Current Prob No: Visual/5	
Is Chronic:	No
Operation Priority:	Critical to operation
Repair Priority:	3-Important

What is the Cause: Insulation suspected of damp due to poor panel seals

Recommendations: Repair or replace panel seals to prevent water ingress

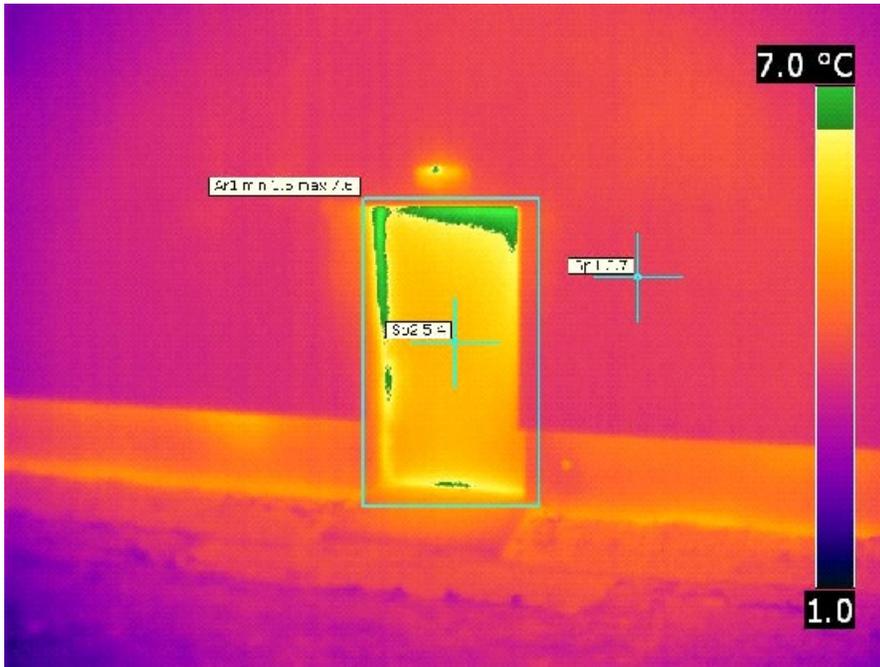
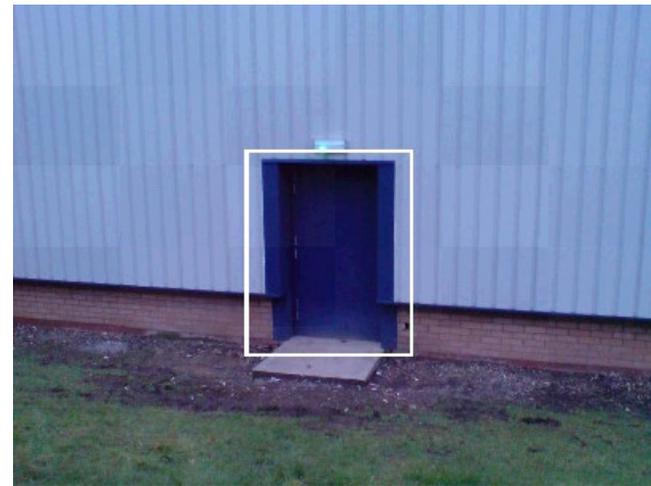
File: IR_1399A.jpg	Date: 23/04/2012
File: DC_1400.jpg	Date: 23/04/2012

Current Prob No: Visual/6	
Is Chronic:	No
Operation Priority:	Critical to operation
Repair Priority:	4-Minor

Classification: Buildings
 Observations: Elevated temperature at AR1
 What is the Cause: Suspected air leakage
 Recommendations: Check seals and repair or replace where necessary

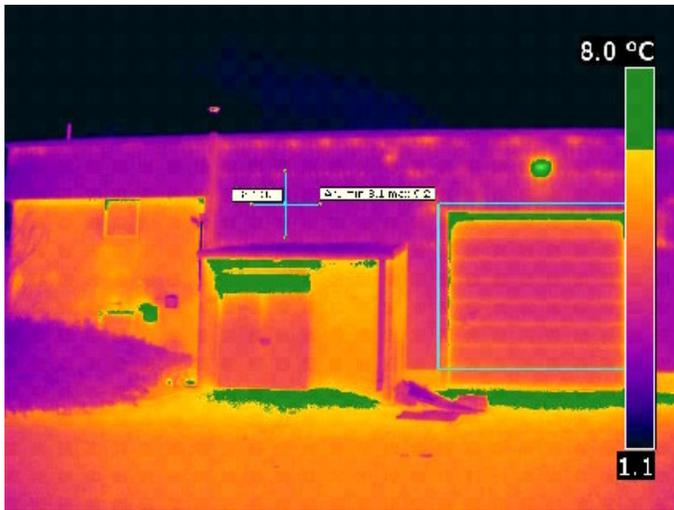
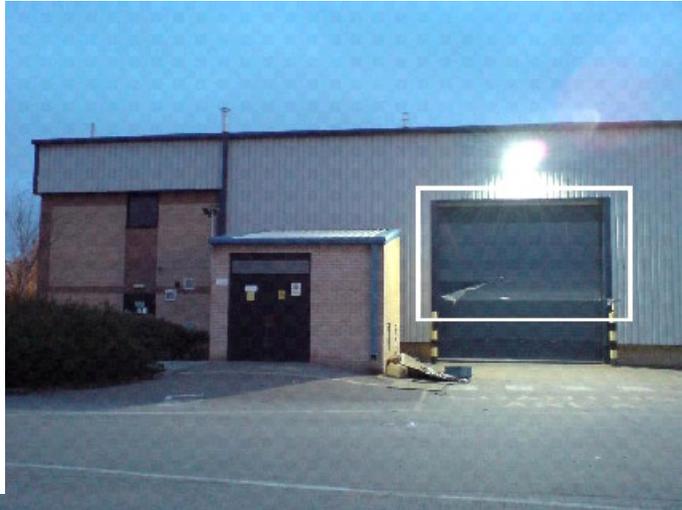
Photo File: IR_1379A.jpg

Location/Equipment Information	
Asset ID:	-
Barcode:	NI
Location:	SIDE ELEVATIONS SOUTH WEST

Repair Priority:	4-Minor
Hazard Type:	Visual
Hazard Classification:	Buildings
Hazard Group:	Elevated temperature
Hazard Issue:	at AR1
Observations:	Elevated temperature at AR1
What is the Cause:	Suspected air leakage

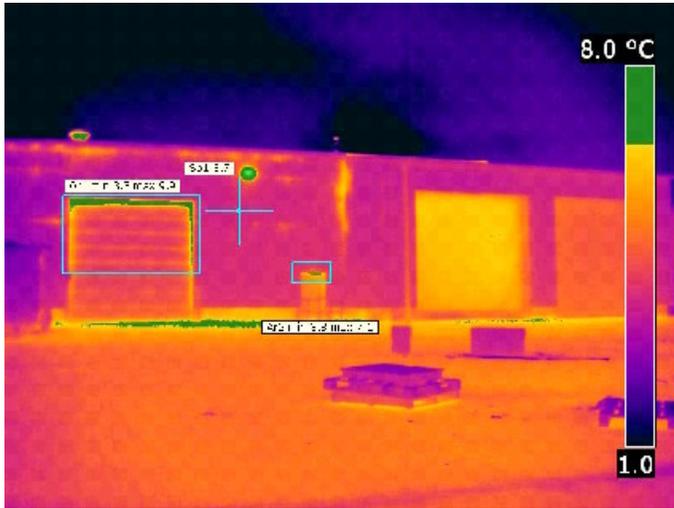
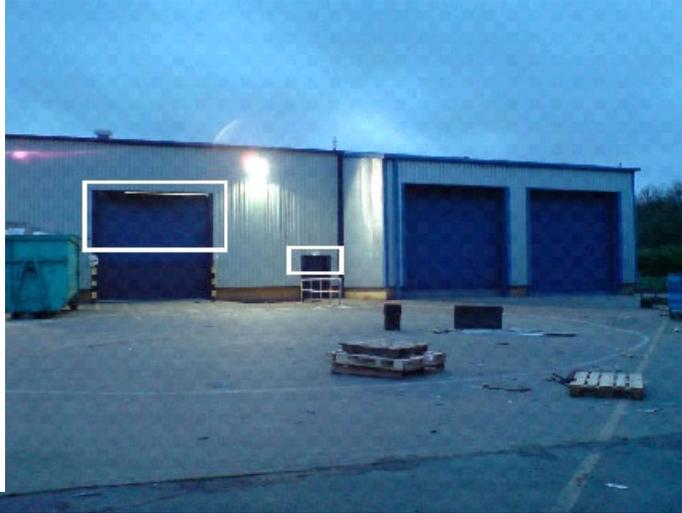
Photo File: IR_1383A.jpg

Location/Equipment Information	
Asset ID:	-
Barcode:	NI
Location:	SIDE ELEVATIONS SOUTH EAST

Repair Priority:	4-Minor
Hazard Type:	Visual
Hazard Classification:	Buildings
Hazard Group:	Elevated temperature
Hazard Issue:	at AR1 and AR2
Observations:	Elevated temperature at AR1 and AR2
What is the Cause:	Suspected air leakage

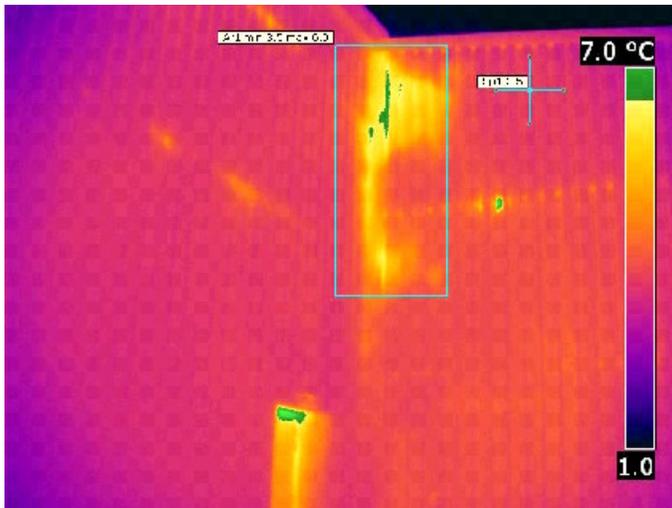
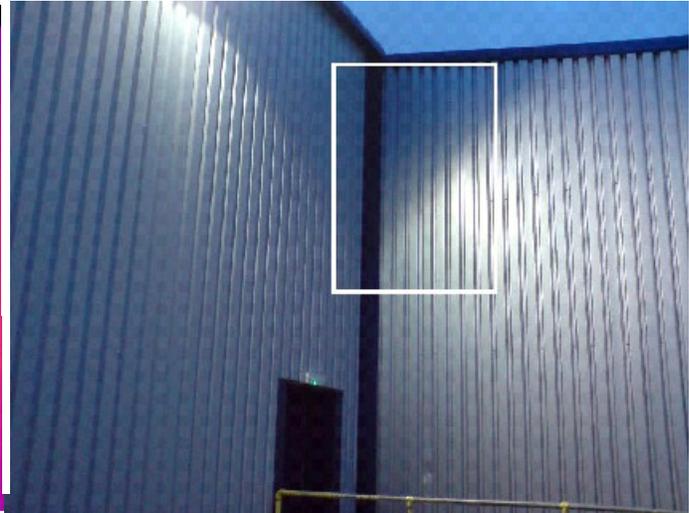
Photo File: IR_1385A.jpg

Location/Equipment Information	
Asset ID:	-
Barcode:	NI
Location:	SIDE ELEVATIONS SOUTH ABOVE REAR ACCESS DOOR

Repair Priority:	4-Minor
Hazard Type:	Visual
Hazard Classification:	Buildings
Hazard Group:	Elevated temperature
Hazard Issue:	at AR1
Observations:	Elevated temperature at AR1
What is the Cause:	Suspected insulation incontinuity

Repair Information		Loss to Production	
<p>PLEASE FAX BACK AFTER REPAIR TO: 0871 900 4978 OR INFO@THERMALIMAGING.CO.UK</p>		<input type="checkbox"/> Yes <input type="checkbox"/> No <input checked="" type="checkbox"/> Unknown	
		Consequences of Failure: <input type="text"/> _____ _____	Repair Date: <input type="text"/>
Parts Req. Before Failure: <input type="text"/> _____ _____	Root Cause: <input type="text"/> _____ _____	Repair Procedure: Check seals and insulation and repair or replace where necessary	
Parts Req. After Failure: <input type="text"/> _____ _____	Repair Notes: <input type="text"/> _____ _____		
Repair Recommendation: Repair, add or replace insulation as necessary

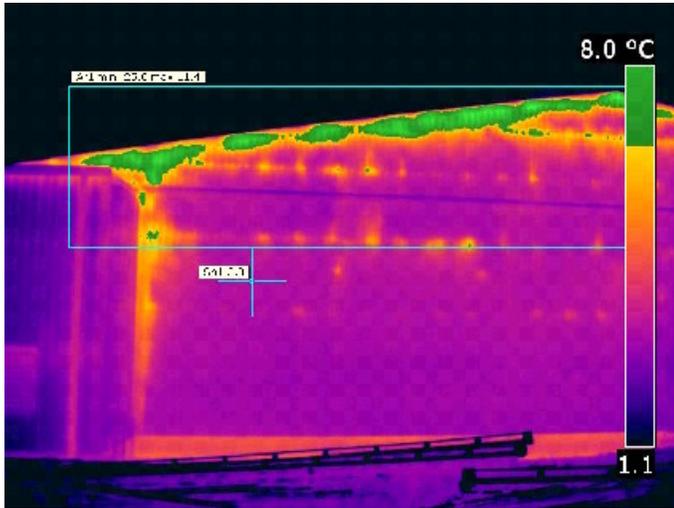
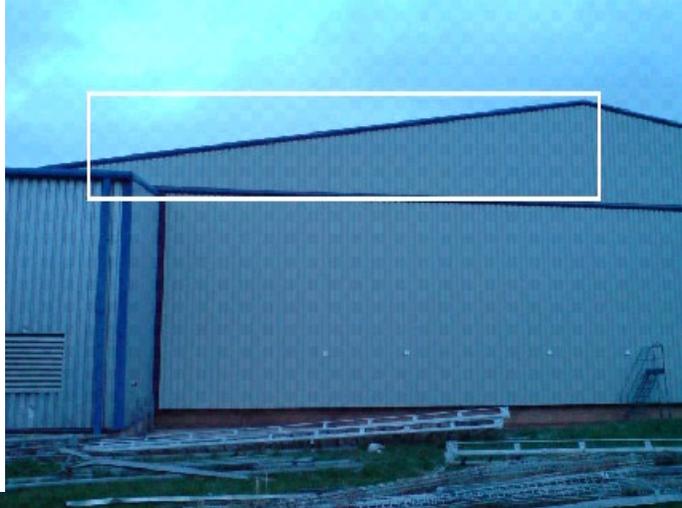
Photo File: IR_1389A.jpg

Location/Equipment Information	
Asset ID:	-
Barcode:	NI
Location:	SIDE ELEVATIONS EAST SOUTH SIDE

Repair Priority:	3-Important
Hazard Type:	Visual
Hazard Classification:	Buildings
Hazard Group:	Elevated temperature
Hazard Issue:	at AR1
Observations:	Elevated temperature at AR1
What is the Cause:	Insulation suspected of damp due to poor panel seals

Repair Information		Loss to Production	
<p>PLEASE FAX BACK AFTER REPAIR TO: 0871 900 4978 OR INFO@THERMALIMAGING.CO.UK</p>		<input type="checkbox"/> Yes <input type="checkbox"/> No <input checked="" type="checkbox"/> Unknown	
		Consequences of Failure: <input type="text"/> _____ _____	Repair Date: <input type="text"/>
Parts Req. Before Failure: <input type="text"/> _____ _____	Root Cause: <input type="text"/> _____ _____	Repair Procedure: <input type="text"/> _____ _____	
Parts Req. After Failure: <input type="text"/> _____ _____	Repair Notes: <input type="text"/> _____ _____	_____ _____	
Repair Recommendation: <input type="text"/> Repair or replace panel seals to prevent water ingress _____ _____

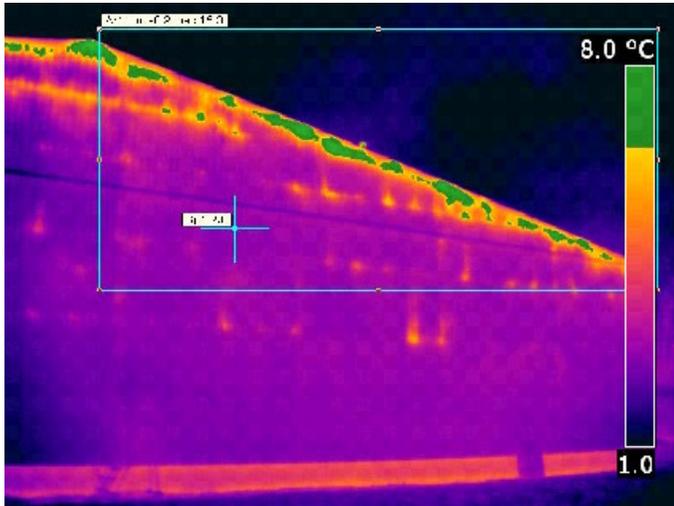
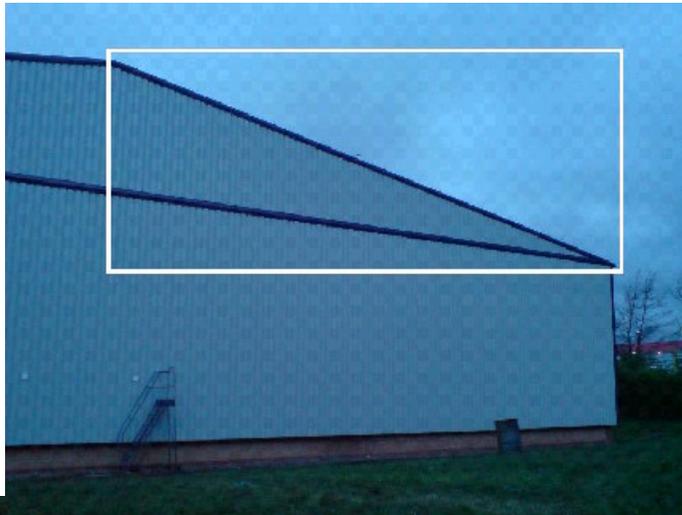
Photo File: IR_1391A.jpg

Location/Equipment Information	
Asset ID:	-
Barcode:	NI
Location:	SIDE ELEVATIONS EAST NORTH SIDE

Repair Priority:	3-Important
Hazard Type:	Visual
Hazard Classification:	Buildings
Hazard Group:	Elevated temperature
Hazard Issue:	at AR1
Observations:	Elevated temperature at AR1
What is the Cause:	Insulation suspected of damp due to poor panel seals

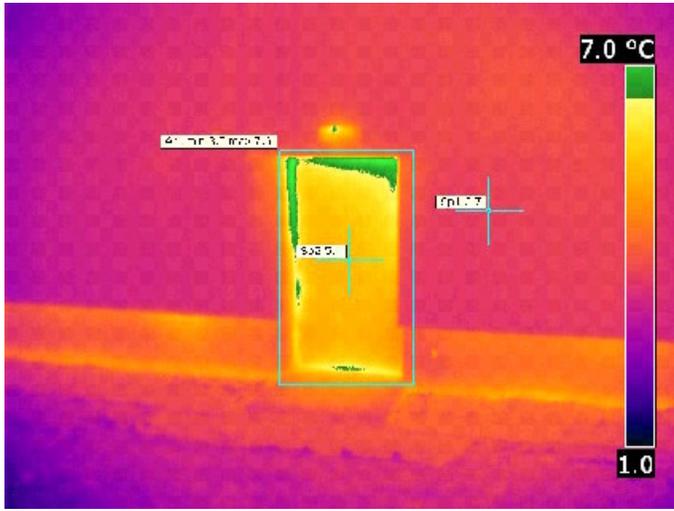
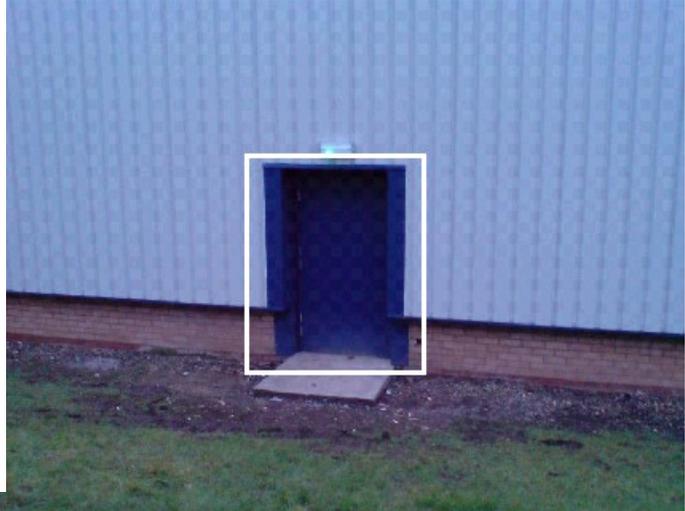
Photo File: IR_1399A.jpg

Location/Equipment Information	
Asset ID:	-
Barcode:	NI
Location:	SIDE ELEVATIONS NORTH ACCESS DOOR

Repair Priority:	4-Minor
Hazard Type:	Visual
Hazard Classification:	Buildings
Hazard Group:	Elevated temperature
Hazard Issue:	at AR1
Observations:	Elevated temperature at AR1
What is the Cause:	Suspected air leakage

Repair Information		Loss to Production	
<p>PLEASE FAX BACK AFTER REPAIR TO: 0871 900 4978 OR INFO@THERMALIMAGING.CO.UK</p>		<input type="checkbox"/> Yes <input type="checkbox"/> No <input checked="" type="checkbox"/> Unknown	
		Consequences of Failure: <input type="text"/> _____ _____	Repair Date: <input type="text"/>
Parts Req. Before Failure: <input type="text"/> _____ _____	Root Cause: <input type="text"/> _____ _____	Repair Procedure: Check seals and repair or replace where necessary	
Parts Req. After Failure: <input type="text"/> _____ _____	Repair Notes: <input type="text"/> _____ _____	Repair Recommendation: Check seals and repair or replace where necessary
