RISK MANAGEMENT THERMOGRAPHIC INSPECTION FOR:

THE PINNACLE – LIGHTING LEVEL 2A

MILTON KEYNES BUCKINGHAMSHIRE

TI-15367

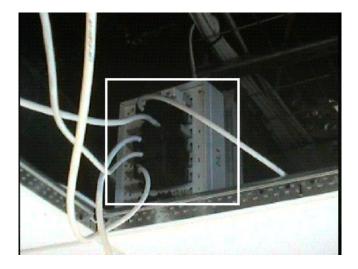
Report Date.	20/01/2012
Classification:	Electrical
Observations:	Dangerous work environment leading to possible HSE issues
What is the Caus	e: Equipment unfixed
Recommendatio	ns: Re-fit to required standard

Location/Equipment Information Asset ID: DB 7 7 L1 A DISTRIBUTION BOARD 7

Current Prob No: Visual/1						
Is Chronic:	No					
Operation Priority:	Critical to operation					
Repair Priority:	3-Important

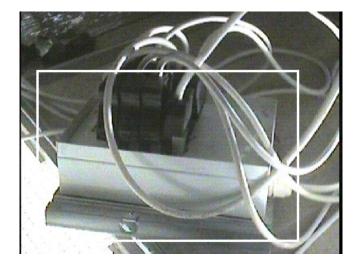
Classification:	Electrical
Observations:	Dangerous work environment leading to possible HSE issues
What is the Cause	e: Equipment unfixed
Recommendation	s: Re-fit to required standard

Location/Equipment Information Asset ID: DB 7 6 L2 A DISTRIBUTION BOARD 7 DB 7

Current Prob No: Visual/2							
Is Chronic:	No						
Operation Priority:	Critical to operation						
Repair Priority:	3-Important

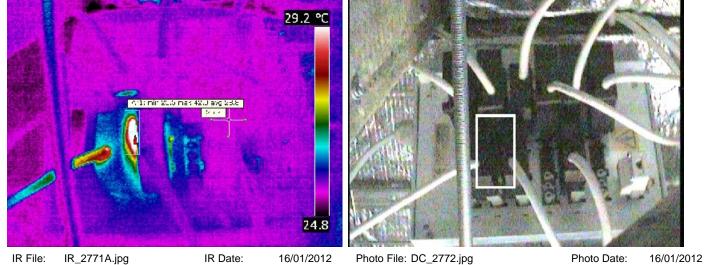
1732-1 Current Prob No: T/D Electrical/1

oment Information	Load Test Results		
DB 7 5 L2 B NI DISTRIBUTION BOARD 7 DB 7	Component Rated Load: Plug Connection: Plug Connection:	4 4	amps amps amps amps
	Thermal Information Operation Priority: Critical to operation		
Lighting Plug Connection Indicated higher	Repair Priority: 3-Important Ambient: 20 C Enviroment: Indoors		•
	Plug Connection Reference Temperature: Temperature Rise Above Reference:	34 (<u>26</u> (8 (С
Unknown NA : 240 Volts	ANSI/EEE/NEMA Max Allowable Temp @ 100% Load: Est Temp Rise over reference @ 50% Load:	50 C 3	С
	DB 7 5 L2 B NI DISTRIBUTION BOARD 7 DB 7 Lighting Plug Connection Indicated higher temperature than expected on Flourescent Unknown NA	DB 7 5 L2 B Component Rated Load: NI Plug Connection: DISTRIBUTION BOARD 7 Plug Connection: DB 7 Plug Connection: Lighting Operation Priority: Critical to operation Plug Connection Indicated higher Ma Operation Priority: S-Important Unknown NA Ambient: 20 C Environment: Indoors Value Plug Connection Reference Thermal unformation Component Rated Load: Est Temp Rise over reference @ 50% Load:	DB 7 5 L2 B Component Rated Load: 5 NI Plug Connection: 4 DISTRIBUTION BOARD 7 Plug Connection: 4 DB 7 Plug Connection: 4 Lighting Plug Connection Indicated higher Operation Priority: Critical to operation Plug Connection Indicated higher Component Temperature On Plug Connectio 34 Unknown NA Na Solution Reference: 8

Repair Information Consequences of Failure:	PLEASE FAX BACK AFTER REPAIR TO: 0871 900 4978 OR INFO@THERMALIMAGING.CO.UK	Loss to Produ	uction	Unknown
POSSIBLE FIRE RISK	Repair Date:		Repaired By:	
Parts Req. Before Failure:	Root Cause:			
Parts Req. After Failure:	Repair Procedure:			
Repair Recommendation:	Repair Action:			
Further investigation required

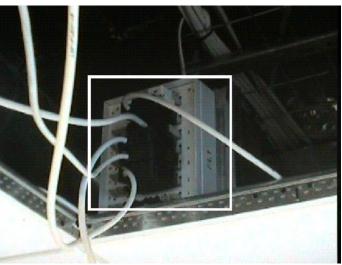
1732-1 Current Prob No: Visual/1

Location/Equi	pment information		
Asset ID:	DB 7 7 L1 A	Operation Priority:	Critical to operation
Barcode:	NI	Repair Priority:	3-Important
Location:	DISTRIBUTION BOARD 7 DB 7	Hazard Type:	Visual
		Hazard Classification:	Electrical
		Hazard Group:	Dangerous work environment
		Hazard Issue:	leading to possible HSE issues
		Observations:	Dangerous work environment leading to possible HSE issues
		What is the Cause:	Equipment unfixed

Photo File:	Photo Date:	Photo File:	DC_2741.jpg	Photo Date: 16/01/2012
Repair Information	PLEASE FAX BACK A 0871 900 4 INFO@THERMALI	1978 OR	UK Yes	duction No Unknown red By:
		Root Cause:		
Parts Req. Before Failure:				
		Repair	Re-fit to required standa	ard
Parts Req. After Failure:		Procedure:		
		Repair Notes:		
Repair Recommendation:				
Re-fit to required standard

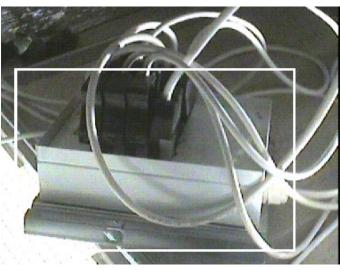
1732-2 Current Prob No: Visual/2

Location/Equipment Information			
Asset ID:	DB 7 6 L2 A	Operation Priority:	Critical to operation
Barcode:	NI	Repair Priority:	3-Important
Location:	DISTRIBUTION BOARD 7 DB 7	Hazard Type:	Visual
		Hazard Classification:	Electrical
		Hazard Group:	Dangerous work environment
		Hazard Issue:	leading to possible HSE issues
		Observations:	Dangerous work environment leading to possible HSE issues
		What is the Cause:	Equipment unfixed

Photo File:	Photo Date:	Photo File:	DC_2751.jpg	Photo Date: 16/01/2012
Repair Information	PLEASE FAX BACK / 0871 900 / INFO@THERMAL	4978 OR	Loss to Produc	□ No ✔ Unknown
Parts Req. Before Failure:		Root Cause:		
Parts Req. After Failure:		Repair Procedure:	Re-fit to required standard	I
Repair Recommendation:		Repair Notes:		
Re-fit to required standard
