RISK MANAGEMENT THERMOGRAPHIC MECHANICAL INSPECTION FOR:

SAMPLE

20/10/10

TI-13513

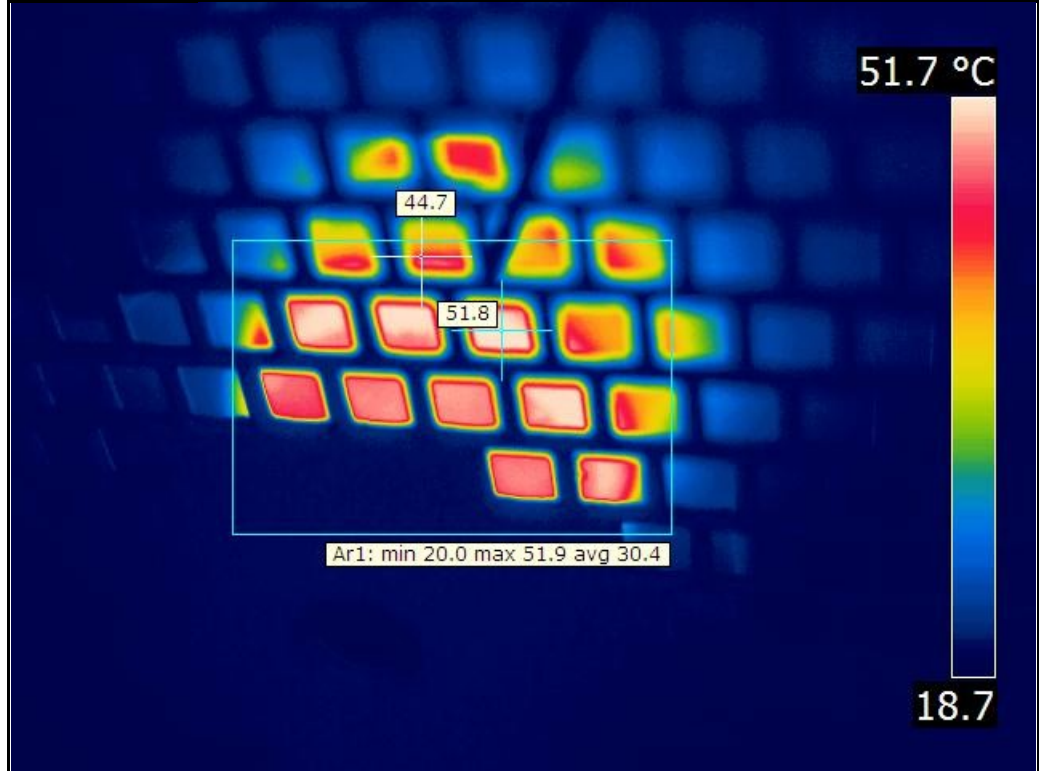
Infrared Image: IR_16569A.jpg	Date: 26/10/2010
-------------------------------	------------------

Location / Equipment Information	
Work Order	NOT ISSUED
Equipment ID	1K-P53202
Location	
Description	WATER PUMP NO. 2
Severity	4-Minor
Anomaly	Elevated bearing temperature on 22kwh 3 Phase Motor
Possible Root Cause	Deteriorated running bearing
Recommendation	Investigate bearing internals and either recondition or replace

Current Prob No: Mechanical/1	
Operation Priority:	Critical to operation
Max Component Temperature - Ar1 Max Temperature	52 C
Reference Temperature or SP2 Temperature	45 C
Temperature Rise Above Reference	7 C
Maximum allowable Temperature British Standard Reference	75 C
British Standard Reference - BS7671

Temperature Information	
Cubicle ambient:	21 C
Emissivity:	0.96
Environment:	Indoors
Adjusted Temperature Rise above reference:	7 C
Estimated Temp Rise over reference @ 50% Load: (See * 1)	C
Estimated Temp Rise over reference @ 100% Load: (See * 2)	C

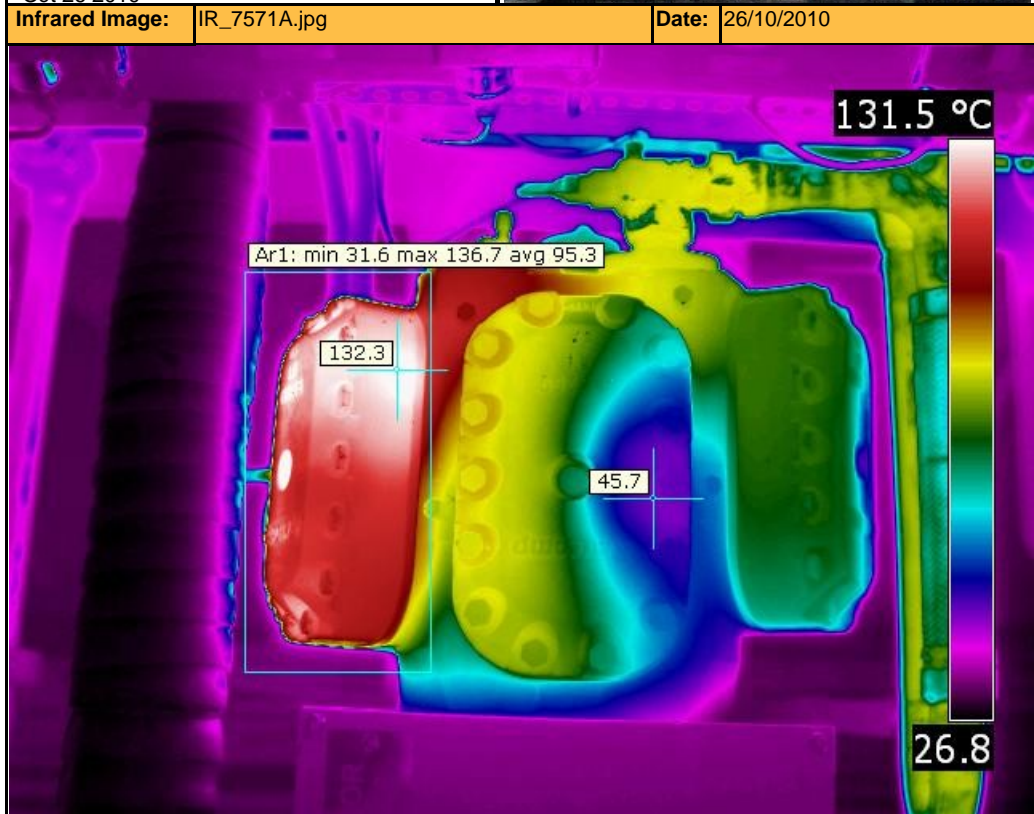
Location / Equipment Information	
Work Order	NOT ISSUED
Equipment ID	1S-HCOM7703
Location	
Description	COMPRESSOR 12
Severity	1-Critical
Anomaly	Overheated cylinder head on Compressor
Possible Root Cause	Unknown
Recommendation	Investigate and repair or replace

Current Prob No: Mechanical/2	
Operation Priority:	Critical to operation
Max Component Temperature - Ar1 Max Temperature	137 C
Reference Temperature or SP2 Temperature	46 C
Temperature Rise Above Reference	91 C
Maximum allowable Temperature British Standard Reference	75 C
British Standard Reference - BS7671

Temperature Information	
Cubicle ambient:	21 C
Emissivity:	0.96
Environment:	Indoors
Adjusted Temperature Rise above reference:	91 C
Estimated Temp Rise over reference @ 50% Load: (See * 1)	C
Estimated Temp Rise over reference @ 100% Load: (See * 2)	C

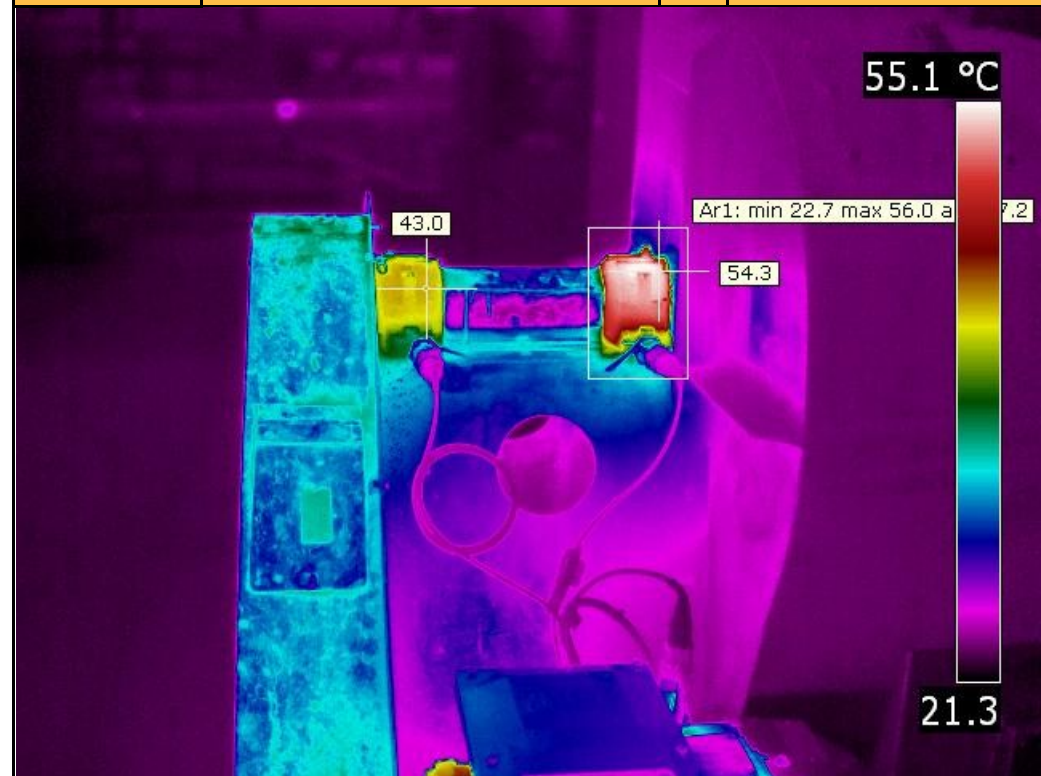
Infrared Image: IR_19237A.jpg	Date: 26/10/2010
-------------------------------	------------------

Location / Equipment Information	
Work Order	NOT ISSUED
Equipment ID	LSB-4002B-BF8D
Location	
Description	EXTRACT FAN MOTOR RESERVE TANK
Severity	3-Important
Anomoly	Elevated bearing temperature on 22KWH 3 PHASE MOTOR
Possible Root Cause	Deteriorated running bearing
Recommendation	Investigate bearing internals and either recondition or replace

Current Prob No: Mechanical/3	
Operation Priority:	Critical to operation
Max Component Temperature - Ar1 Max Temperature	57 C
Reference Temperature or SP2 Temperature	43 C
Temperature Rise Above Reference	14 C
Maximum allowable Temperature British Standard Reference	75 C
British Standard Reference - BS7671

Temperature Information	
Cubicle ambient:	21 C
Emissivity:	0.96
Environment:	Indoors
Adjusted Temperature Rise above reference:	14 C
Estimated Temp Rise over reference @ 50% Load: (See * 1)	C
Estimated Temp Rise over reference @ 100% Load: (See * 2)	C

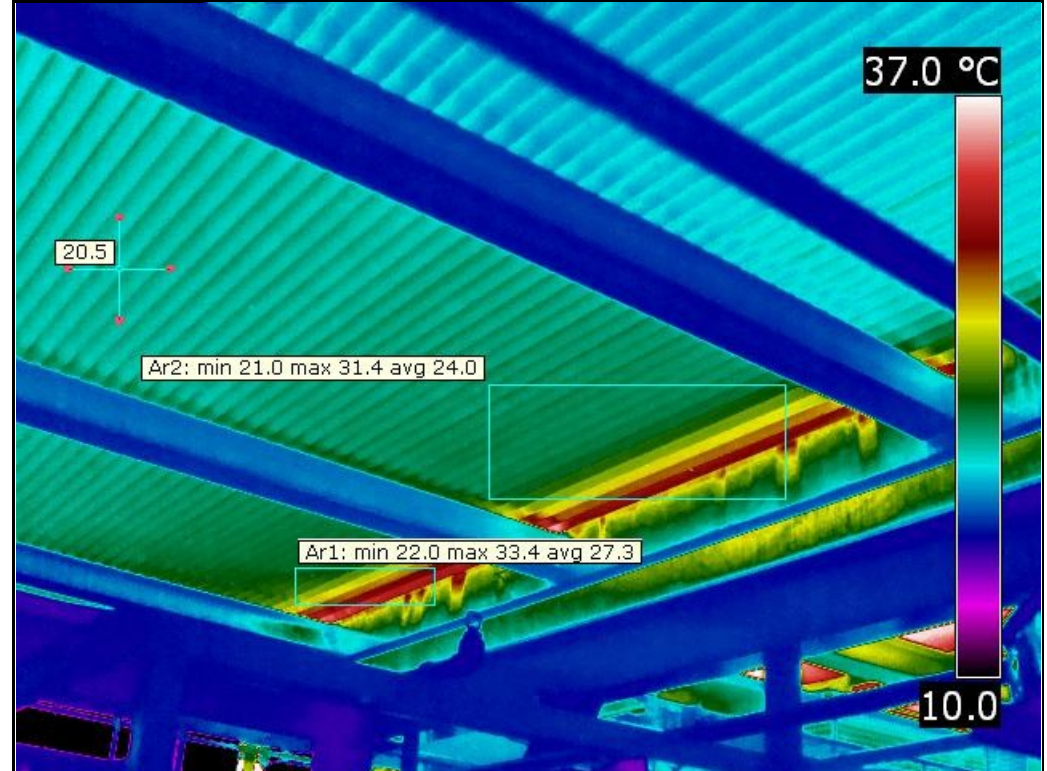
Infrared Image: IR_2010-02-05_0095.jpg	Date: 26/10/2010
--	------------------

Location / Equipment Information	
Work Order	NOT ISSUED
Equipment ID	1G-2376YF4-1B
Location	
Description	TRAIN 1 FIN FAN BANK
Severity	3-Important
Anomaly	Elevated temperature on Fin Fan
Possible Root Cause	Unknown
Recommendation	Investigate and repair or replace

Current Prob No: Mechanical/4	
Operation Priority:	Critical to operation
Max Component Temperature - Ar1 Max Temperature	33 C
Reference Temperature or SP2 Temperature	21 C
Temperature Rise Above Reference	12 C
Maximum allowable Temperature British Standard Reference	75 C
British Standard Reference - BS7671

Temperature Information	
Cubicle ambient:	21 C
Emissivity:	0.96
Environment:	Indoors
Adjusted Temperature Rise above reference:	12 C
Estimated Temp Rise over reference @ 50% Load: (See * 1)	C
Estimated Temp Rise over reference @ 100% Load: (See * 2)	C

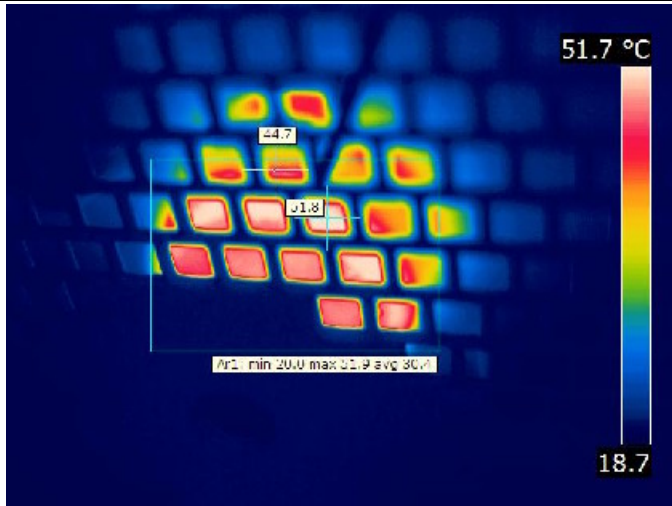
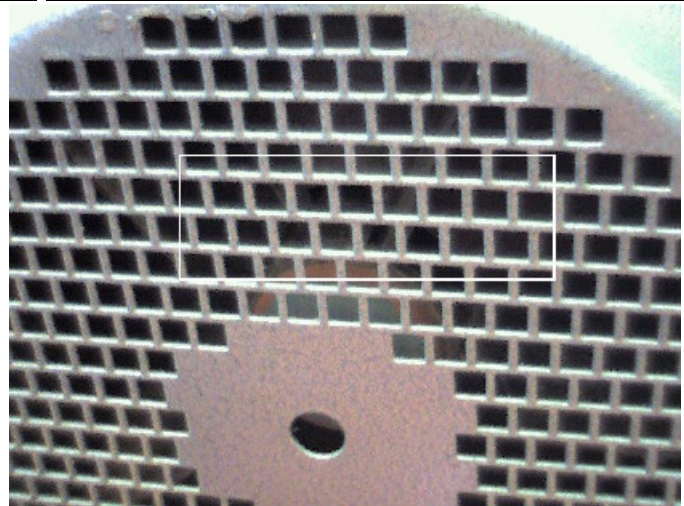
IR File: IR_16569A.jpg

Operation Priority:	Critical to operation
Repair Priority:	4-Minor
Ambient:	21 C Enviroment: Indoors
Component Temperature:	52 C
Reference Temperature:	45 C
Temperature Rise Above Reference:	7 C
ANSI/EEE/NEMA Max Allowable Temp @ 100% Load:	65 C

Investigate bearing internals and either recondition or replace

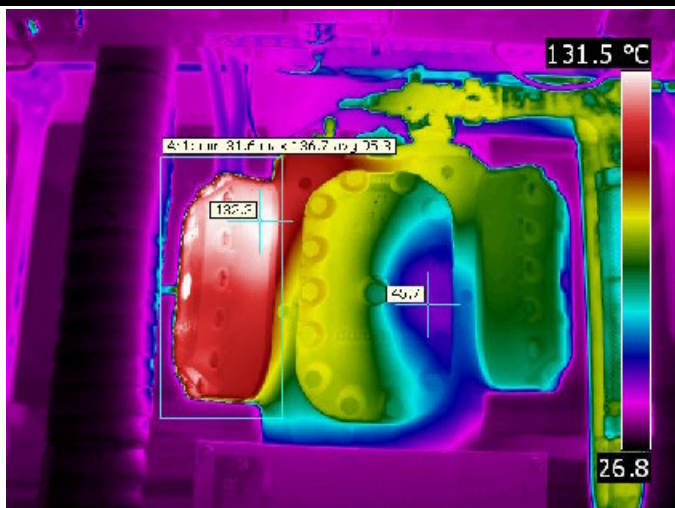
IR File: IR_7571A.jpg

Operation Priority:	Critical to operation
Repair Priority:	1-Critical
Ambient:	21 C Enviroment: Indoors
Component Temperature:	137 C
Reference Temperature:	46 C
Temperature Rise Above Reference:	91 C
ANSI/EEE/NEMA Max Allowable Temp @ 100% Load:	100 C

Investigate and repair or replace

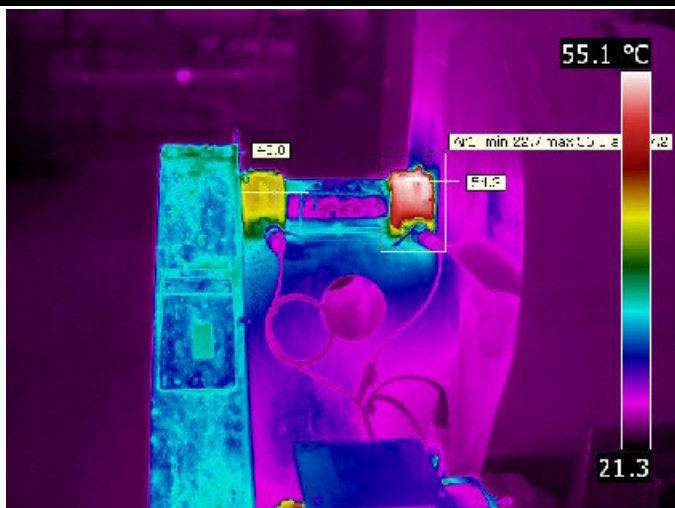
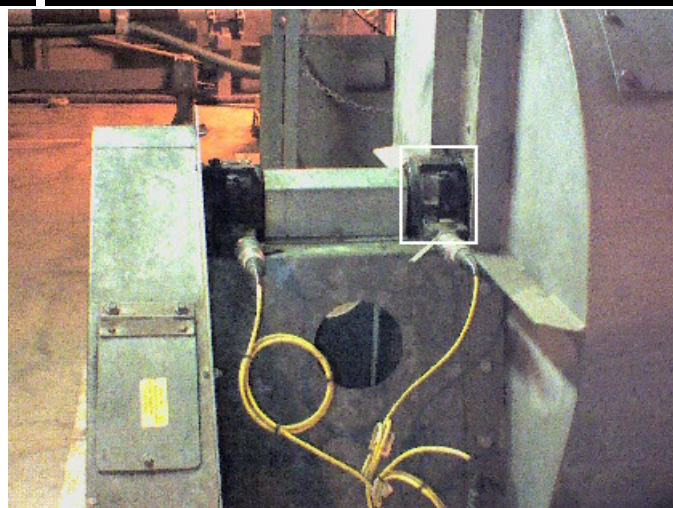
IR File: IR_19237A.jpg

Operation Priority:	Critical to operation
Repair Priority:	3-Important
Ambient:	21 C Enviroment: Indoors
Component Temperature:	57 C
Reference Temperature:	43 C
Temperature Rise Above Reference:	14 C
ANSI/EEE/NEMA Max Allowable Temp @ 100% Load:	65 C

Investigate bearing internals and either recondition or replace

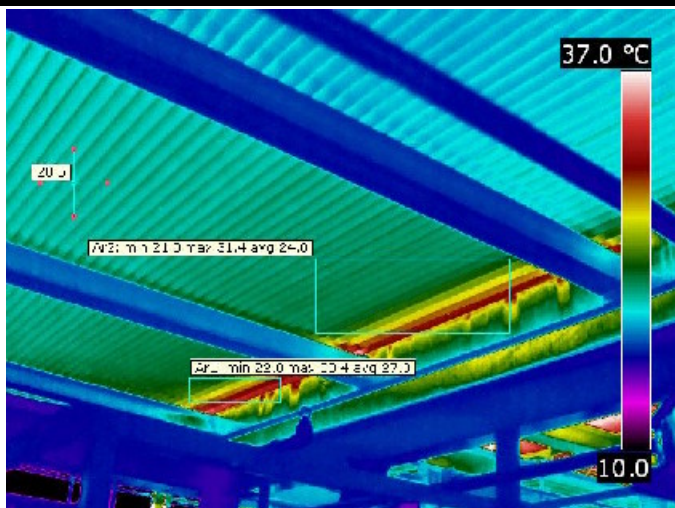
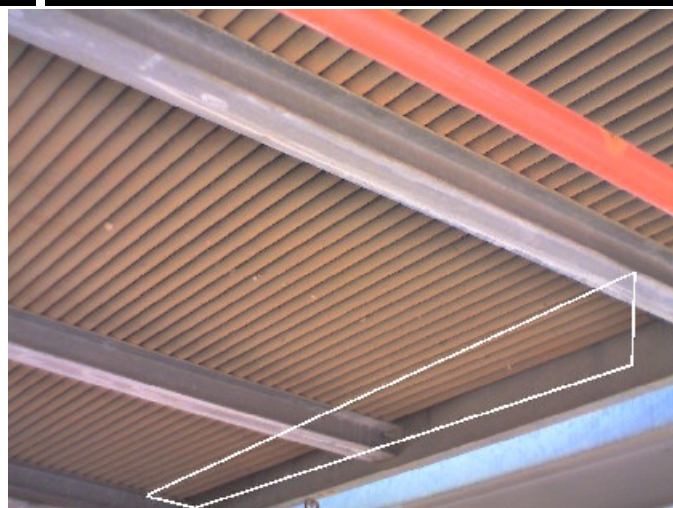
IR File: IR_2010-02-05_0095.jpg

Operation Priority:	Critical to operation
Repair Priority:	3-Important
Ambient:	21 C
Environment:	Indoors
Component Temperature:	33 C
Reference Temperature:	21 C
Temperature Rise Above Reference:	12 C
ANSI/EEE/NEMA Max Allowable Temp @ 100% Load:	40 C

Investigate and repair or replace
