RISK MANAGEMENT ELECTRICAL THERMOGRAPHIC INSPECTION FOR:

TI UPS CELLS DISCHARGING SAMPLE

UNIT 8 66 YORK ROAD
WEYBRIDGE
SURREY
KT13 9DY

22/11/11

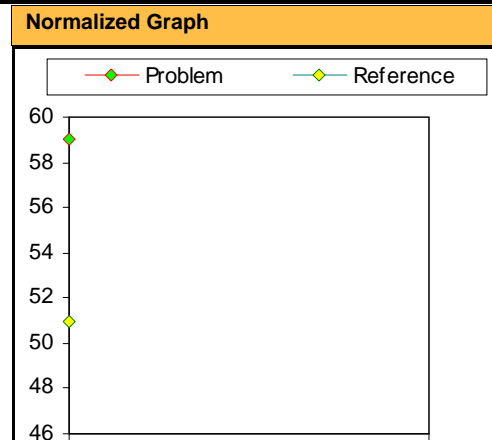
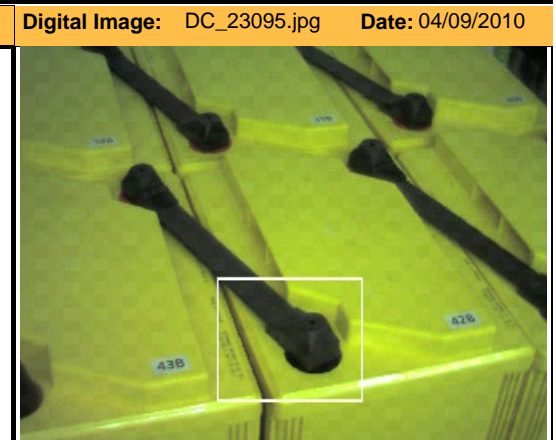
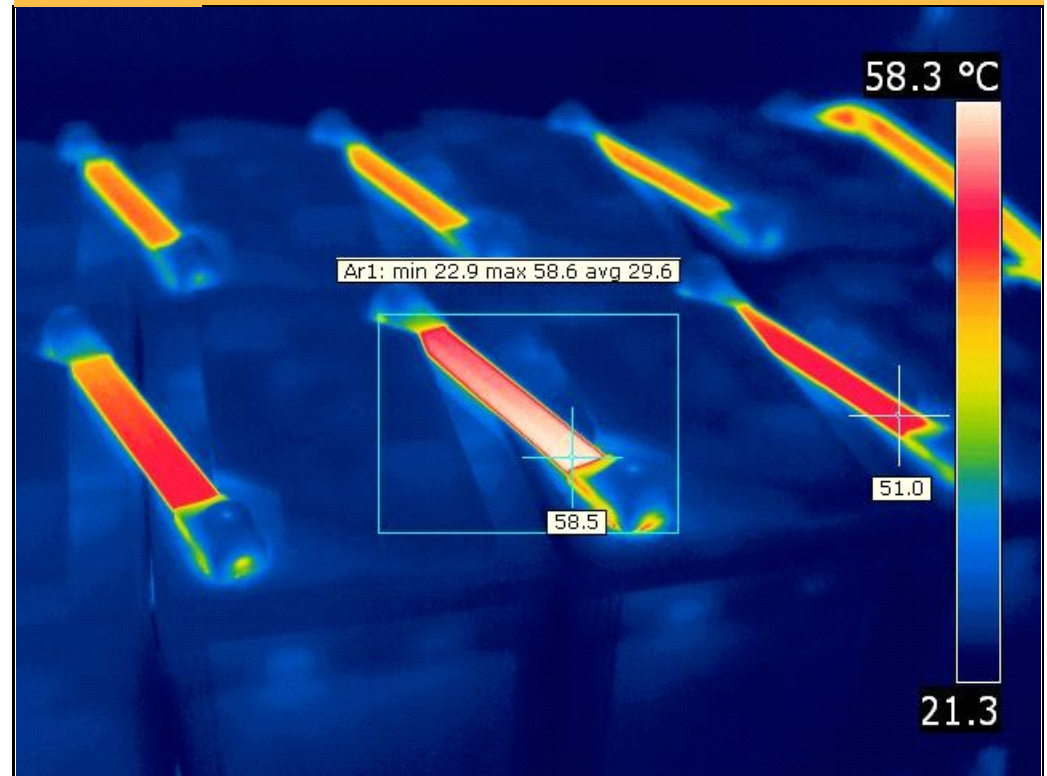
Infrared Image: IR_23094a.jpg **Date:** 04/09/2010

Location / Equipment Information	
Work Order	NOT ISSUED
Equipment ID	B203804
Location	UPSA3
Description	STRING A
Severity	3-Important
Anomaly	Cell link 43A-42A connection indicates higher temperature than expected on 6v cell
Possible Root Cause	Suspected loose/deteriorated connection
Recommendation	Check, clean & re-make connection

Current Prob No: T/D Electrical/1	
Operation Priority:	Critical to operation
Max Component Temperature - Ar1 Max Temperature	59 C
Reference Temperature or SP2 Temperature	51 C
Temperature Rise Above Reference	8 C
Maximum allowable Temperature British Standard Reference	75 C
British Standard Reference - BS7671

Temperature Information	
Cubicle ambient:	22 C
Emissivity:	0.96
Environment:	Indoors
Adjusted Temperature Rise above reference:	8 C
Estimated Temp Rise over reference @ 50% Load: (See * 1)	0 C
Estimated Temp Rise over reference @ 100% Load: (See * 2)	0 C

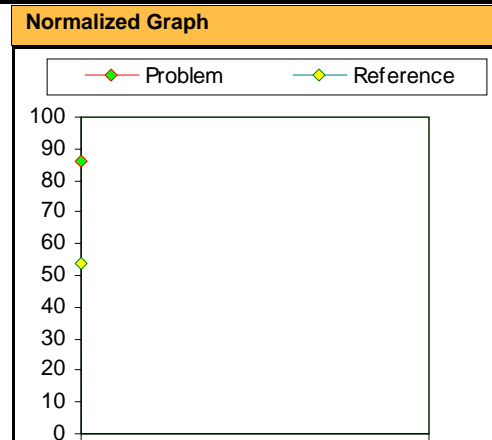
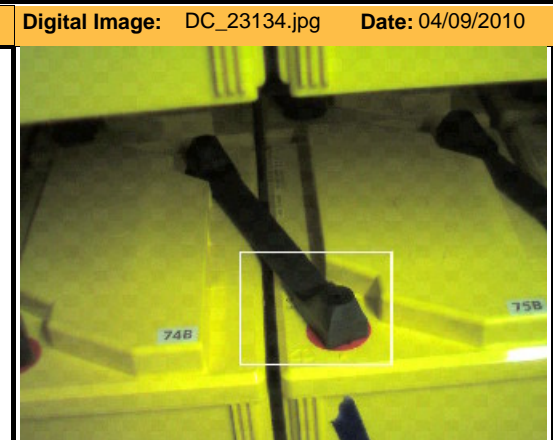
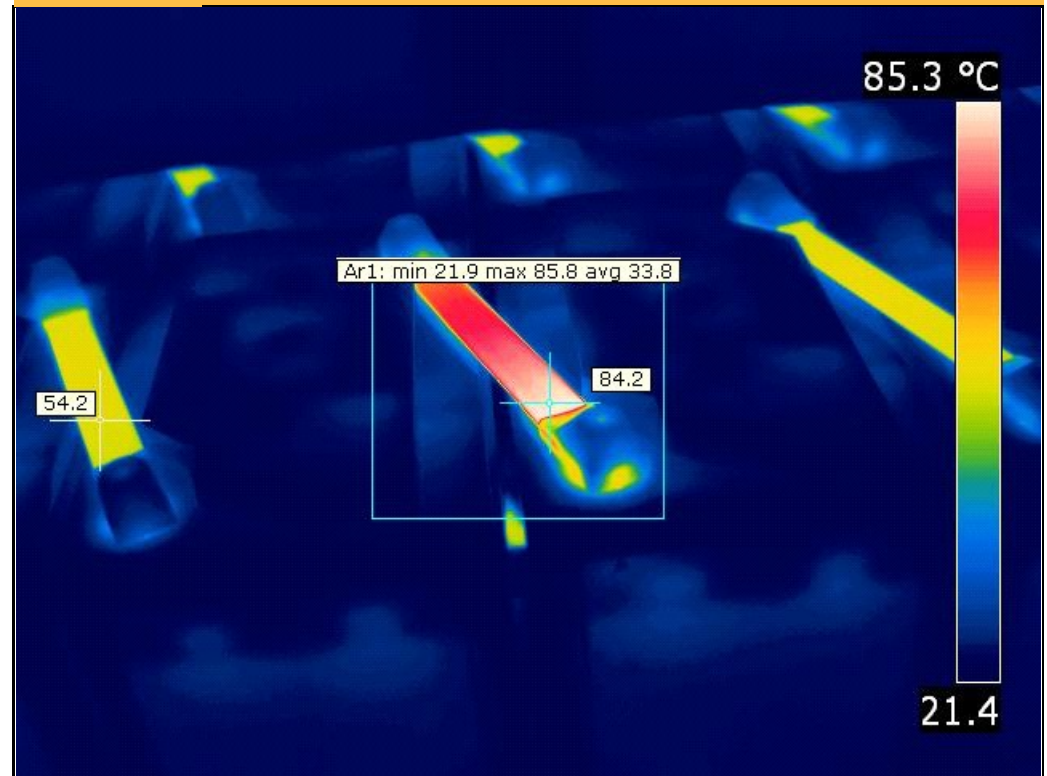
Infrared Image: IR_23133a.jpg Date: 04/09/2010

Location / Equipment Information	
Work Order	NOT ISSUED
Equipment ID	B203804
Location	UPSA3
Description	STRING B
Severity	2-Serious
Anomaly	Cell link 74B-75B connection indicates higher temperature than expected on 6v cell
Possible Root Cause	Suspected loose/deteriorated connection
Recommendation	Check, clean & re-make connection

Current Prob No: T/D Electrical/2	
Operation Priority:	Critical to operation
Max Component Temperature - Ar1 Max Temperature	86 C
Reference Temperature or SP2 Temperature	54 C
Temperature Rise Above Reference	32 C
Maximum allowable Temperature British Standard Reference	75 C
British Standard Reference - BS7671

Temperature Information	
Cubicle ambient:	22 C
Emissivity:	0.96
Environment:	Indoors
Adjusted Temperature Rise above reference:	32 C
Estimated Temp Rise over reference @ 50% Load: (See * 1)	0 C
Estimated Temp Rise over reference @ 100% Load: (See * 2)	0 C

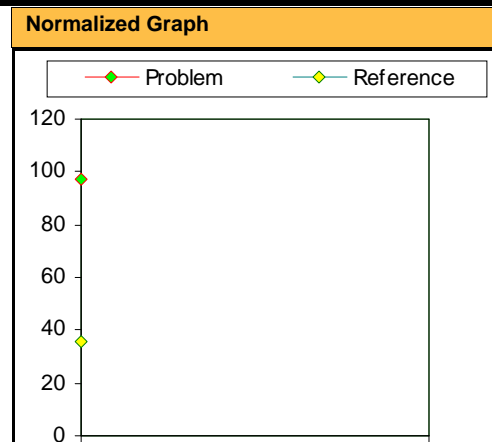
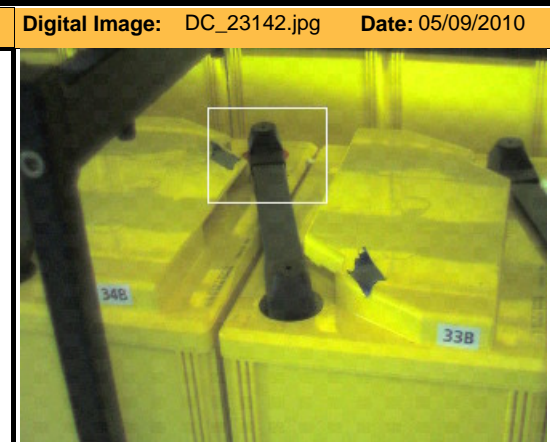
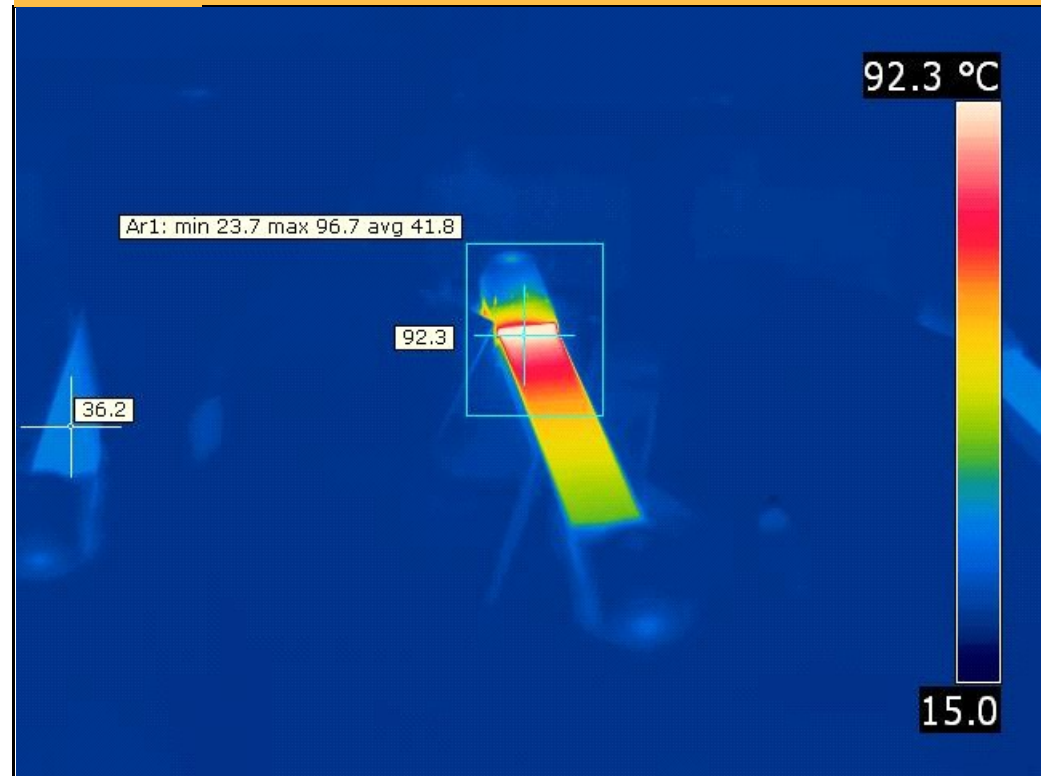
Infrared Image: IR_23141a.jpg **Date:** 05/09/2010

Location / Equipment Information	
Work Order	NOT ISSUED
Equipment ID	B203722
Location	UPSA1
Description	STRING B
Severity	1-Critical
Anomaly	Cell link 33B-34B connection indicates higher temperature than expected on 6v cell
Possible Root Cause	Suspected loose/deteriorated connection
Recommendation	Check, clean & re-make connection

Current Prob No: T/D Electrical/3	
Operation Priority:	Critical to operation
Max Component Temperature - Ar1 Max Temperature	97 C
Reference Temperature or SP2 Temperature	36 C
Temperature Rise Above Reference	61 C
Maximum allowable Temperature British Standard Reference	75 C
British Standard Reference - BS7671

Temperature Information	
Cubicle ambient:	22 C
Emissivity:	0.96
Environment:	Indoors
Adjusted Temperature Rise above reference:	61 C
Estimated Temp Rise over reference @ 50% Load: (See * 1)	0 C
Estimated Temp Rise over reference @ 100% Load: (See * 2)	0 C

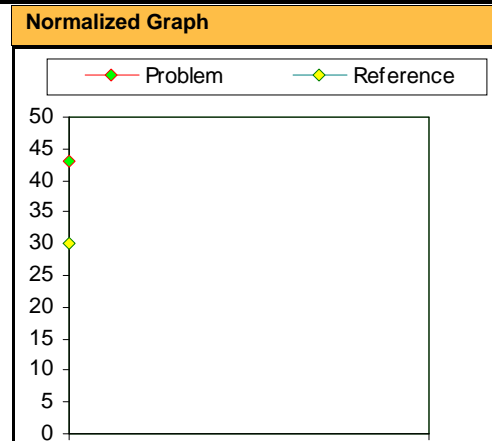
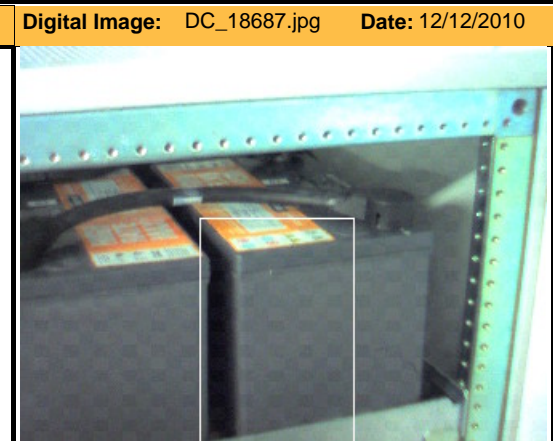
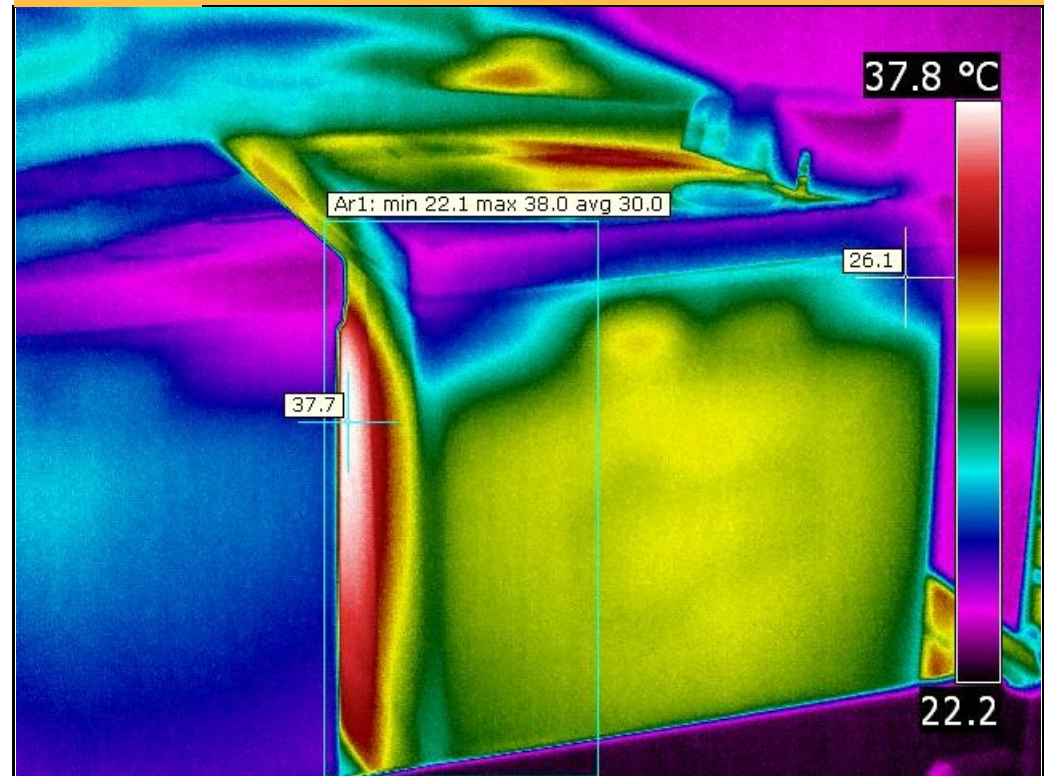
Infrared Image: IR_18686a.jpg Date: 12/12/2010

Location / Equipment Information	
Work Order	NOT ISSUED
Equipment ID	B204784
Location	UPSA4
Description	STRING A
Severity	3-Important
Anomaly	Indicated higher temperature than expected on 6v cell
Possible Root Cause	Suspected internal problem
Recommendation	Either replace or investigate internal contacts to determine source of temperature anomaly

Current Prob No: T/D Electrical/4	
Operation Priority:	Critical to operation
Max Component Temperature - Ar1 Max Temperature	43 C
Reference Temperature or SP2 Temperature	30 C
Temperature Rise Above Reference	13 C
Maximum allowable Temperature British Standard Reference	75 C
British Standard Reference - BS7671

Temperature Information	
Cubicle ambient:	22 C
Emissivity:	0.96
Environment:	Indoors
Adjusted Temperature Rise above reference:	13 C
Estimated Temp Rise over reference @ 50% Load: (See * 1)	0 C
Estimated Temp Rise over reference @ 100% Load: (See * 2)	0 C

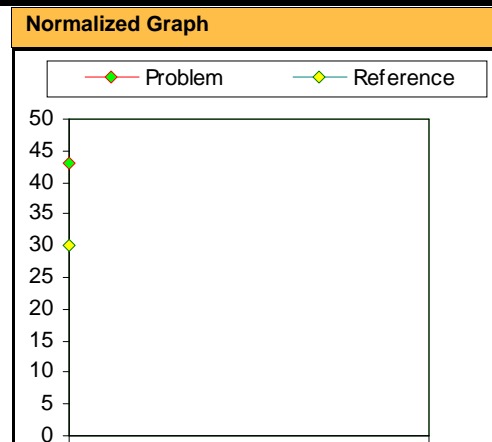
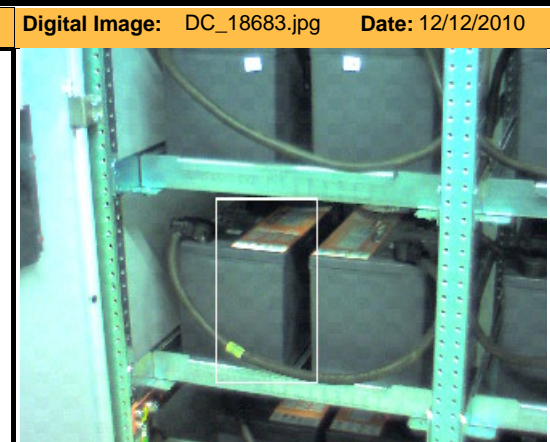
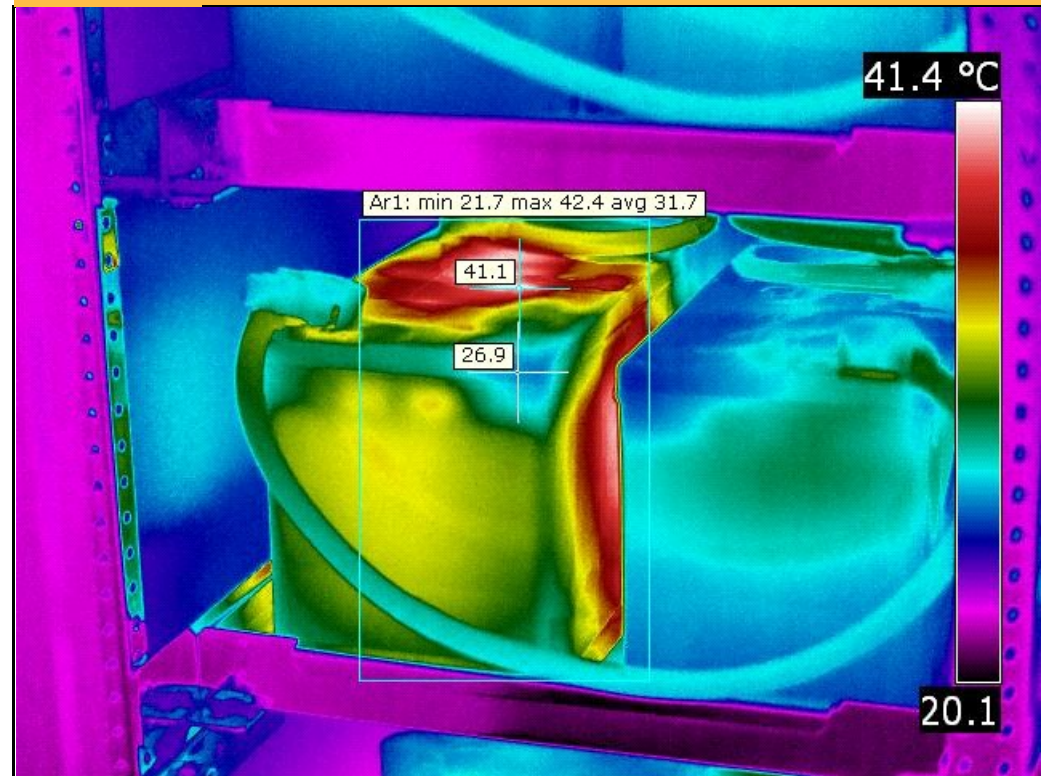
Infrared Image: IR_18682a.jpg Date: 12/12/2010

Location / Equipment Information	
Work Order	NOT ISSUED
Equipment ID	B203806
Location	UPSA2
Description	STRING B
Severity	3-Important
Anomaly	Indicated higher temperature than expected on 6v cell no.8
Possible Root Cause	Suspected internal problem
Recommendation	Either replace or investigate internal contacts to determine source of temperature anomaly

Current Prob No: T/D Electrical/5	
Operation Priority:	Critical to operation
Max Component Temperature - Ar1 Max Temperature	43 C
Reference Temperature or SP2 Temperature	30 C
Temperature Rise Above Reference	13 C
Maximum allowable Temperature British Standard Reference	75 C
British Standard Reference - BS7671

Temperature Information	
Cubicle ambient:	22 C
Emissivity:	0.96
Environment:	Indoors
Adjusted Temperature Rise above reference:	13 C
Estimated Temp Rise over reference @ 50% Load: (See * 1)	0 C
Estimated Temp Rise over reference @ 100% Load: (See * 2)	0 C

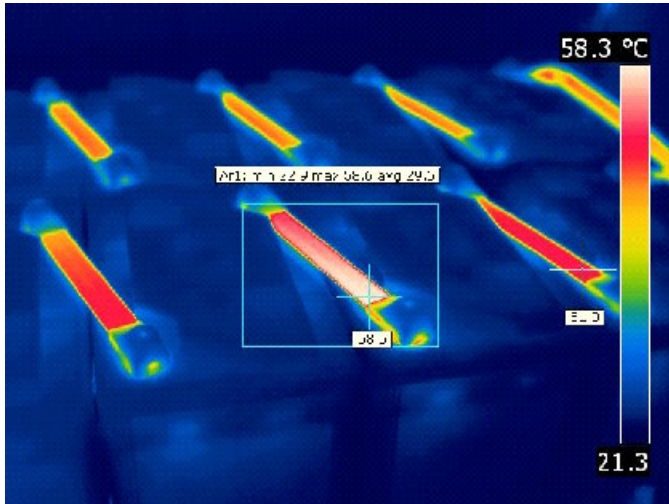
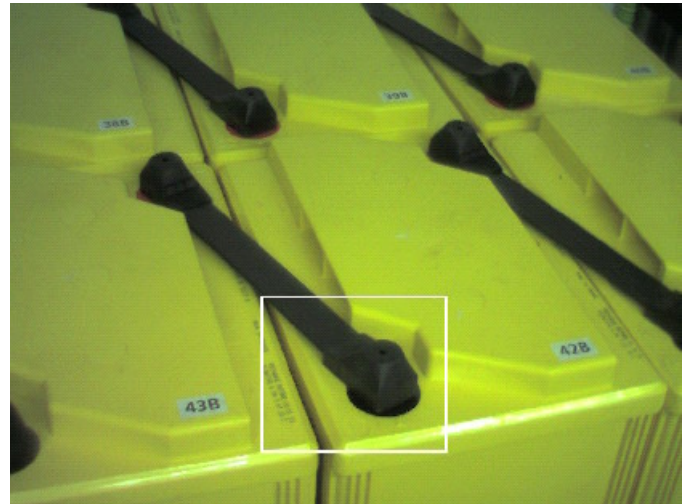
IR File: IR_23094a.jpg

Thermal Information	
Operation Priority:	Critical to operation
Repair Priority:	3-Important
Ambient:	22 C Enviroment: Indoors
Component Temperature On -:	59 C
- Reference Temperature:	51 C
Temperature Rise Above Reference:	8 C
ANSI/EEE/NEMA Max Allowable Temp @ 100% Load:	75 C
Est Temp Rise over reference @ 50% Load:	0
Est Temp Rise over reference @ 100% Load:	0

Repair Information Consequences of Failure: Loss of STRING A <hr/> Parts Req. Before Failure: <hr/> Parts Req. After Failure: <hr/> Repair Recommendation: Check, clean & re-make connection <hr/>	PLEASE FAX BACK AFTER REPAIR TO: 0871 900 4978 OR INFO@THERMALIMAGING.CO.UK		Loss to Production <input type="checkbox"/> Yes <input type="checkbox"/> No <input checked="" type="checkbox"/> Unknown	
	Repair Date: <input type="text"/>	Repaired By: <input type="text"/>		
	Root Cause: <input type="text"/>			
	Repair Procedure: <input type="text"/>			
	Repair Action: <input type="text"/>

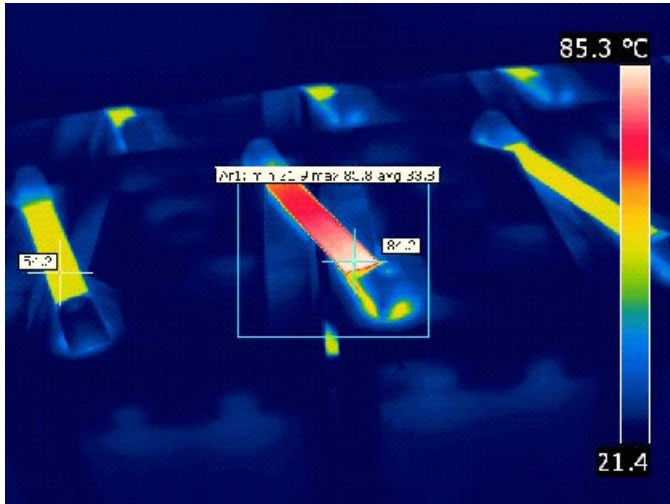
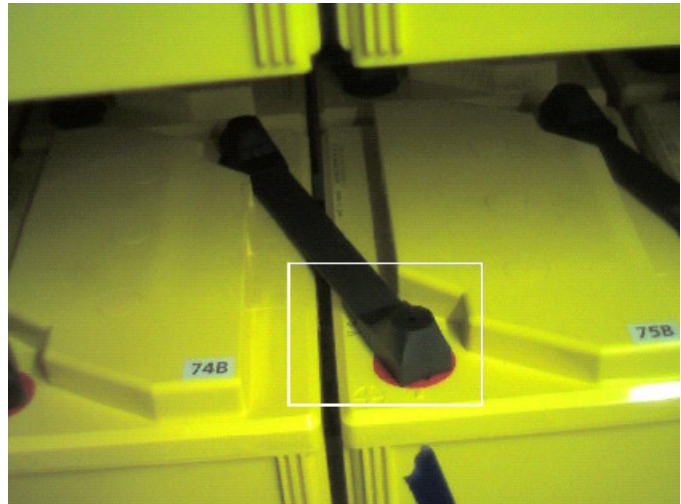
IR File: IR_23133a.jpg

Thermal Information	
Operation Priority:	Critical to operation
Repair Priority:	2-Serious
Ambient:	22 C Enviroment: Indoors
Component Temperature On -:	86 C
- Reference Temperature:	54 C
Temperature Rise Above Reference:	32 C
ANSI/EEE/NEMA Max Allowable Temp @ 100% Load:	75 C
Est Temp Rise over reference @ 50% Load:	0
Est Temp Rise over reference @ 100% Load:	0

PLEASE FAX BACK AFTER REPAIR TO:		Loss to Production	
0871 900 4978 OR		<input type="checkbox"/> Yes <input type="checkbox"/> No <input checked="" type="checkbox"/> Unknown	
INFO@THERMALIMAGING.CO.UK			
Repair Information			
Consequences of Failure:	Repair Date:	<input style="width: 100px;" type="text"/>	Repaired By: <input style="width: 100px;" type="text"/>
Loss of STRING B	Root Cause:	<input style="width: 100%; height: 20px;" type="text"/>	
Parts Req. Before Failure:	Repair Procedure:	<input style="width: 100%; height: 20px;" type="text"/>	
<input style="width: 100%; height: 20px;" type="text"/>	Repair Action:	<input style="width: 100%; height: 20px;" type="text"/>	
Parts Req. After Failure:			
<input style="width: 100%; height: 20px;" type="text"/>			
Repair Recommendation:			
Check, clean & re-make connection

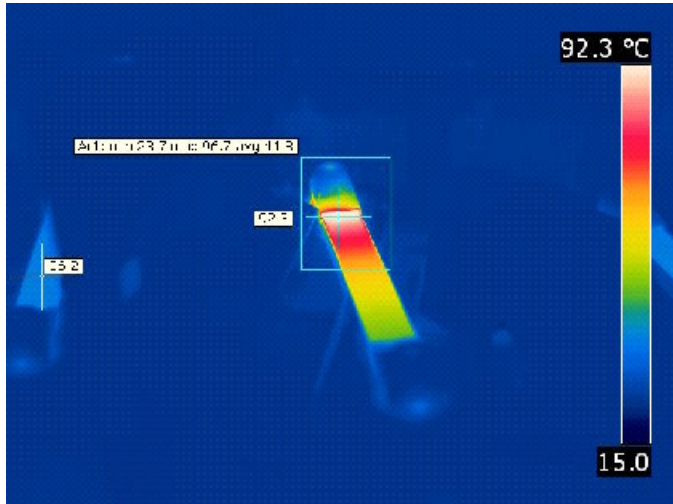
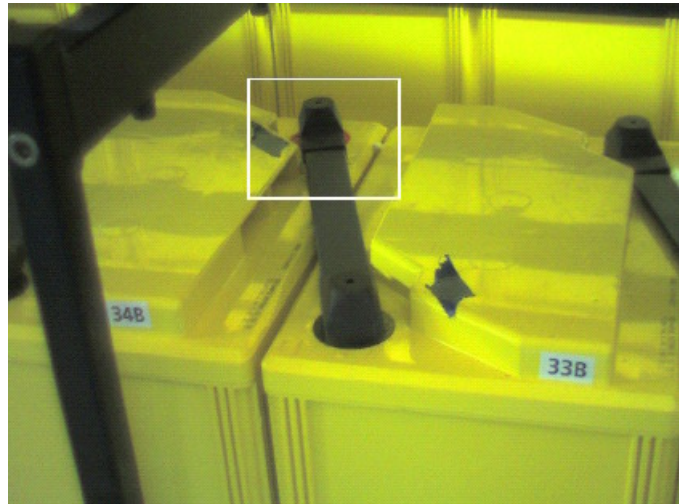
IR File: IR_23141a.jpg

Thermal Information	
Operation Priority:	Critical to operation
Repair Priority:	1-Critical
Ambient:	22 C Enviroment: Indoors
Component Temperature On -:	97 C
- Reference Temperature:	36 C
Temperature Rise Above Reference:	61 C
ANSI/EEE/NEMA Max Allowable Temp @ 100% Load:	75 C
Est Temp Rise over reference @ 50% Load:	0
Est Temp Rise over reference @ 100% Load:	0

Repair Information Consequences of Failure: <input type="text"/> Loss of STRING B Parts Req. Before Failure: <input type="text"/> Parts Req. After Failure: <input type="text"/> Repair Recommendation: <input type="text"/> Check, clean & re-make connection	PLEASE FAX BACK AFTER REPAIR TO: 0871 900 4978 OR INFO@THERMALIMAGING.CO.UK		Loss to Production <input type="checkbox"/> Yes <input type="checkbox"/> No <input checked="" type="checkbox"/> Unknown	
	Repair Date: <input type="text"/>	Repaired By: <input type="text"/>		
	Root Cause: <input type="text"/>			
	Repair Procedure: <input type="text"/>			
	Repair Action: <input type="text"/>

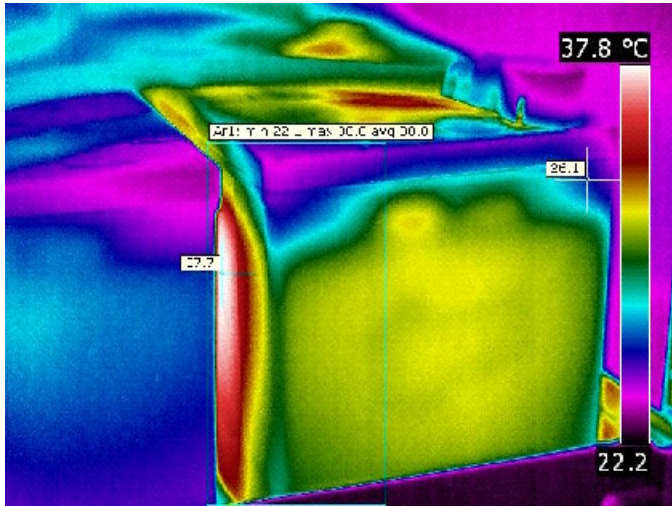
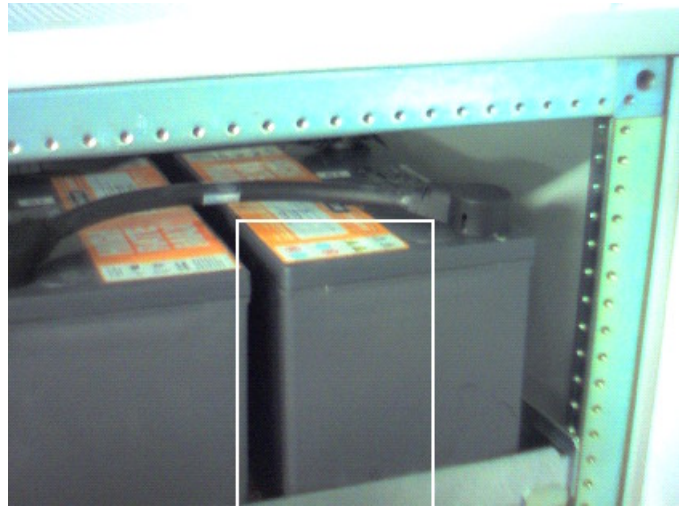
IR File: IR_18686a.jpg

Thermal Information	
Operation Priority:	Critical to operation
Repair Priority:	3-Important
Ambient:	22 C Enviroment: Indoors
Component Temperature On -:	43 C
- Reference Temperature:	30 C
Temperature Rise Above Reference:	13 C
ANSI/EEE/NEMA Max Allowable Temp @ 100% Load:	75 C
Est Temp Rise over reference @ 50% Load:	0
Est Temp Rise over reference @ 100% Load:	0

PLEASE FAX BACK AFTER REPAIR TO:		Loss to Production	
0871 900 4978 OR		<input type="checkbox"/> Yes <input type="checkbox"/> No <input checked="" type="checkbox"/> Unknown	
INFO@THERMALIMAGING.CO.UK			
Repair Information			
Consequences of Failure:	Repair Date:	<input style="width: 80px;" type="text"/>	Repaired By: <input style="width: 80px;" type="text"/>
Loss of STRING A	Root Cause:	<input style="width: 100%;" type="text"/>	
Parts Req. Before Failure:	Repair Procedure:	<input style="width: 100%;" type="text"/>	
<input style="width: 100%;" type="text"/>	Repair Action:	<input style="width: 100%;" type="text"/>	
Parts Req. After Failure:			
<input style="width: 100%;" type="text"/>			
Repair Recommendation:			
Either replace or investigate internal contacts to determine source of temperature anomaly

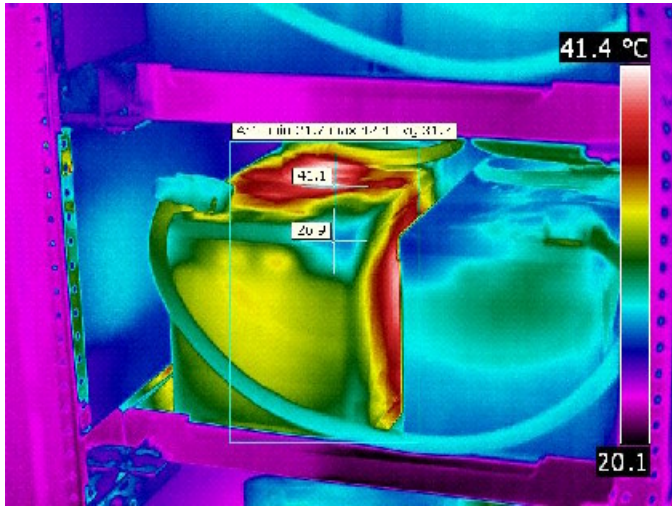
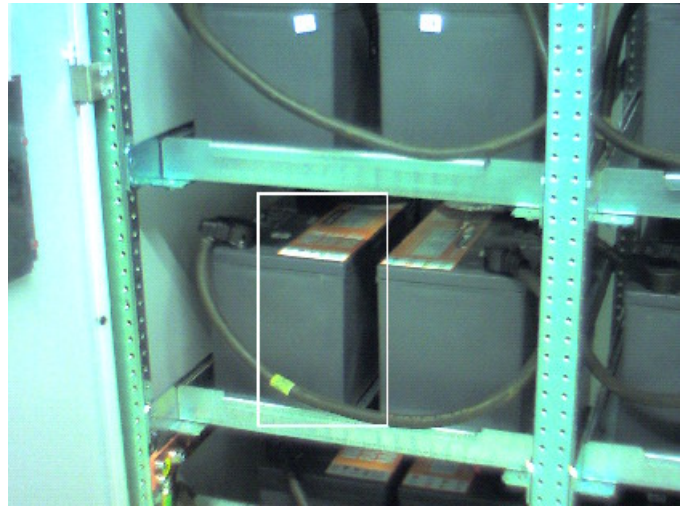
IR File: IR_18682a.jpg

Thermal Information	
Operation Priority:	Critical to operation
Repair Priority:	3-Important
Ambient:	22 C Enviroment: Indoors
Component Temperature On -:	43 C
- Reference Temperature:	30 C
Temperature Rise Above Reference:	13 C
ANSI/EEE/NEMA Max Allowable Temp @ 100% Load:	75 C
Est Temp Rise over reference @ 50% Load:	0
Est Temp Rise over reference @ 100% Load:	0

Repair Information Consequences of Failure: Loss of STRING B <hr/> Parts Req. Before Failure: <hr/> Parts Req. After Failure: <hr/> Repair Recommendation: Either replace or investigate internal contacts to determine source of temperature anomaly	PLEASE FAX BACK AFTER REPAIR TO: 0871 900 4978 OR INFO@THERMALIMAGING.CO.UK		Loss to Production <input type="checkbox"/> Yes <input type="checkbox"/> No <input checked="" type="checkbox"/> Unknown	
	Repair Date: <input type="text"/>	Repaired By: <input type="text"/>		
	Root Cause: <input type="text"/>			
	Repair Procedure: <input type="text"/>			
	Repair Action: <input type="text"/>
