# Thermographic inspection of: T-801A

TI Job No:  
TI\_14710

24 May 2011

T-801A

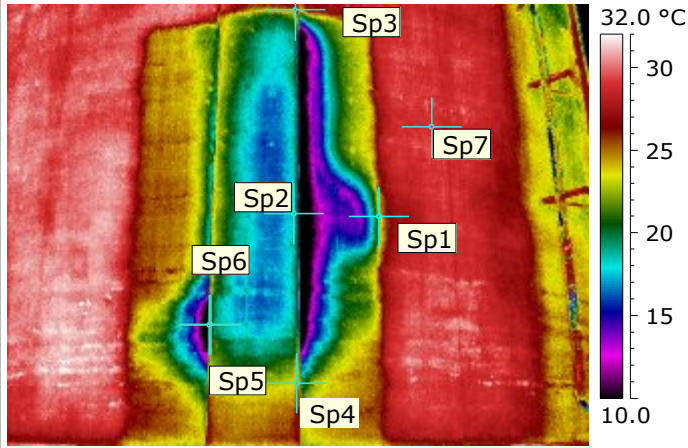
Inspection 1 - 24/05/2011

Filename	IR_6039.jpg
Sp7 Temperature	29.4 °C
Object Distance	2100.0 m
spot_dist_1-2	260
spot_dist_3-4	1119
spot_dist_5-6	6

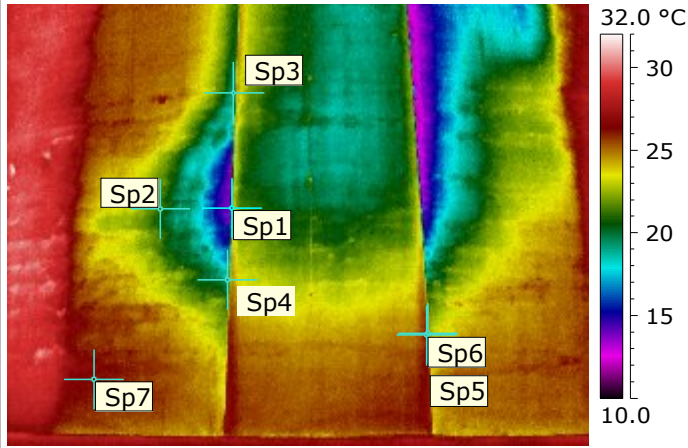
Inspection 1 - 24/05/2011

Filename	IR_6037.jpg
Sp7 Temperature	26.4 °C
Object Distance	1200.0 m
spot_dist_1-2	125
spot_dist_3-4	321
spot_dist_5-6	4

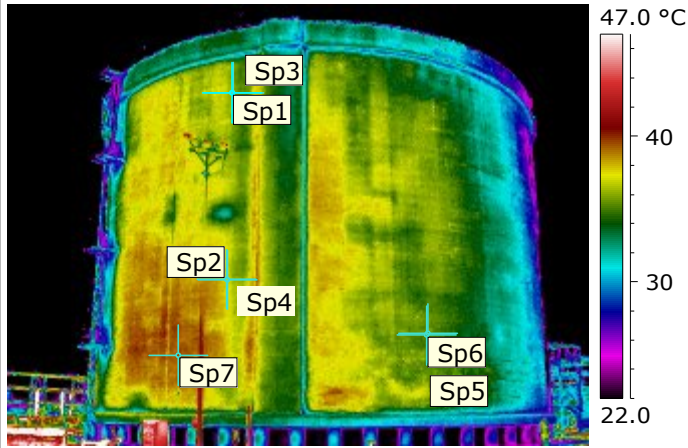
Inspection 1 - 24/05/2011

Filename	IR_6043.jpg
Sp7 Temperature	39.5 °C
Object Distance	5000.0 m
spot_dist_1-2	1330
spot_dist_3-4	1336
spot_dist_5-6	19

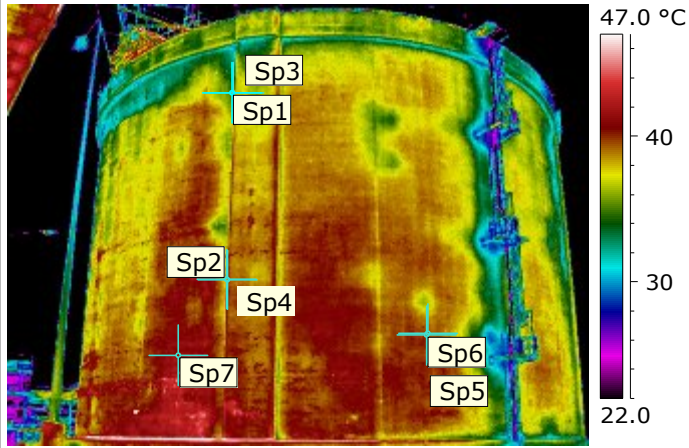
Inspection 1 - 24/05/2011

Filename	IR_6045.jpg
Sp7 Temperature	41.5 °C
Object Distance	5000.0 m
spot_dist_1-2	1330
spot_dist_3-4	1336
spot_dist_5-6	19

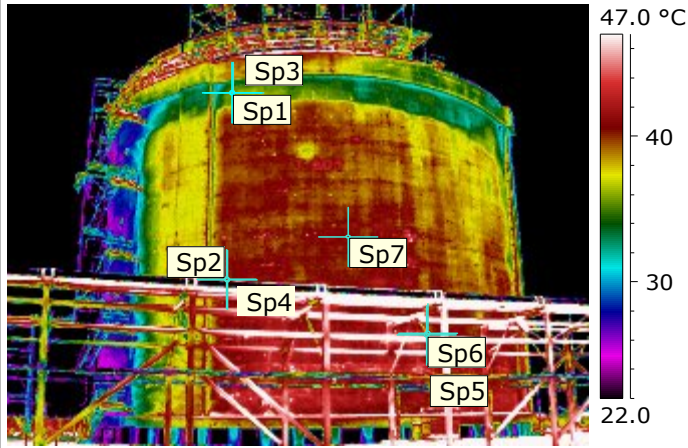
Inspection 1 - 24/05/2011

Filename	IR_6047.jpg
Sp7 Temperature	40.9 °C
Object Distance	5000.0 m
spot_dist_1-2	1330
spot_dist_3-4	1336
spot_dist_5-6	19

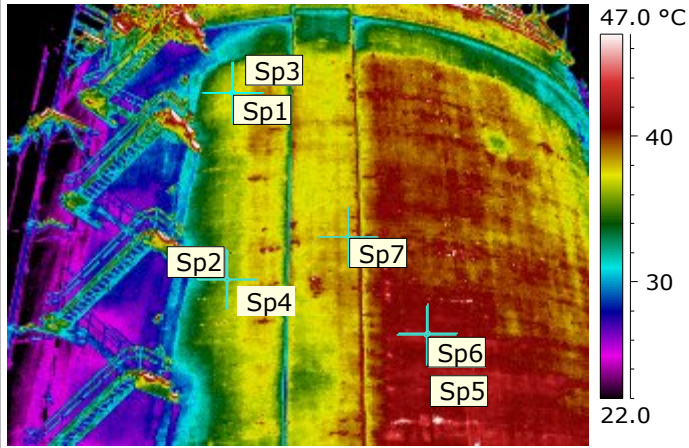
Inspection 1 - 24/05/2011

Filename	IR_6049.jpg
Sp7 Temperature	38.8 °C
Object Distance	3000.0 m
spot_dist_1-2	798
spot_dist_3-4	802
spot_dist_5-6	11
