**Thermographic inspection of:
V21110 HP1**

**TI Job No:
TI_16442**

9 March 2013

Executive Summary – V21110 HP1

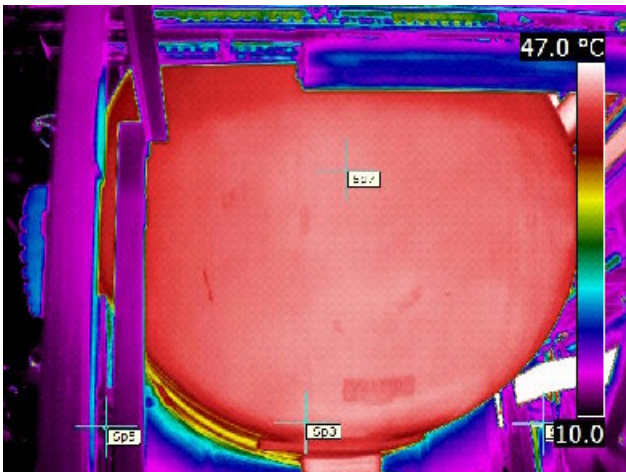
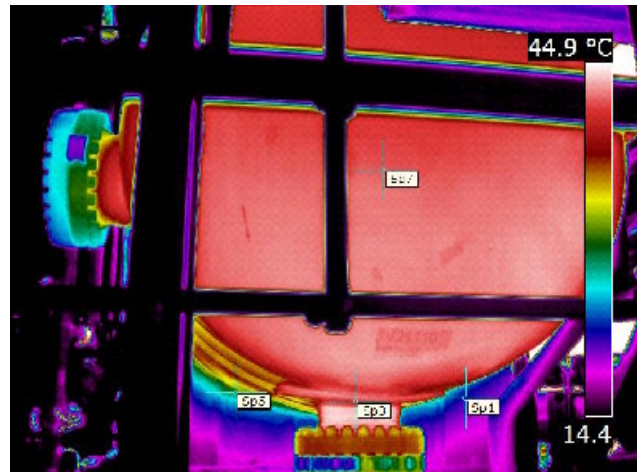
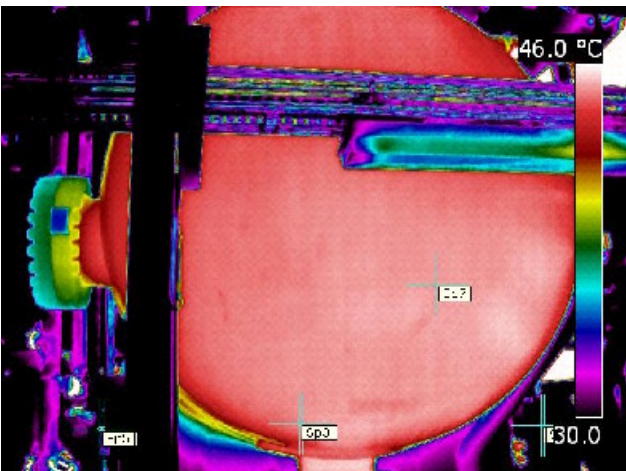
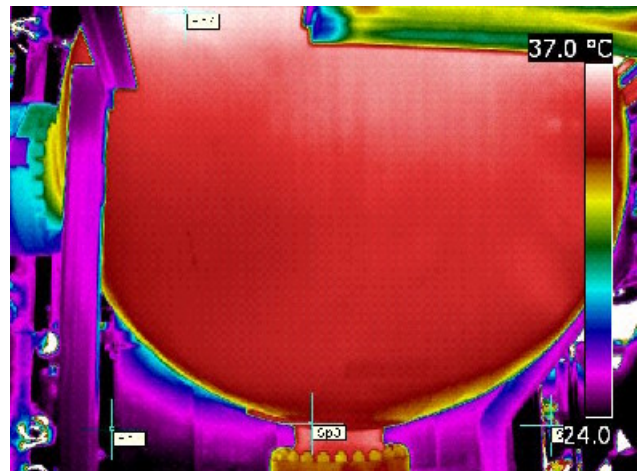
V21110 HP1 \ SOUTH \ OUTLET DOME

Inspection No	Date Inspected	Sp1-Sp2	Sp3-Sp4	Sp5-Sp6	Sand Level %		
1744	28/01/2012	0 cm	0 cm	0 cm	Sp1-2 % = 0	Sp3-4 % = 0	Sp5-6 % = 0
1777	08/03/2012	0 cm	0 cm	0 cm	Sp1-2 % = 0	Sp3-4 % = 0	Sp5-6 % = 0
1839	02/06/2012	0 cm	0 cm	0 cm	Sp1-2 % = 0	Sp3-4 % = 0	Sp5-6 % = 0
1850	22/09/2012	0 cm	0 cm	0 cm	Sp1-2 % = 1	Sp3-4 % = 1	Sp5-6 % = 1
1861	10/12/2012	0 cm	0 cm	0 cm	Sp1-2 % = 0	Sp3-4 % = 0	Sp5-6 % = 0
1877	09/03/2013	0 cm	0 cm	0 cm	Sp1-2 % = 0	Sp3-4 % = 0	Sp5-6 % = 0

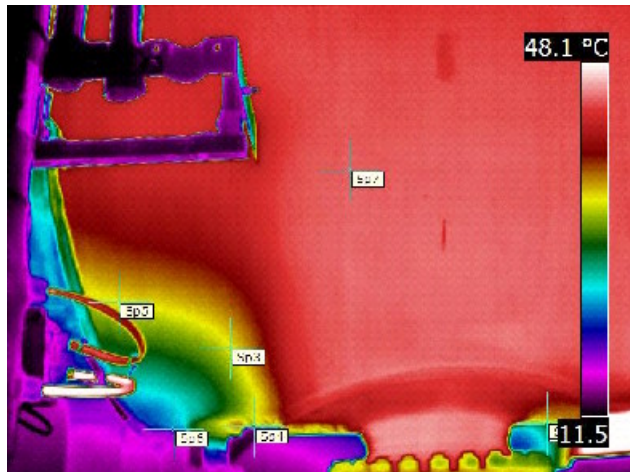
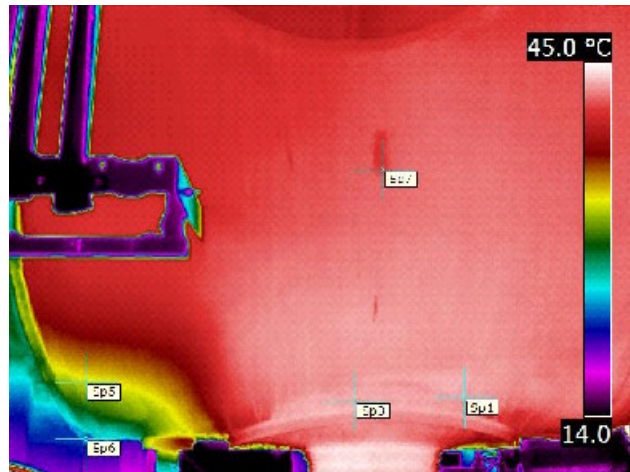
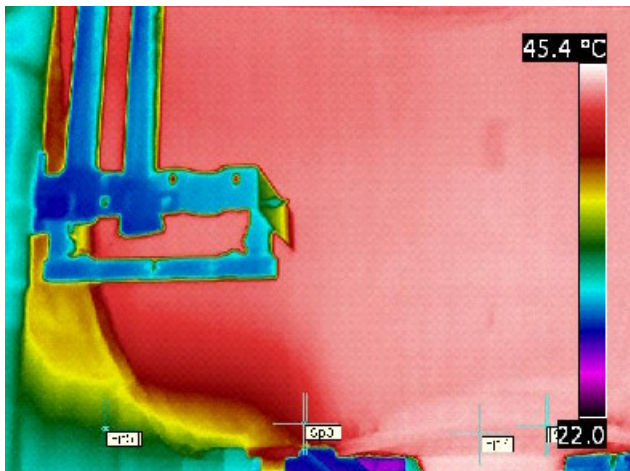
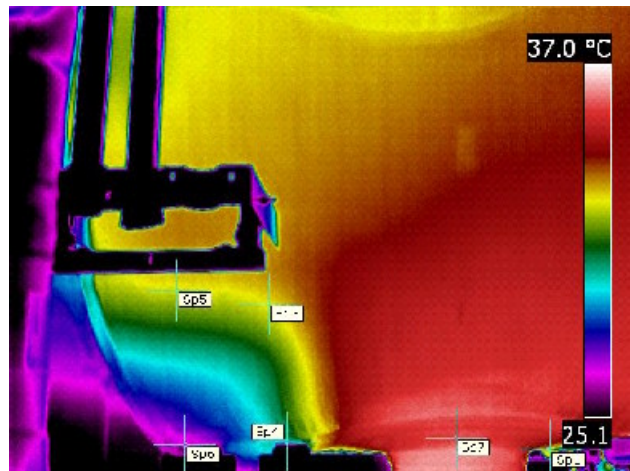
EQUIPMENT LOCATION:
V21110 HP1 \ WEST \ OUTLET DOME - SADDLE

Inspection No	Date Inspected	Sp1-Sp2	Sp3-Sp4	Sp5-Sp6	Sand Level %		
1744	28/01/2012	0 cm	0 cm	42 cm	Sp1-2 % = 0	Sp3-4 % = 0	Sp5-6 % = 14
1777	08/03/2012	0 cm	1 cm	41 cm	Sp1-2 % = 0	Sp3-4 % = 0	Sp5-6 % = 14
1839	02/06/2012	0 cm	34 cm	38 cm	Sp1-2 % = 0	Sp3-4 % = 12	Sp5-6 % = 13
1850	22/09/2012	0 cm	0 cm	0 cm	Sp1-2 % = 0	Sp3-4 % = 0	Sp5-6 % = 0
1861	10/12/2012	0 cm	0 cm	16 cm	Sp1-2 % = 0	Sp3-4 % = 0	Sp5-6 % = 6
1877	09/03/2013	0 cm	22 cm	37 cm	Sp1-2 % = 0	Sp3-4 % = 8	Sp5-6 % = 13

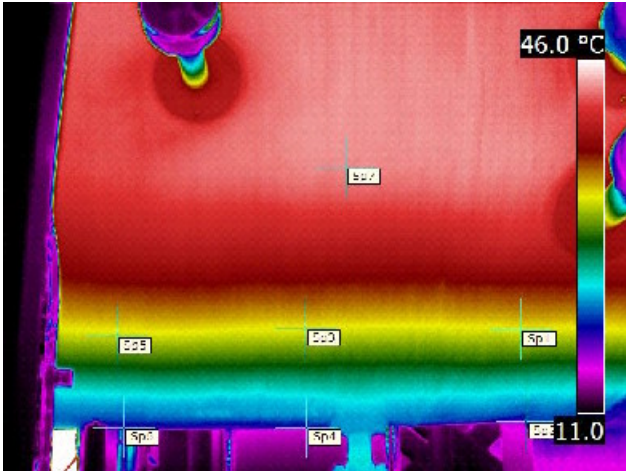
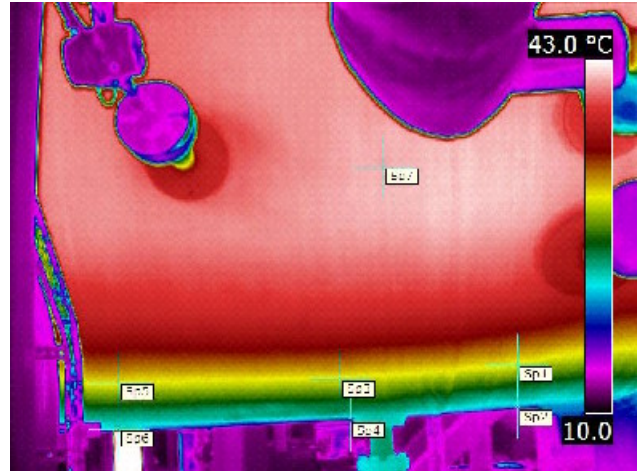
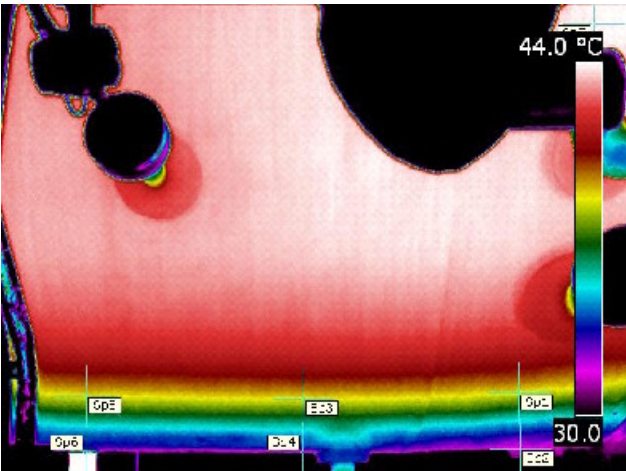
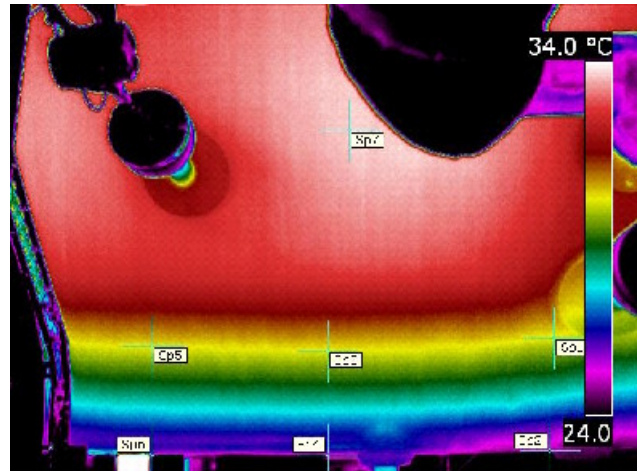
V21110 HP1 \ WEST \ OUTLET SADDLE - CENTER

Inspection No	Date Inspected	Sp1-Sp2	Sp3-Sp4	Sp5-Sp6	Sand Level %		
1744	28/01/2012	39 cm	34 cm	35 cm	Sp1-2 % = 14	Sp3-4 % = 12	Sp5-6 % = 12
1777	08/03/2012	24 cm	24 cm	24 cm	Sp1-2 % = 8	Sp3-4 % = 8	Sp5-6 % = 8
1839	02/06/2012	28 cm	26 cm	27 cm	Sp1-2 % = 10	Sp3-4 % = 9	Sp5-6 % = 9
1850	22/09/2012	14 cm	13 cm	14 cm	Sp1-2 % = 5	Sp3-4 % = 5	Sp5-6 % = 5
1861	10/12/2012	12 cm	12 cm	13 cm	Sp1-2 % = 4	Sp3-4 % = 4	Sp5-6 % = 4
1877	09/03/2013	25 cm	27 cm	25 cm	Sp1-2 % = 9	Sp3-4 % = 9	Sp5-6 % = 8

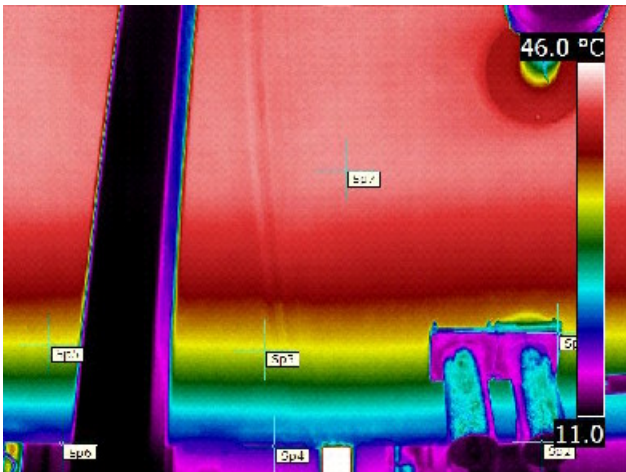
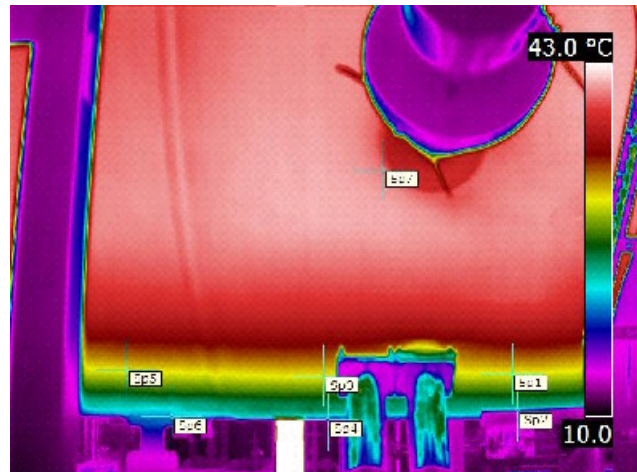
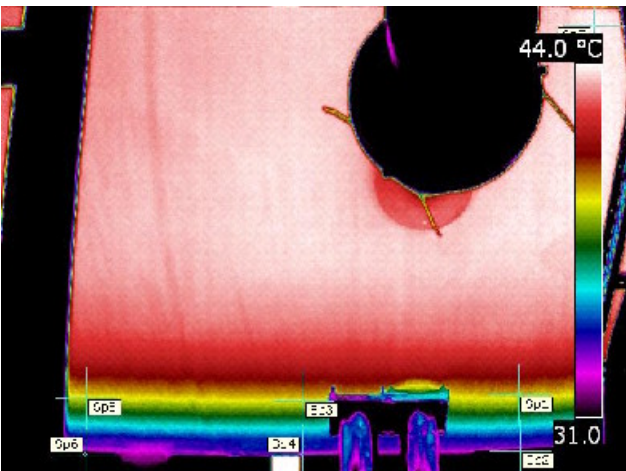
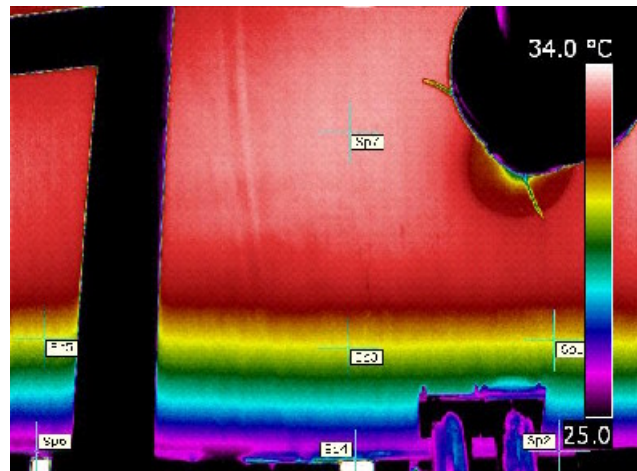
EQUIPMENT LOCATION:
V21110 HP1 \ WEST \ CENTER

Inspection No	Date Inspected	Sp1-Sp2	Sp3-Sp4	Sp5-Sp6	Sand Level %		
1744	28/01/2012	35 cm	33 cm	32 cm	Sp1-2 % = 12	Sp3-4 % = 11	Sp5-6 % = 11
1777	08/03/2012	28 cm	31 cm	29 cm	Sp1-2 % = 10	Sp3-4 % = 11	Sp5-6 % = 10
1839	02/06/2012	27 cm	28 cm	28 cm	Sp1-2 % = 9	Sp3-4 % = 10	Sp5-6 % = 10
1850	22/09/2012	14 cm	14 cm	14 cm	Sp1-2 % = 5	Sp3-4 % = 5	Sp5-6 % = 5
1861	10/12/2012	10 cm	12 cm	18 cm	Sp1-2 % = 4	Sp3-4 % = 4	Sp5-6 % = 6
1877	09/03/2013	30 cm	26 cm	27 cm	Sp1-2 % = 10	Sp3-4 % = 9	Sp5-6 % = 9

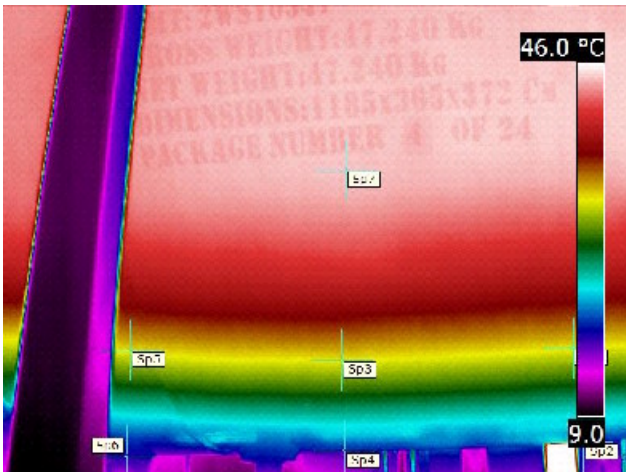
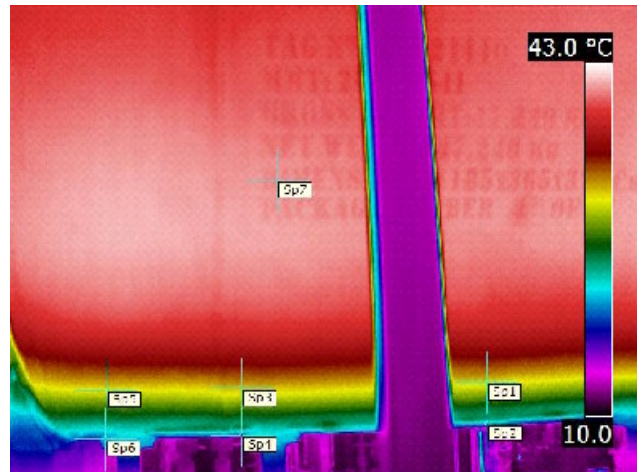
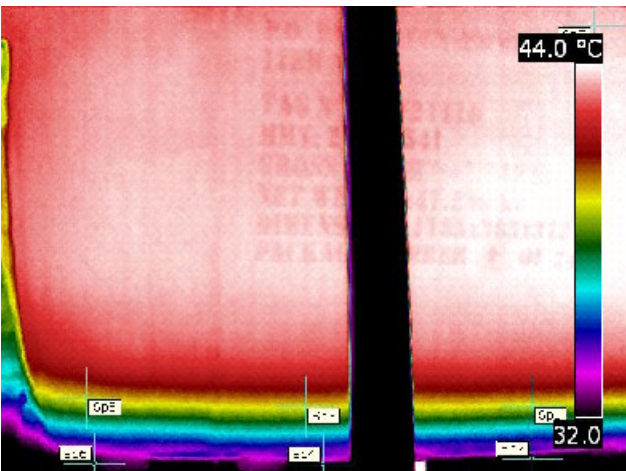
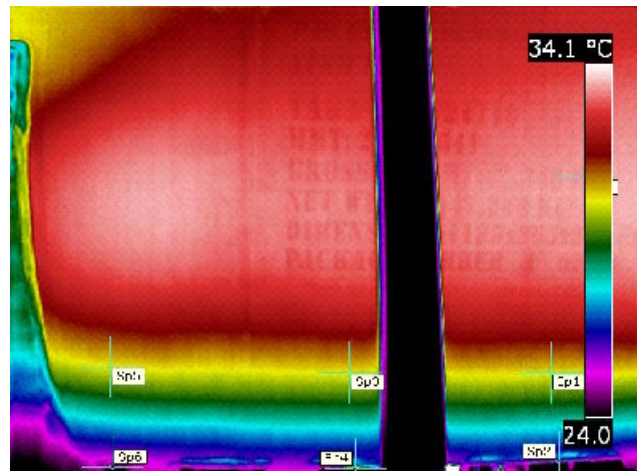
EQUIPMENT LOCATION:
V21110 HP1 \ WEST \ CENTER - INLET SADDLE

Inspection No	Date Inspected	Sp1-Sp2	Sp3-Sp4	Sp5-Sp6	Sand Level %		
1744	28/01/2012	35 cm	36 cm	38 cm	Sp1-2 % = 12	Sp3-4 % = 13	Sp5-6 % = 13
1777	08/03/2012	35 cm	36 cm	43 cm	Sp1-2 % = 12	Sp3-4 % = 12	Sp5-6 % = 15
1839	02/06/2012	25 cm	27 cm	28 cm	Sp1-2 % = 9	Sp3-4 % = 9	Sp5-6 % = 10
1850	22/09/2012	15 cm	17 cm	19 cm	Sp1-2 % = 5	Sp3-4 % = 6	Sp5-6 % = 6
1861	10/12/2012	11 cm	13 cm	13 cm	Sp1-2 % = 4	Sp3-4 % = 4	Sp5-6 % = 5
1877	09/03/2013	27 cm	26 cm	30 cm	Sp1-2 % = 9	Sp3-4 % = 9	Sp5-6 % = 10

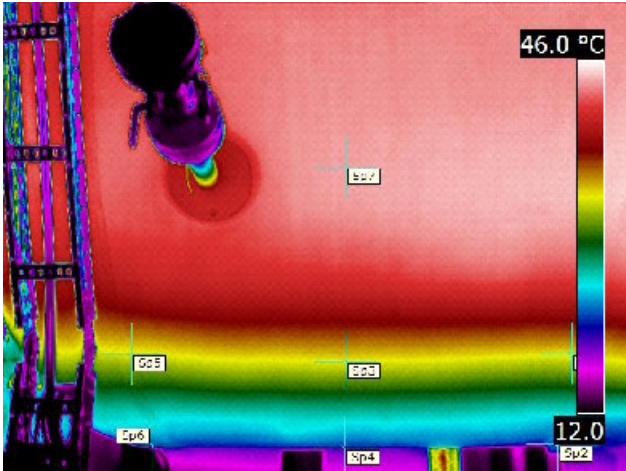
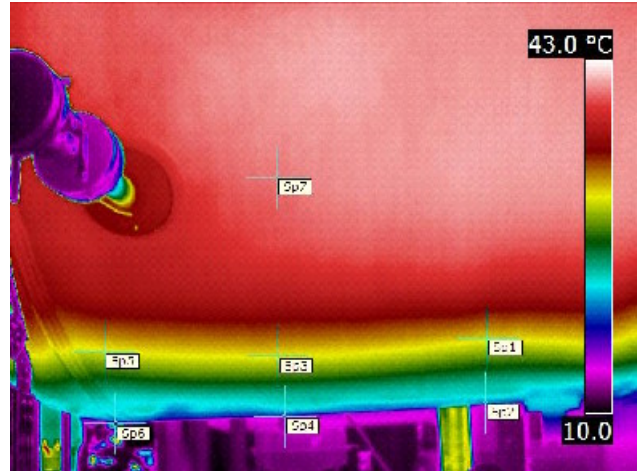
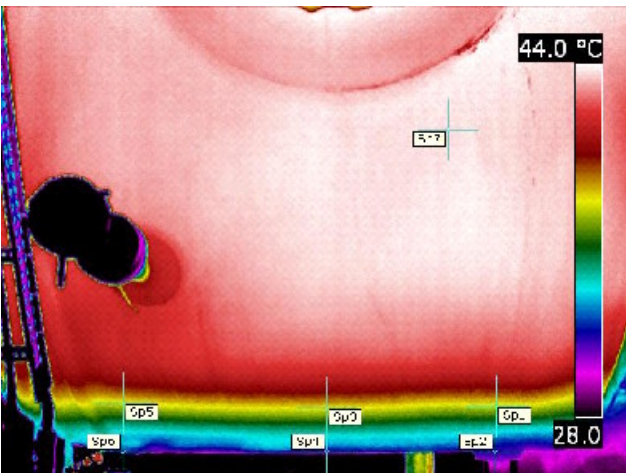
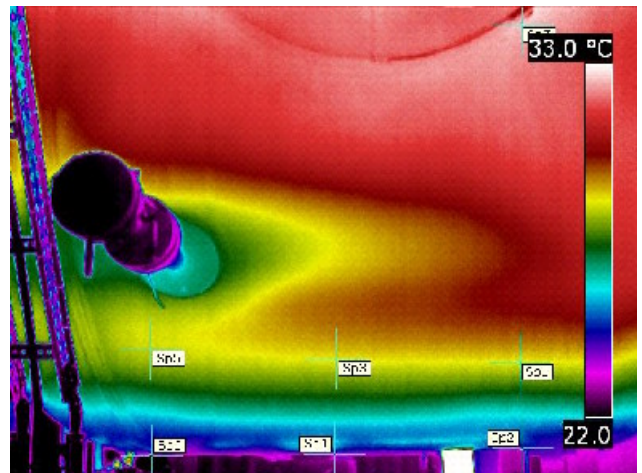
EQUIPMENT LOCATION:
V21110 HP1 \ WEST \ INLET SADDLE - DOME

Inspection No	Date Inspected	Sp1-Sp2	Sp3-Sp4	Sp5-Sp6	Sand Level %		
1744	28/01/2012	30 cm	33 cm	34 cm	Sp1-2 % = 10	Sp3-4 % = 11	Sp5-6 % = 12
1777	08/03/2012	28 cm	31 cm	92 cm	Sp1-2 % = 10	Sp3-4 % = 11	Sp5-6 % = 32
1839	02/06/2012	22 cm	25 cm	28 cm	Sp1-2 % = 8	Sp3-4 % = 8	Sp5-6 % = 10
1850	22/09/2012	13 cm	13 cm	14 cm	Sp1-2 % = 5	Sp3-4 % = 4	Sp5-6 % = 5
1861	10/12/2012	16 cm	15 cm	18 cm	Sp1-2 % = 6	Sp3-4 % = 5	Sp5-6 % = 6
1877	09/03/2013	26 cm	24 cm	27 cm	Sp1-2 % = 9	Sp3-4 % = 8	Sp5-6 % = 9

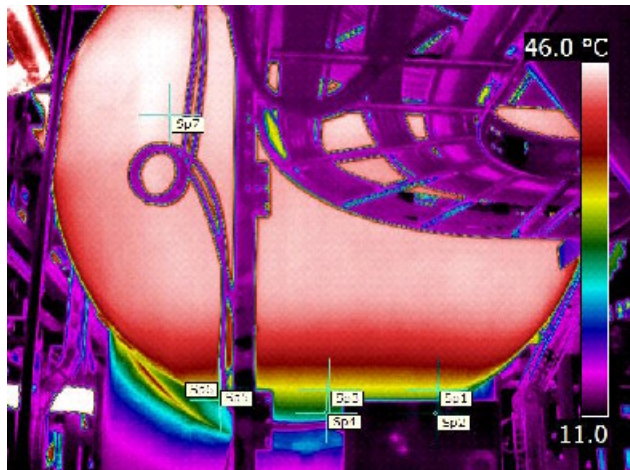
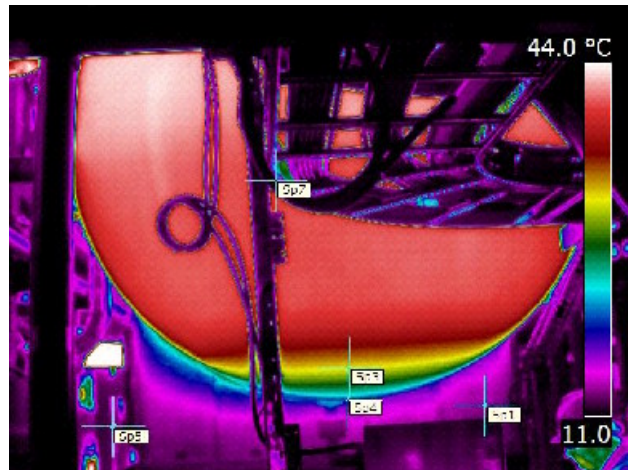
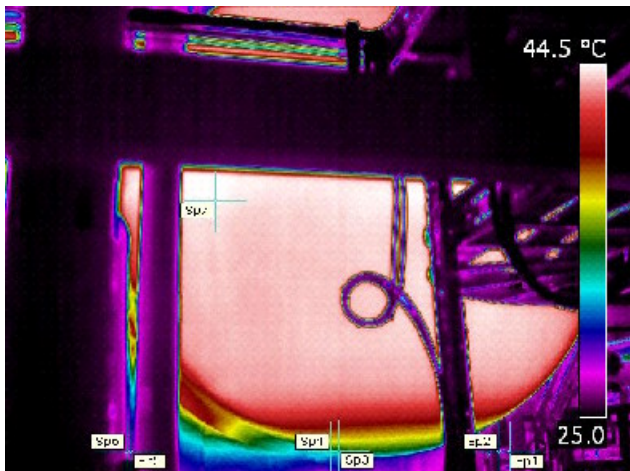
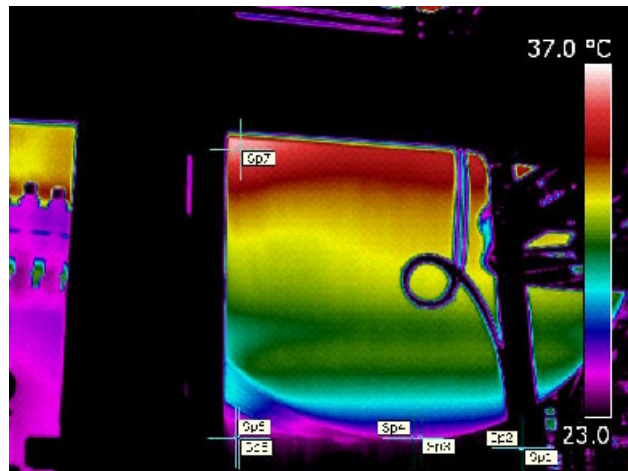
EQUIPMENT LOCATION:
V21110 HP1 \ NORTH \ INLET DOME

Inspection No	Date Inspected	Sp1-Sp2	Sp3-Sp4	Sp5-Sp6	Sand Level %		
1744	28/01/2012	25 cm	25 cm	24 cm	Sp1-2 % = 9	Sp3-4 % = 9	Sp5-6 % = 8
1777	09/03/2012	116 cm	126 cm	120 cm	Sp1-2 % = 40	Sp3-4 % = 44	Sp5-6 % = 42
1839	02/06/2012	0 cm	0 cm	0 cm	Sp1-2 % = 0	Sp3-4 % = 1	Sp5-6 % = 1
1850	22/09/2012	0 cm	0 cm	0 cm	Sp1-2 % = 2	Sp3-4 % = 1	Sp5-6 % = 1
1861	10/12/2012	1 cm	15 cm	1 cm	Sp1-2 % = 0	Sp3-4 % = 5	Sp5-6 % = 0
1877	09/03/2013	11 cm	11 cm	6 cm	Sp1-2 % = 4	Sp3-4 % = 4	Sp5-6 % = 2

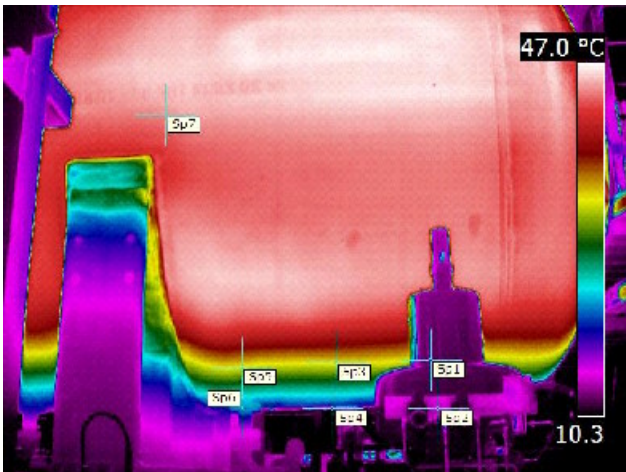
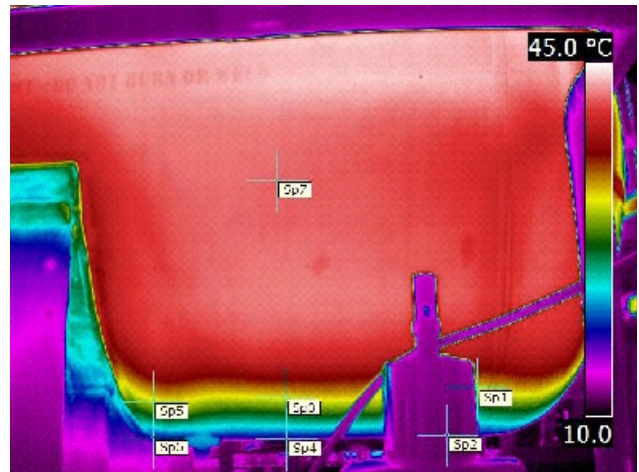
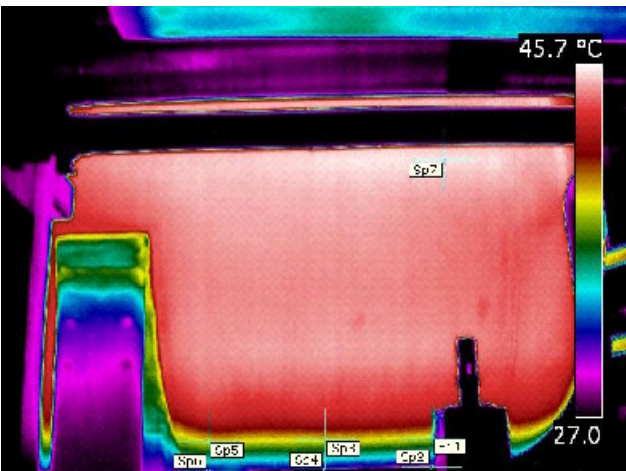
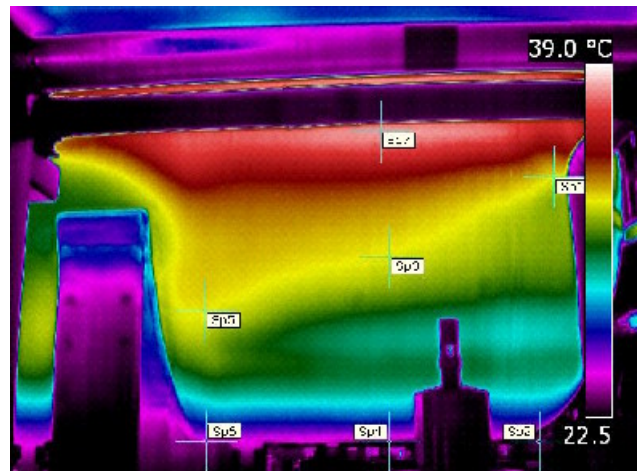
EQUIPMENT LOCATION:
V21110 HP1 \ EAST \ INLET DOME - SADDLE

Inspection No	Date Inspected	Sp1-Sp2	Sp3-Sp4	Sp5-Sp6	Sand Level %		
1744	28/01/2012	48 cm	49 cm	48 cm	Sp1-2 % = 17	Sp3-4 % = 17	Sp5-6 % = 17
1777	09/03/2012	118 cm	105 cm	115 cm	Sp1-2 % = 41	Sp3-4 % = 36	Sp5-6 % = 40
1839	02/06/2012	130 cm	91 cm	64 cm	Sp1-2 % = 45	Sp3-4 % = 31	Sp5-6 % = 22
1850	22/09/2012	14 cm	15 cm	15 cm	Sp1-2 % = 5	Sp3-4 % = 5	Sp5-6 % = 5
1861	10/12/2012	25 cm	18 cm	16 cm	Sp1-2 % = 9	Sp3-4 % = 6	Sp5-6 % = 6
1877	09/03/2013	27 cm	26 cm	22 cm	Sp1-2 % = 9	Sp3-4 % = 9	Sp5-6 % = 8

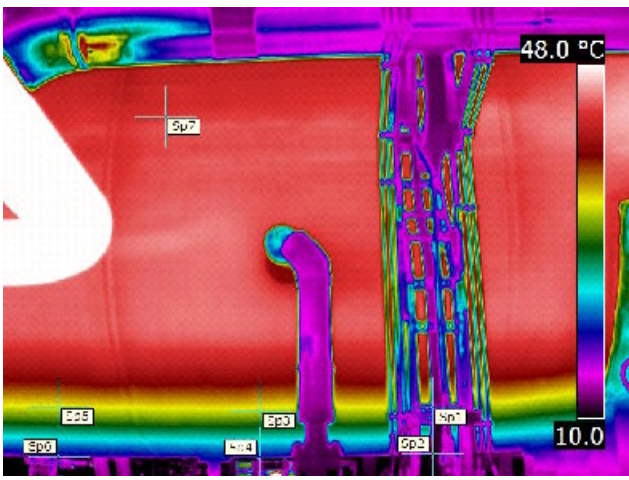
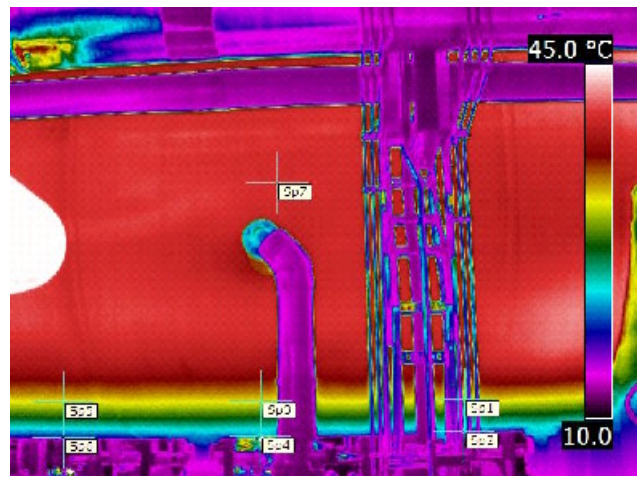
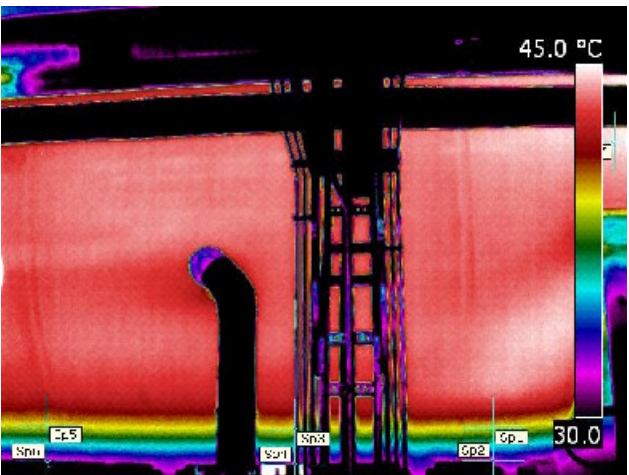
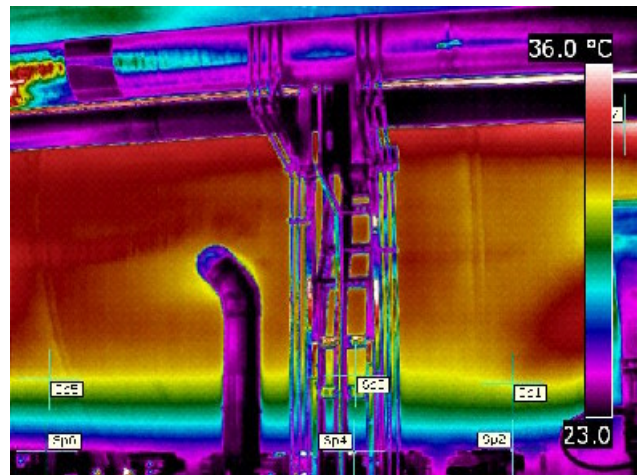
EQUIPMENT LOCATION:
V21110 HP1 \ EAST \ INLET SADDLE - CENTER

Inspection No	Date Inspected	Sp1-Sp2	Sp3-Sp4	Sp5-Sp6	Sand Level %		
1744	28/01/2012	45 cm	49 cm	47 cm	Sp1-2 % = 15	Sp3-4 % = 17	Sp5-6 % = 16
1777	08/03/2012	45 cm	41 cm	39 cm	Sp1-2 % = 15	Sp3-4 % = 14	Sp5-6 % = 14
1839	02/06/2012	32 cm	37 cm	35 cm	Sp1-2 % = 11	Sp3-4 % = 13	Sp5-6 % = 12
1850	22/09/2012	16 cm	17 cm	17 cm	Sp1-2 % = 6	Sp3-4 % = 6	Sp5-6 % = 6
1861	10/12/2012	17 cm	18 cm	18 cm	Sp1-2 % = 6	Sp3-4 % = 6	Sp5-6 % = 6
1877	09/03/2013	25 cm	25 cm	27 cm	Sp1-2 % = 9	Sp3-4 % = 9	Sp5-6 % = 9

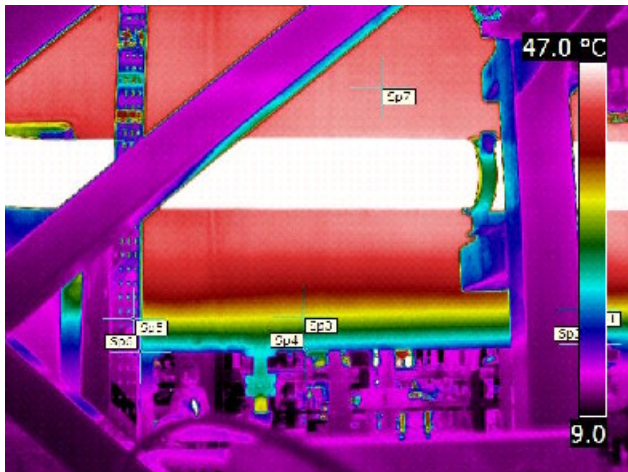
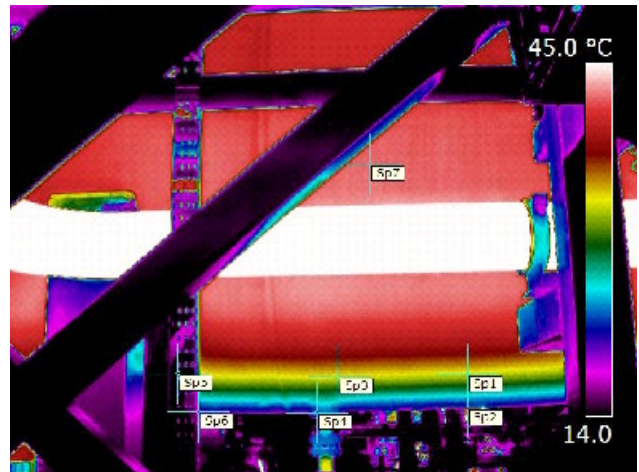
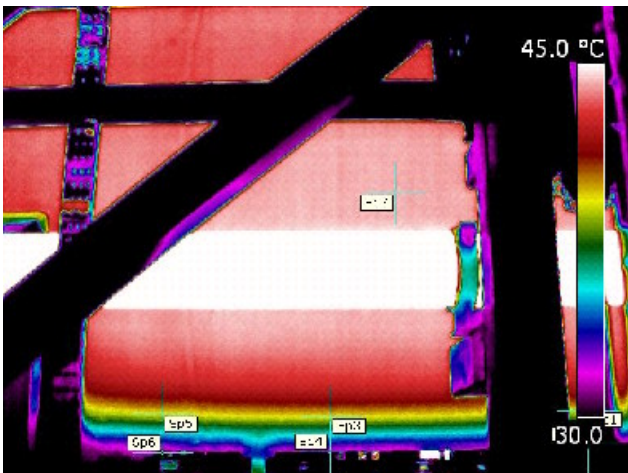
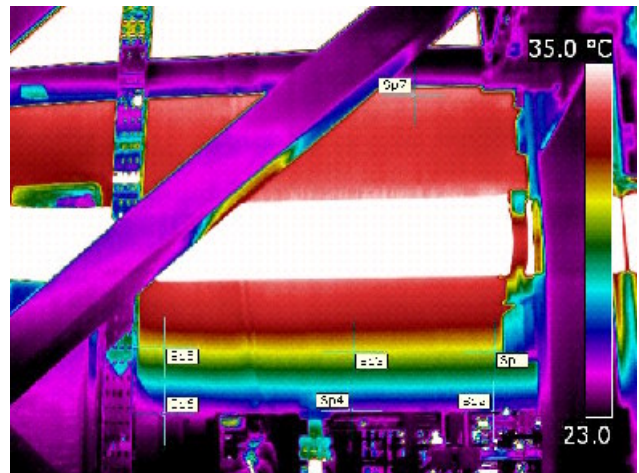
V21110 HP1 \ EAST \ CENTER - OUTLET SADDLE

Inspection No	Date Inspected	Sp1-Sp2	Sp3-Sp4	Sp5-Sp6	Sand Level %		
1744	28/01/2012	38 cm	39 cm	43 cm	Sp1-2 % = 13	Sp3-4 % = 13	Sp5-6 % = 15
1777	08/03/2012	48 cm	48 cm	48 cm	Sp1-2 % = 17	Sp3-4 % = 17	Sp5-6 % = 16
1839	02/06/2012	30 cm	29 cm	23 cm	Sp1-2 % = 10	Sp3-4 % = 10	Sp5-6 % = 11
1850	22/09/2012	16 cm	17 cm	18 cm	Sp1-2 % = 6	Sp3-4 % = 6	Sp5-6 % = 6
1861	10/12/2012	19 cm	24 cm	25 cm	Sp1-2 % = 7	Sp3-4 % = 8	Sp5-6 % = 9
1877	09/03/2013	19 cm	19 cm	19 cm	Sp1-2 % = 7	Sp3-4 % = 6	Sp5-6 % = 7

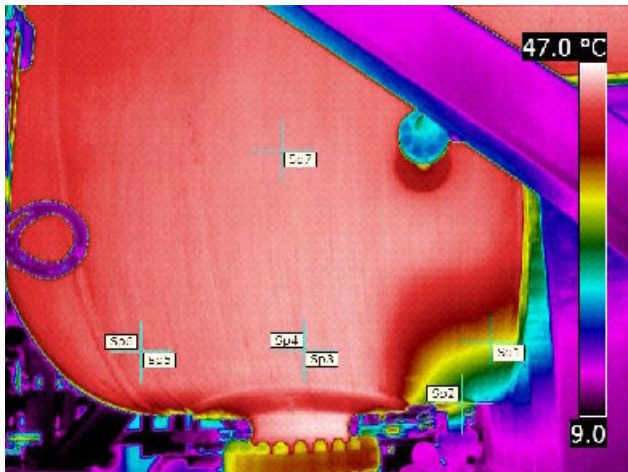
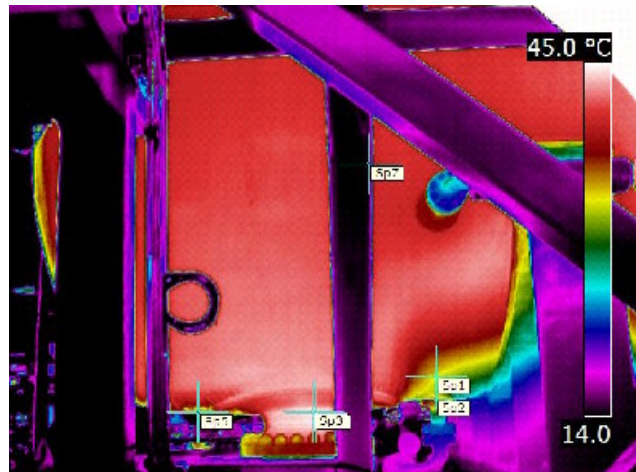
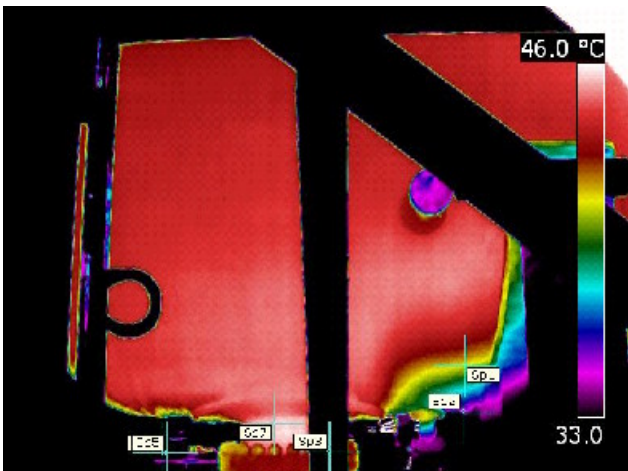
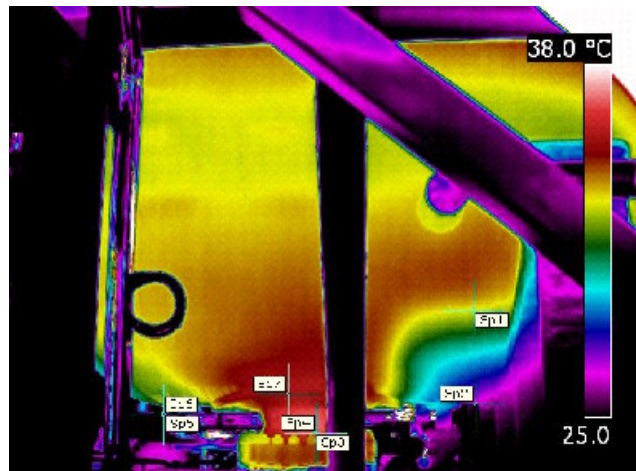
EQUIPMENT LOCATION:
V21110 HP1 \ EAST \ OUTLET SADDLE - DOME

Inspection No	Date Inspected	Sp1-Sp2	Sp3-Sp4	Sp5-Sp6	Sand Level %		
1744	28/01/2012	12 cm	0 cm	0 cm	Sp1-2 % = 12	Sp3-4 % = 0	Sp5-6 % = 0
1777	08/03/2012	46 cm	1 cm	2 cm	Sp1-2 % = 16	Sp3-4 % = 0	Sp5-6 % = 1
1839	02/06/2012	43 cm	0 cm	0 cm	Sp1-2 % = 15	Sp3-4 % = 0	Sp5-6 % = 0
1850	22/09/2012	21 cm	0 cm	0 cm	Sp1-2 % = 7	Sp3-4 % = 0	Sp5-6 % = 1
1861	10/12/2012	11 cm	2 cm	1 cm	Sp1-2 % = 4	Sp3-4 % = 1	Sp5-6 % = 0
1877	09/03/2013	21 cm	0 cm	0 cm	Sp1-2 % = 7	Sp3-4 % = 0	Sp5-6 % = 0
