THERMOGRAPHIC INSPECTION FOR:

UNDERFLOOR HEATING PIPEWORK

TI SITE 7 SAMPLE REPORT

TI , TI Site 7 Hot Water Pipe Leakage

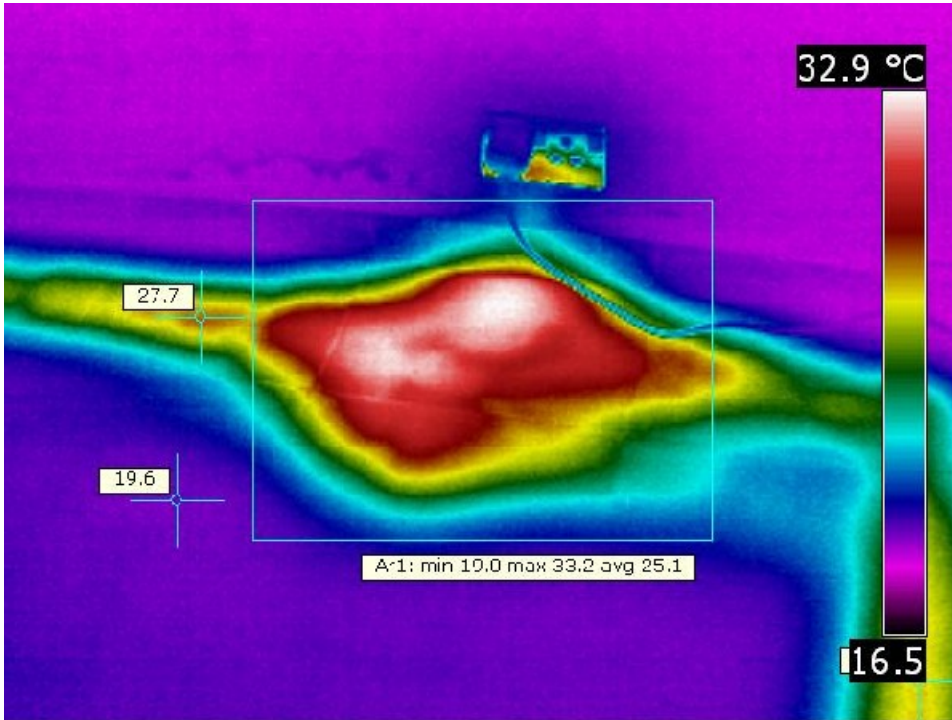
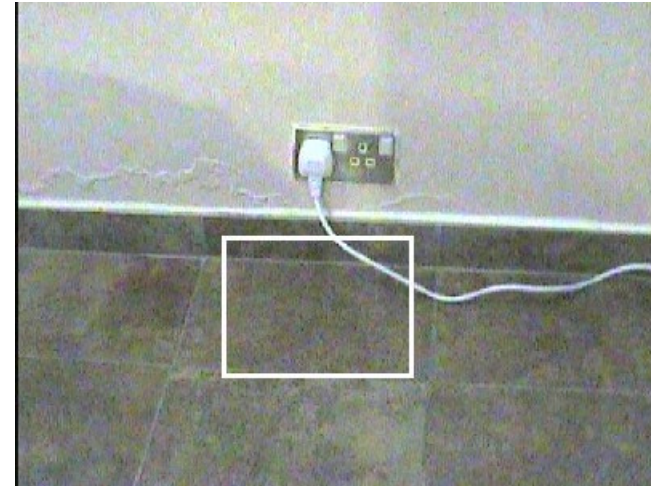
Location/Equipment Information
Asset ID: - LIVING ROOM BENEATH FRONT WINDOW

Prob#	Asset ID		Insp#	Temp Rise	% Load	Severity	Status
V 1	-	Equipment: LIVING ROOM \ BENEATH FRONT WINDOW Component: Elevated surface temperature found indicating possible area of underfloor water leakage	1417			1-Critical	TESTED

- Classification:** Hot Water Supply & Heating Systems
- Observations:** Elevated surface temperature found indicating possible area of underfloor water leakage
- What is the Cause:** Suspected water leak
- Recommendations:** Investigate source of leak and repair. Isolate equipment if necessary

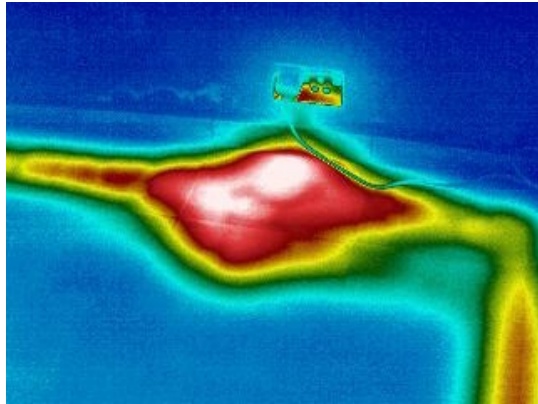
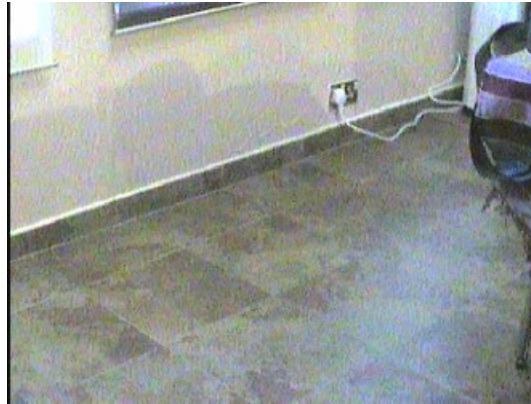
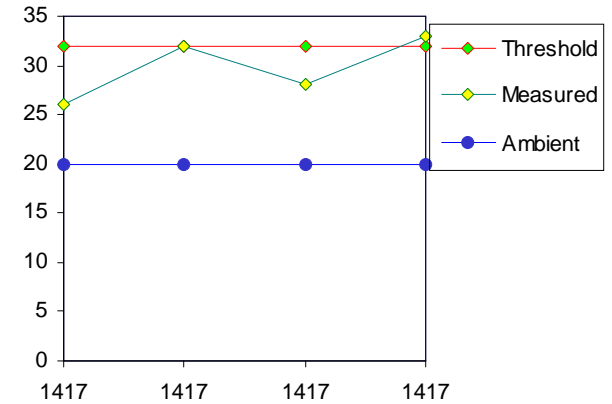
LIVING ROOM \ BENEATH FRONT WINDOW

Inspection No	Date Inspected	Test Status	Measured Temp	Threshold Temp	Ambient Temp	Status Note	Customer Notes
1417	22/11/2010	TESTED	26 C	32 C	20 C		
1417	22/11/2010	TESTED	32 C	32 C	20 C		
1417	22/11/2010	TESTED	28 C	32 C	20 C		
1417	22/11/2010	TESTED	33 C	32 C	20 C

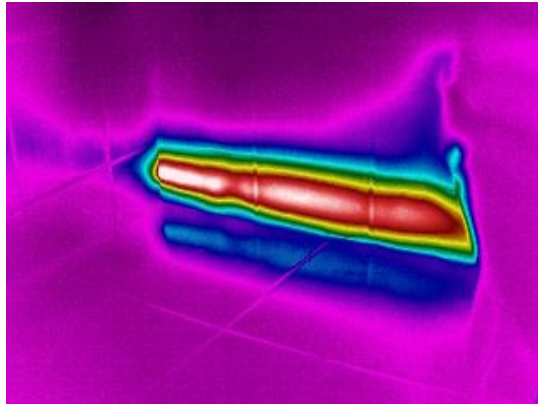
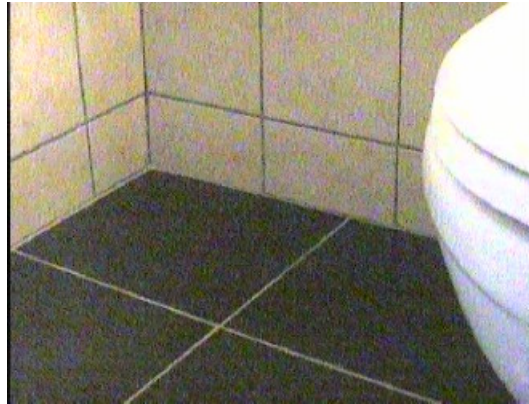
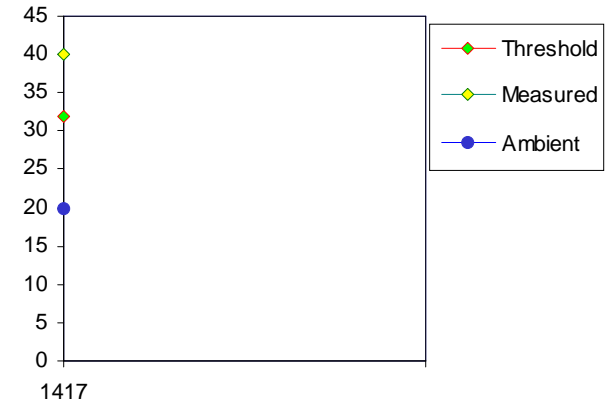
BATHROOM \ LEFT OF SINK

Inspection No	Date Inspected	Test Status	Measured Temp	Threshold Temp	Ambient Temp	Status Note	Customer Notes
1417	22/11/2010	TESTED	40 C	32 C	20 C

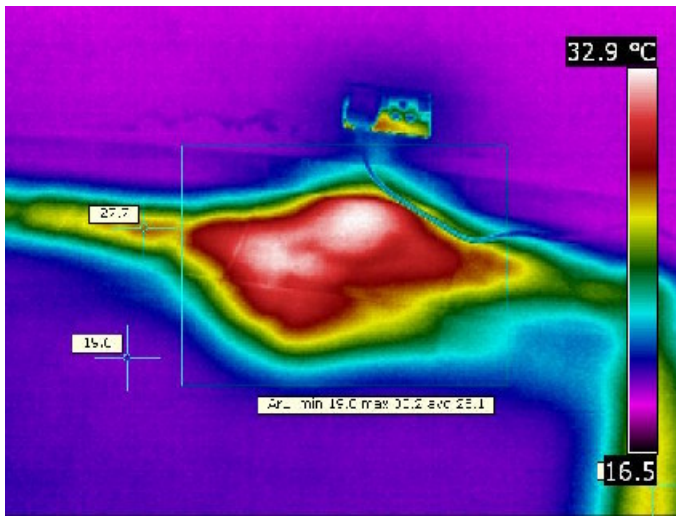
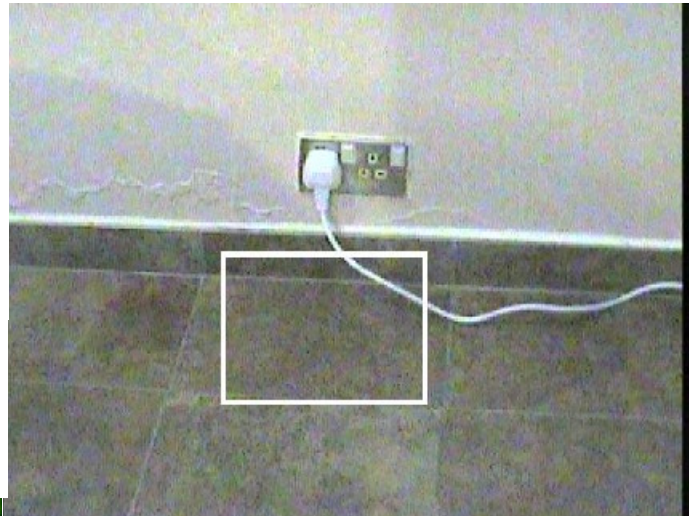
Location/Equipment Information	
Asset ID:	-
Barcode:	NI
Location:	LIVING ROOM BENEATH FRONT WINDOW

Operation Priority:	Critical to operation
Repair Priority:	1-Critical
Hazard Type:	Visual
Hazard Classification:	Hot Water Supply & Heating Systems
Hazard Group:	Elevated surface temperature found
Hazard Issue:	indicating possible area of underfloor water leakage
Observations:	Elevated surface temperature found indicating possible area of underfloor water leakage
What is the Cause:	Suspected water leak

Repair Information		Loss to Production	
<p>PLEASE FAX BACK AFTER REPAIR TO: 0871 900 4978 OR INFO@THERMALIMAGING.CO.UK</p>		<input type="checkbox"/> Yes <input type="checkbox"/> No <input checked="" type="checkbox"/> Unknown	
		Consequences of Failure: <input type="text"/> Parts Req. Before Failure: <input type="text"/> Parts Req. After Failure: <input type="text"/> Repair Recommendation: <input type="text"/> Investigate source of leak and repair. Isolate equipment if necessary	Repair Date: <input type="text"/> Repaired By: <input type="text"/> Root Cause: <input type="text"/> Repair Procedure: Investigate source of leak and repair. Isolate equipment if necessary Repair Notes: <input type="text"/>
