Thermal Imaging Report

Inspection Ref. TI WATER LEAK DEMO (PIPE WORK)

TI LTD / TI WATER LEAK DEMO

10th Mar 2014

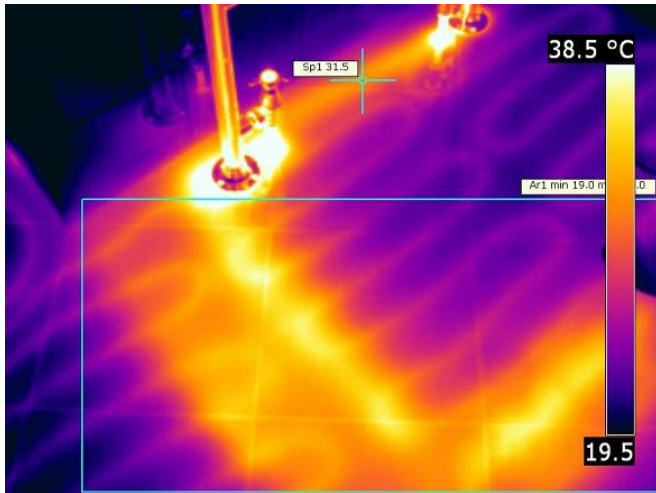
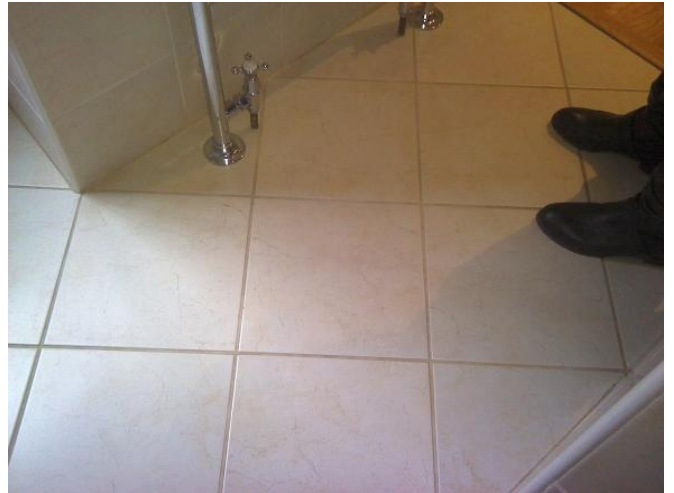
Client	Asset	Report Date	Problem #	Problem Type	Fault Rating	Problem Status
TI LTD	TI WATER LEAK DEMO	01/09/2015	2	THERMAL	■ CRITICAL	■ OPEN

Location/Equipment Information	
Location	BATHROOM
Component	ADJACENT RADIATOR
Item ID	
Status	T
PM WORK ORDER	N/A
Fault Item/Description

Problem	
Anomaly	ELEVATED SURFACE TEMPERATURE
Root Cause	POSSIBLE AREA OF WATER INGRESS
Remedial	FURTHER INVESTIGATION REQUIRED

Trending Data	
Pipework temp.	75
Min temp	23
Max temp	36
Moisture meter reading - Top (%)	0.0
Moisture meter reading - Middle (%)	N/A
Moisture meter reading - Bottom (%)	N/A
Chlorine Meter reading (PPM)	N/A
Gas (PPM)	N/A
Distance 1 from (cm)	N/A
Distance 2 from (cm)	N/A

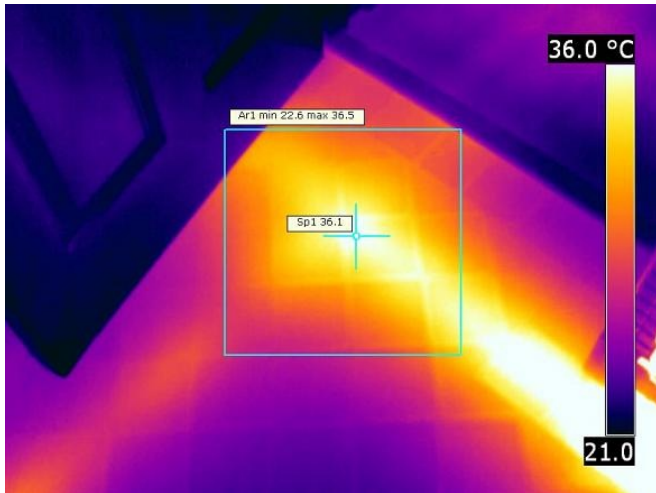
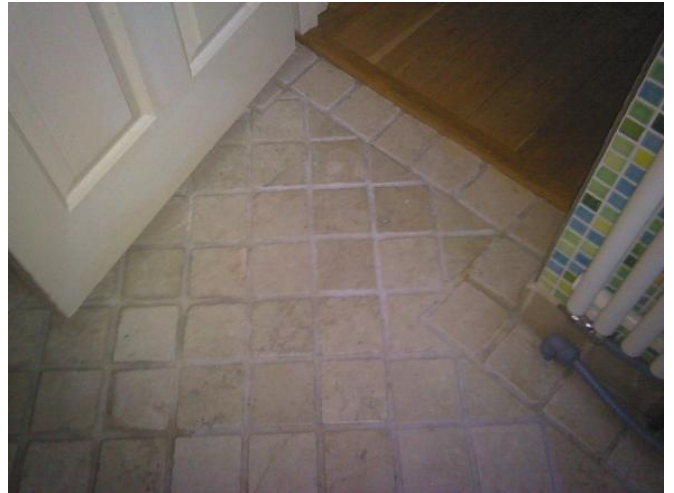
Client	Asset	Report Date	Problem #	Problem Type	Fault Rating	Problem Status
TI LTD	TI WATER LEAK DEMO	01/09/2015	3	THERMAL	MINOR	OPEN

Location/Equipment Information	
Location	EN SUITE
Component	TOWARDS DOOR
Item ID	
Status	T
PM WORK ORDER	N/A
Fault Item/Description

Problem	
Anomaly	ELEVATED SURFACE TEMPERATURE
Root Cause	POSSIBLE AREA OF WATER INGRESS
Remedial	FURTHER INVESTIGATION REQUIRED

Trending Data	
Pipework temp.	75
Min temp	23
Max temp	35
Moisture meter reading - Top (%)	0.0
Moisture meter reading - Middle (%)	N/A
Moisture meter reading - Bottom (%)	N/A
Chlorine Meter reading (PPM)	N/A
Gas (PPM)	N/A
Distance 1 from (cm)	N/A
Distance 2 from (cm)	N/A

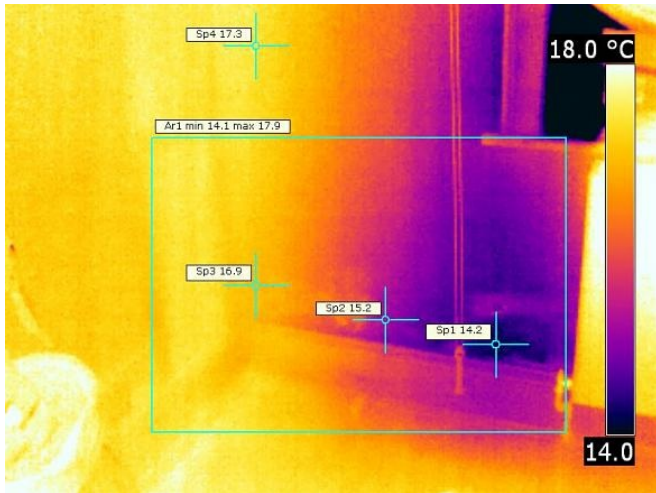
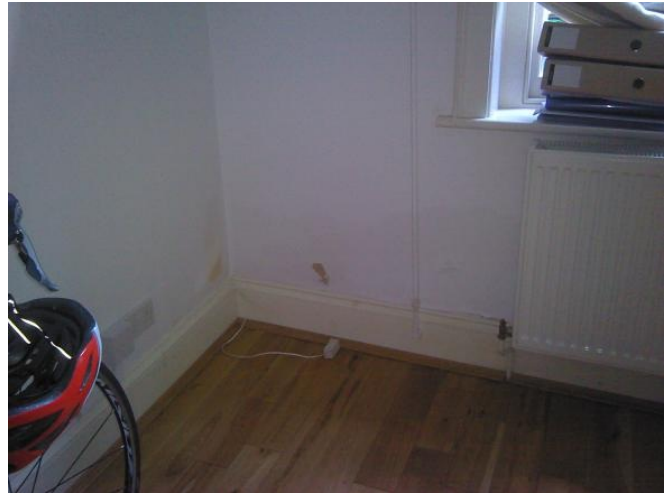
Client	Asset	Report Date	Problem #	Problem Type	Fault Rating	Problem Status
TI LTD	TI WATER LEAK DEMO	01/09/2015	4	THERMAL	IMPORTANT	OPEN

Location	SECOND BEDROOM
Component	LEFT CORNER FROM WINDOW
Item ID	
Status	T
PM WORK ORDER	N/A
Fault Item/Description

Anomaly	DECREASED SURFACE TEMPERATURE
Root Cause	AREA OF DELAMINATION FROM SUBSTRATE
Remedial	IDENTIFY ROOT CAUSE THEN ASSESS SUBSTRATE FOR INTEGRITY PRIOR TO REPAIR

Pipework temp.	75.0
Min temp	16.0
Max temp	17.0
Moisture meter reading - Top (%)	0.0
Moisture meter reading - Middle (%)	N/A
Moisture meter reading - Bottom (%)	N/A
Chlorine Meter reading (PPM)	N/A
Gas (PPM)	N/A
Distance 1 from (cm)	N/A
Distance 2 from (cm)	N/A

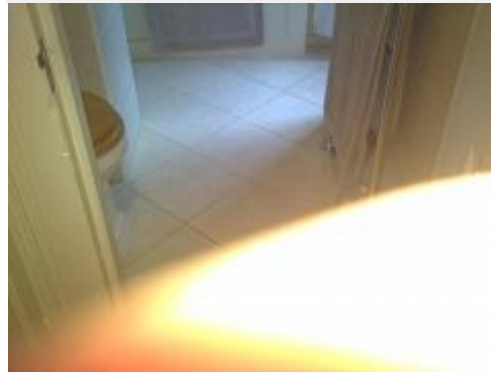
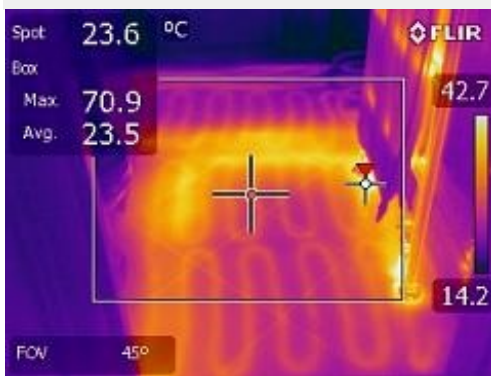
BATHROOM - ADJACENT RADIATOR

Inspection Reference	Date Inspected	Pipework temp.	Min temp	Max temp	Moisture meter reading - Top (%)
TI WATER LEAK DEMO	10 th Mar 2014	75	23	36	0.0

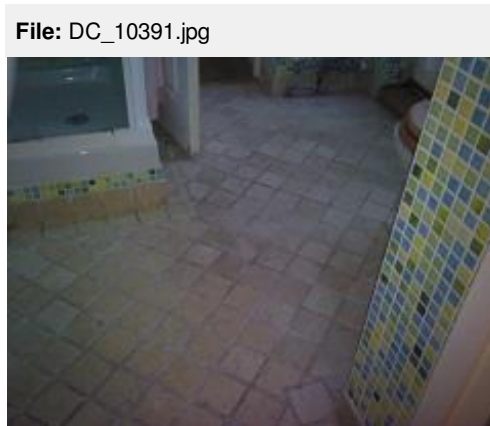
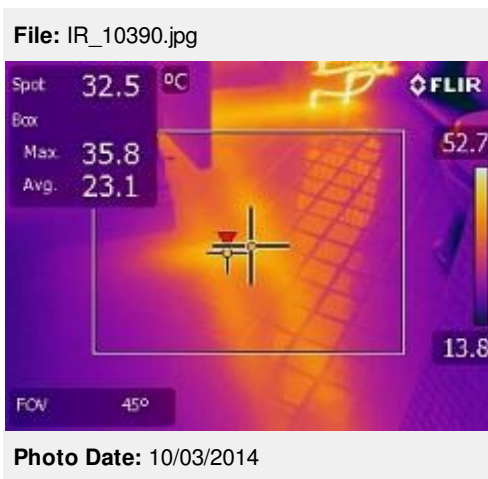
EN SUITE - TOWARDS DOOR

Inspection Reference	Date Inspected	Pipework temp.	Min temp	Max temp	Moisture meter reading - Top (%)
TI WATER LEAK DEMO	10 th Mar 2014	75	23	35	0.0

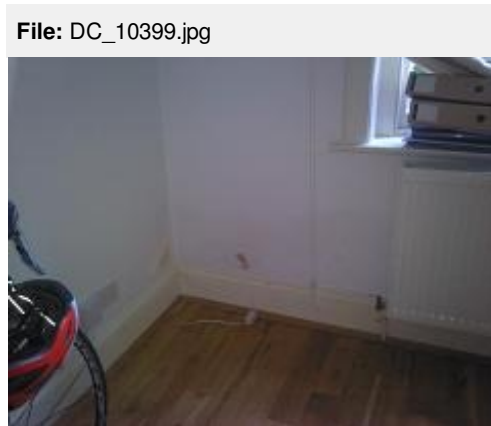
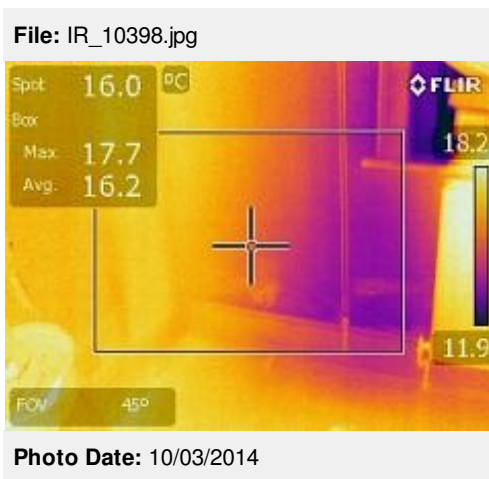
SECOND BEDROOM - LEFT CORNER FROM WINDOW

Inspection Reference	Date Inspected	Pipework temp.	Min temp	Max temp	Moisture meter reading - Top (%)
TI WATER LEAK DEMO	10 th Mar 2014	75.0	16.0	17.0	0.0

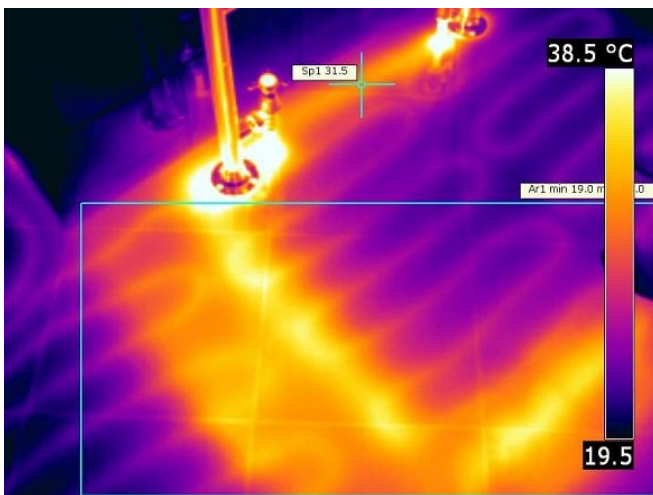
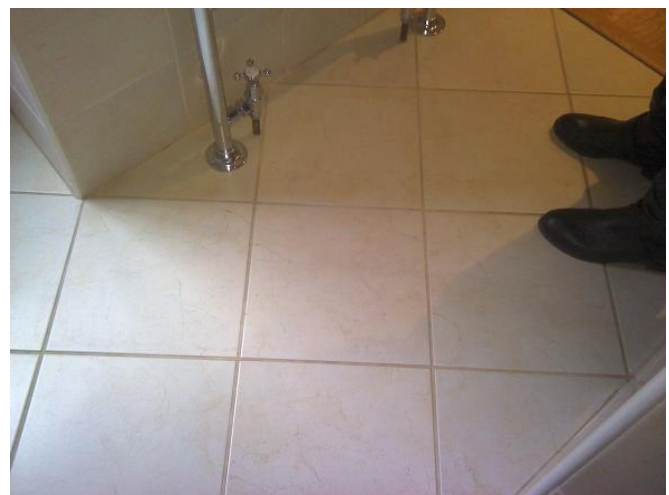
Location/Equipment Information	
Location	BATHROOM
Component	ADJACENT RADIATOR
Item ID	
PM WORK ORDER	N/A
Problem

Thermal Information	
Pipework temp.	75
Min temp	23
Max temp	36
Moisture meter reading - Top (%)	0.0
Moisture meter reading - Middle (%)	N/A
Moisture meter reading - Bottom (%)	N/A
Chlorine Meter reading (PPM)	N/A
Gas (PPM)	N/A
Distance 1 from (cm)	N/A
Distance 2 from (cm)	N/A

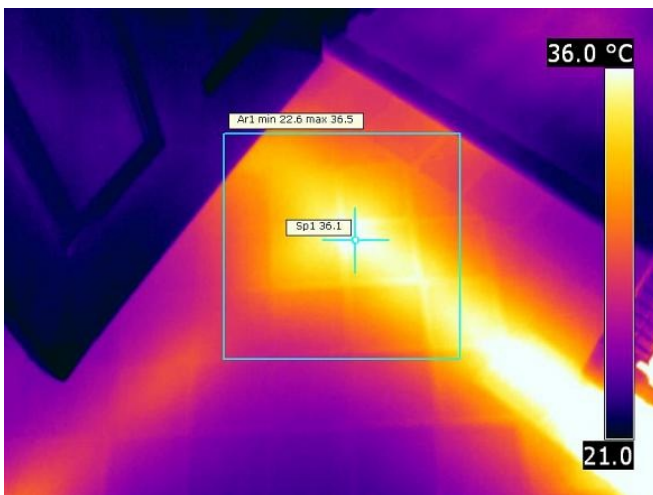
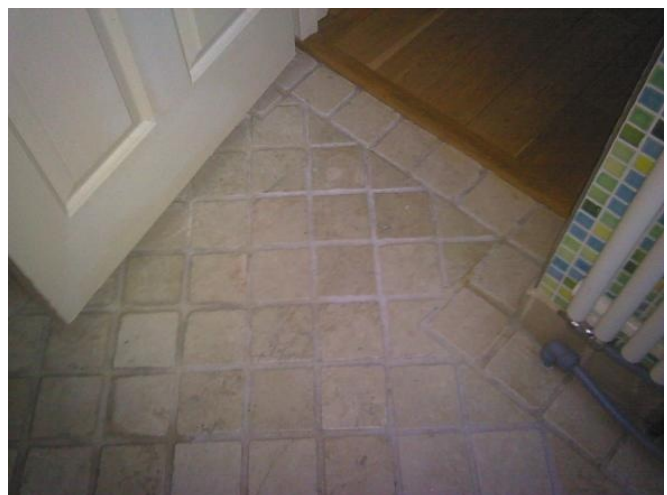
Location/Equipment Information	
Location	EN SUITE
Component	TOWARDS DOOR
Item ID	
PM WORK ORDER	N/A
Problem

Thermal Information	
Pipework temp.	75
Min temp	23
Max temp	35
Moisture meter reading - Top (%)	0.0
Moisture meter reading - Middle (%)	N/A
Moisture meter reading - Bottom (%)	N/A
Chlorine Meter reading (PPM)	N/A
Gas (PPM)	N/A
Distance 1 from (cm)	N/A
Distance 2 from (cm)	N/A

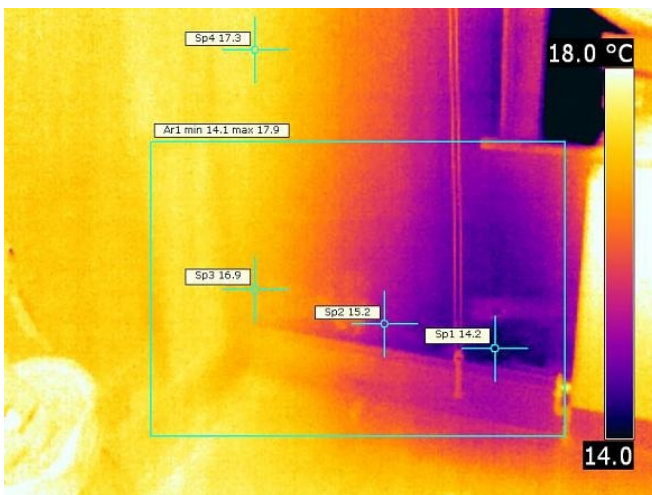
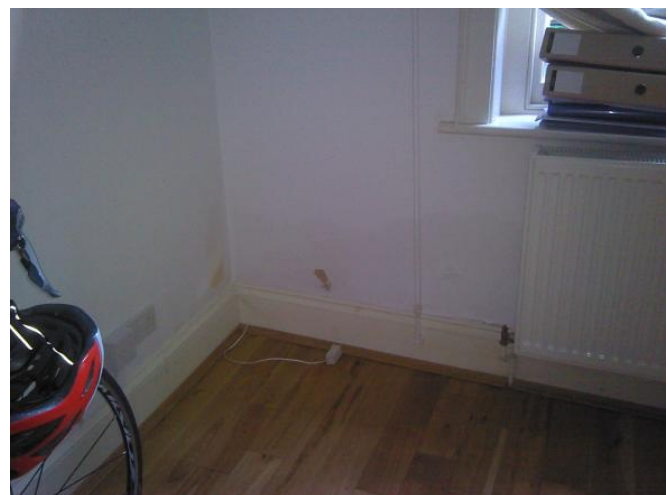
Location/Equipment Information	
Location	SECOND BEDROOM
Component	LEFT CORNER FROM WINDOW
Item ID	
PM WORK ORDER	N/A
Problem

Thermal Information	
Pipework temp.	75.0
Min temp	16.0
Max temp	17.0
Moisture meter reading - Top (%)	0.0
Moisture meter reading - Middle (%)	N/A
Moisture meter reading - Bottom (%)	N/A
Chlorine Meter reading (PPM)	N/A
Gas (PPM)	N/A
Distance 1 from (cm)	N/A
Distance 2 from (cm)	N/A
