RISK MANAGEMENT THERMOGRAPHIC INSPECTION FOR:

**UNIT 8 WEYBRIDGE BUSINESS CENTRE
66 YORK ROAD
WEYBRIDGE
SURREY
KT13 9DY**

25/08/11

INFRARED THERMOGRAPHIC INSPECTION
OF
TRANSMISSION / DISTRIBUTION
ELECTRICAL INSPECTION

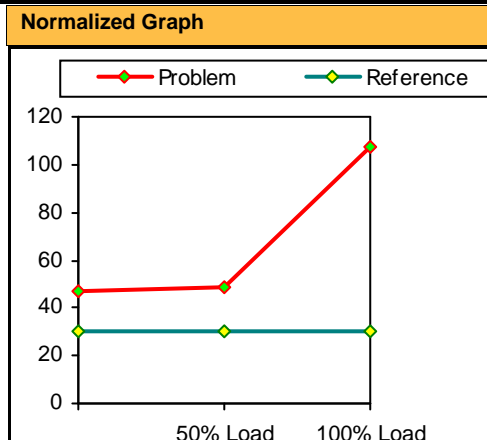
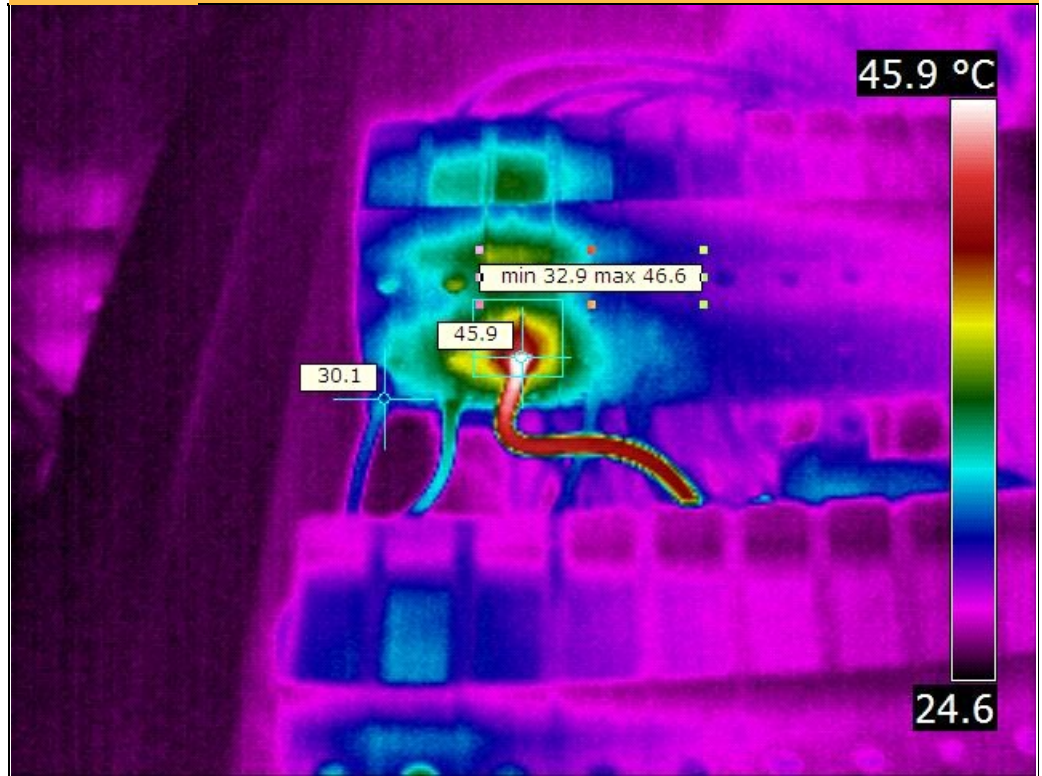
Infrared Image: IR_0555A.jpg Date: 24/08/2011

Location / Equipment Information	
Work Order	1830173
Equipment ID	DB T20 R3
Location	RISER A
Description	DB T20 R3
Severity	2-Serious
Anomaly	Load side connection indicates higher temperature than expected on 32A - 1 Pole Mini Circuit Breaker
Possible Root Cause	Suspected loose/deteriorated load side connection
Recommendation	Check, clean and remake load side connection(s)

Equipment Information			
Component:	Mini Circuit Breakers		
Manufacturer:	Socamec		
Model No:	A32S		
Rated Amps:	32		
Circuit Voltage:	400 Volts		
Measured Loads (Load taken if safe and allowed on PTW)	Phase	Actual Loads (A)	Load %
	Load side:	15	46.88%
	Line side:	15	46.88%
	Neutral

Current Prob No: T/D Electrical/4	
Operation Priority:	Critical to operation
Max Component Temperature - Ar1 Max Temperature	47 C
Reference Temperature or SP2 Temperature	30 C
Temperature Rise Above Reference	17 C
Maximum allowable Temperature British Standard Reference	75 C
British Standard Reference - BS7671

Temperature Information	
Cubicle ambient:	21 C
Emissivity:	0.96
Environment:	Indoors
Adjusted Temperature Rise above reference:	17 C
Estimated Temp Rise over reference @ 50% Load: (See * 1)	19 C
Estimated Temp Rise over reference @ 100% Load: (See * 2)	77 C
