RISK MANAGEMENT SOLAR PANEL THERMOGRAPHIC INSPECTION FOR:

SAMPLE 2

TI-16078

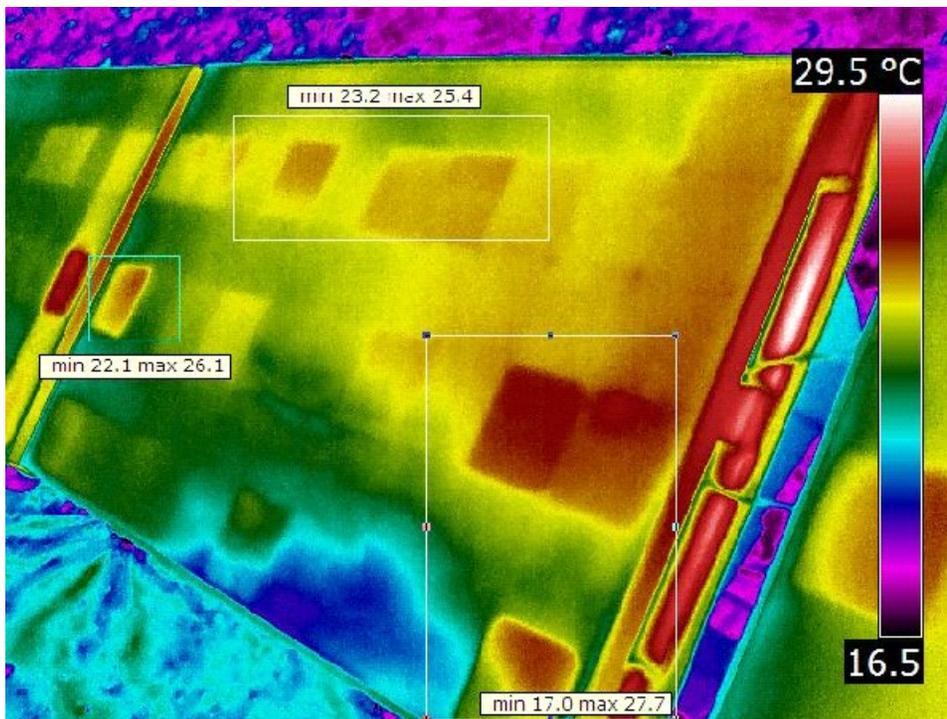
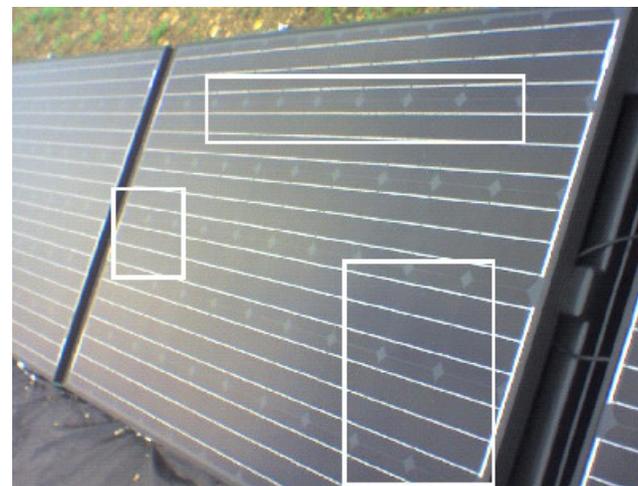
File: IR_11329A.jpg	Date: 15/09/2012	Time: 12:49 PM
File: DC_11330.jpg	Date: 15/09/2012	Time: 12:51 PM

Classification: Solar Panel
Observations: Elevated Surface Temperature at AR1, AR2 and AR3
What is the Cause: Suspected Faulty Solar Cell(s)
Recommendations: Further investigation required

Repair Information		Loss to Production		
<p>PLEASE FAX BACK AFTER REPAIR TO: 0871 900 4978 OR INFO@THERMALIMAGING.CO.UK</p>		<input type="checkbox"/> Yes	<input type="checkbox"/> No	<input checked="" type="checkbox"/> Unknown
		Repair Date: <input type="text"/>	Repaired By: <input type="text"/>	
Consequences of Failure:	<input type="text"/>	Root Cause:	<input type="text"/>	
Parts Req. Before Failure:	<input type="text"/>	Repair Procedure:	Further investigation required	
Parts Req. After Failure:	<input type="text"/>	Repair Notes:	<input type="text"/>	
Repair Recommendation:	Further investigation required

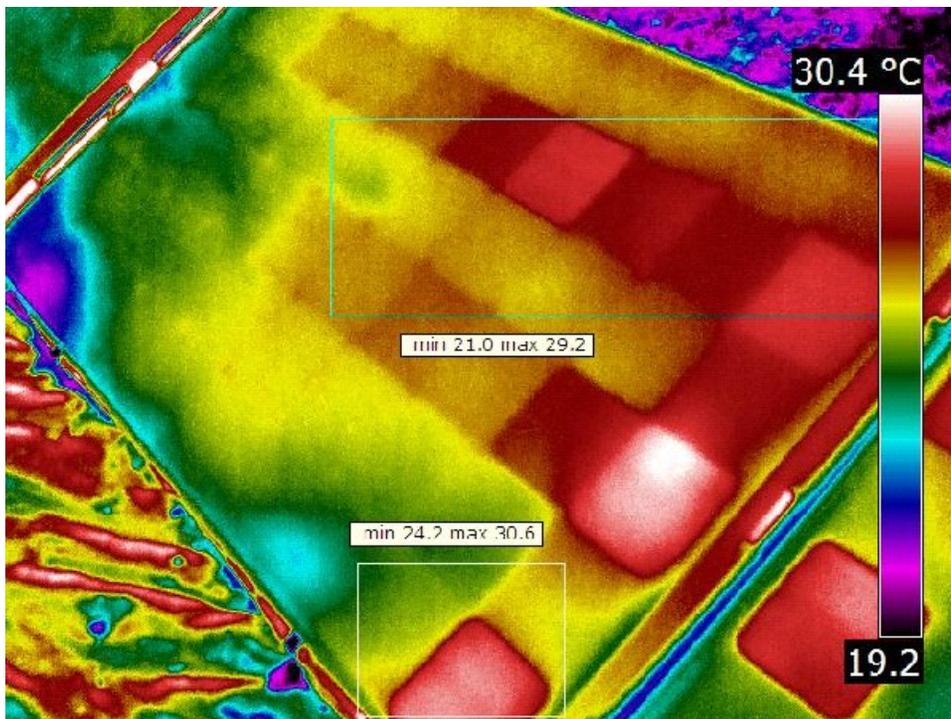
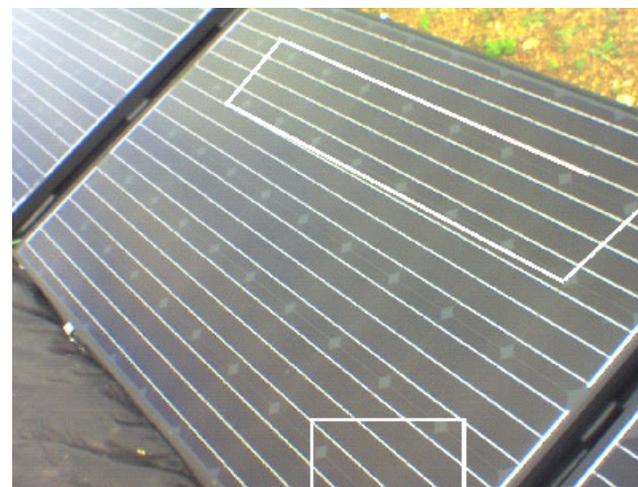
File: IR_11331A.jpg	Date: 15/09/2012	Time: 12:53 PM
File: DC_11332.jpg	Date: 15/09/2012	Time: 12:53 PM

- Classification:** Solar Panel
Observations: Elevated Surface Temperature at AR1 and AR2
What is the Cause: Suspected Faulty Solar Cell(s)
Recommendations: Further investigation required

Repair Information		PLEASE FAX BACK AFTER REPAIR TO:		Loss to Production	
		0871 900 4978 OR		<input type="checkbox"/> Yes <input type="checkbox"/> No <input checked="" type="checkbox"/> Unknown	
		INFO@THERMALIMAGING.CO.UK			
Consequences of Failure:	Repair Date:	Repaired By:			
	Root Cause:				
Parts Req. Before Failure:	Repair Procedure:	Further investigation required			
Parts Req. After Failure:	Repair Notes:				
Repair Recommendation:	Further investigation required

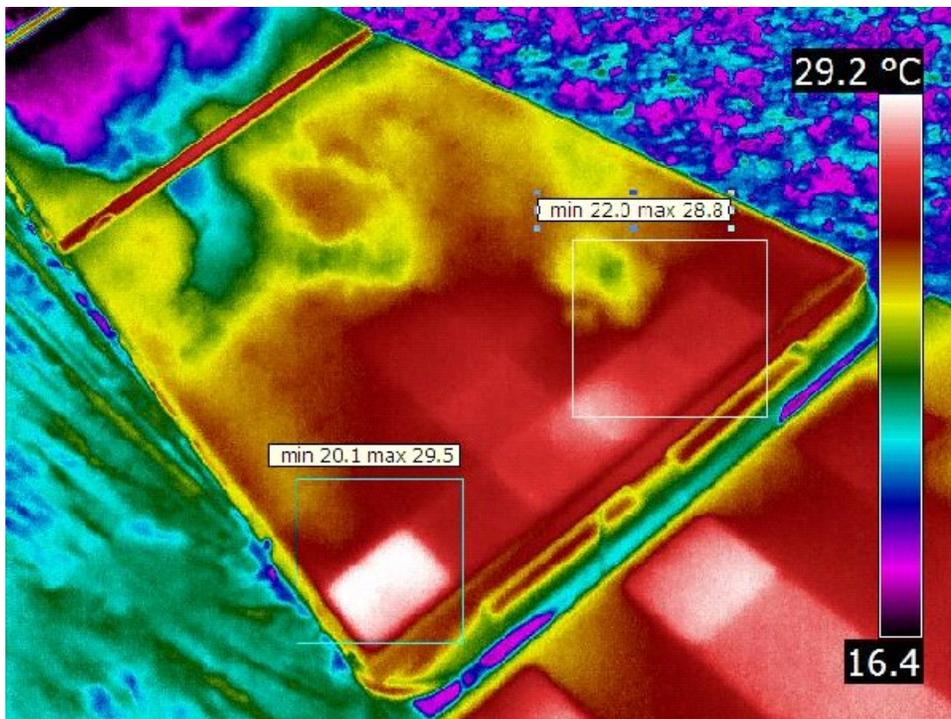
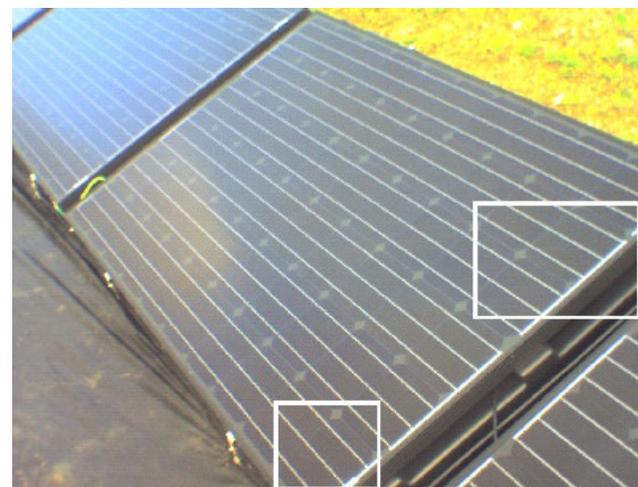
File: IR_11333A.jpg	Date: 15/09/2012	Time: 01:00 PM
File: DC_11334.jpg	Date: 14/09/2012	Time: 10:19 AM

- Classification:** Solar Panel
- Observations:** Elevated Surface Temperature at AR1, AR2 and AR3
- What is the Cause:** Suspected Faulty Solar Cell(s)
- Recommendations:** Further investigation required

Repair Information		Loss to Production	
<p>PLEASE FAX BACK AFTER REPAIR TO: 0871 900 4978 OR INFO@THERMALIMAGING.CO.UK</p>		<input type="checkbox"/> Yes <input type="checkbox"/> No <input checked="" type="checkbox"/> Unknown	
		Repair Date: <input type="text"/>	Repaired By: <input type="text"/>
Consequences of Failure: <input type="text"/> <input type="text"/>	Root Cause: <input type="text"/> <input type="text"/>	Further investigation required <input type="text"/>	
Parts Req. Before Failure: <input type="text"/> <input type="text"/>	Repair Procedure: <input type="text"/> <input type="text"/>	Repair Notes: <input type="text"/> <input type="text"/>	
Parts Req. After Failure: <input type="text"/> <input type="text"/>			
Repair Recommendation: Further investigation required <input type="text"/>

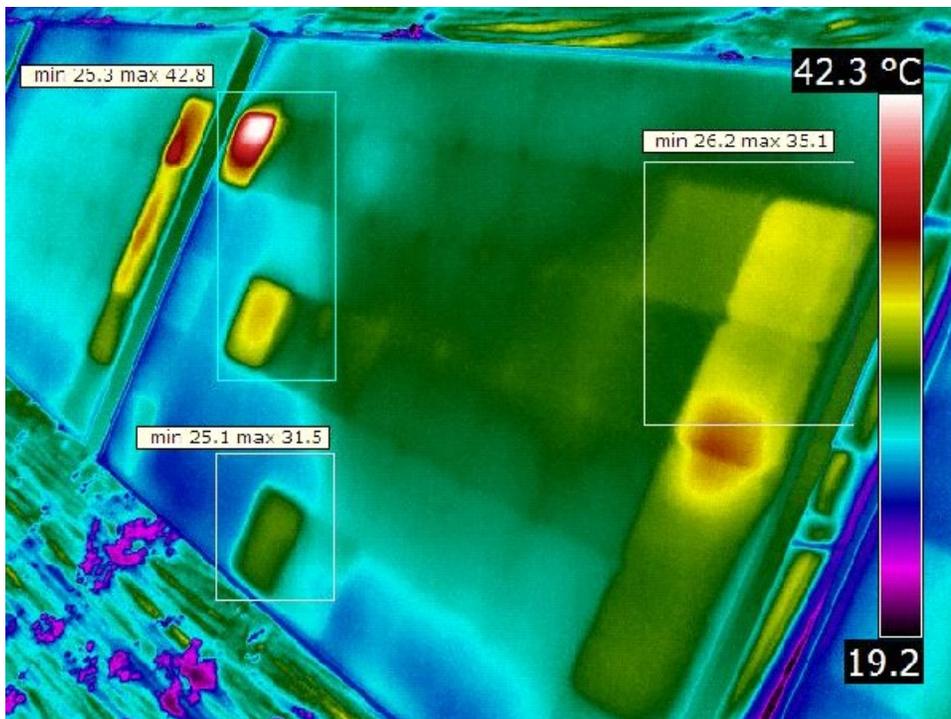
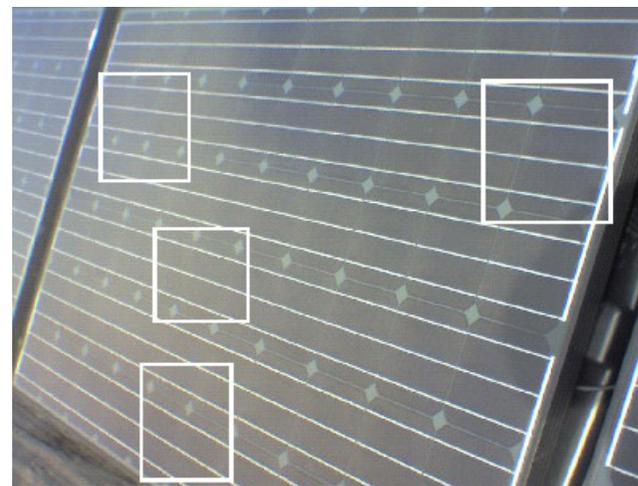
File: IR_11335A.jpg	Date: 15/09/2012	Time: 12:57 PM
File: DC_11336.jpg	Date: 15/09/2012	Time: 12:57 PM

- Classification:** Solar Panel
- Observations:** Elevated Surface Temperature at AR1, AR2 and AR3
- What is the Cause:** Suspected Faulty Solar Cell(s)
- Recommendations:** Further investigation required

Repair Information		Loss to Production	
<p>PLEASE FAX BACK AFTER REPAIR TO: 0871 900 4978 OR INFO@THERMALIMAGING.CO.UK</p>		<input type="checkbox"/> Yes <input type="checkbox"/> No <input checked="" type="checkbox"/> Unknown	
		Repair Date: <input type="text"/>	Repaired By: <input type="text"/>
Consequences of Failure: <input type="text"/>	Root Cause: <input type="text"/>	Further investigation required	
Parts Req. Before Failure: <input type="text"/>	Repair Procedure: <input type="text"/>	Repair Notes: <input type="text"/>	
Parts Req. After Failure: <input type="text"/>			
Repair Recommendation: Further investigation required

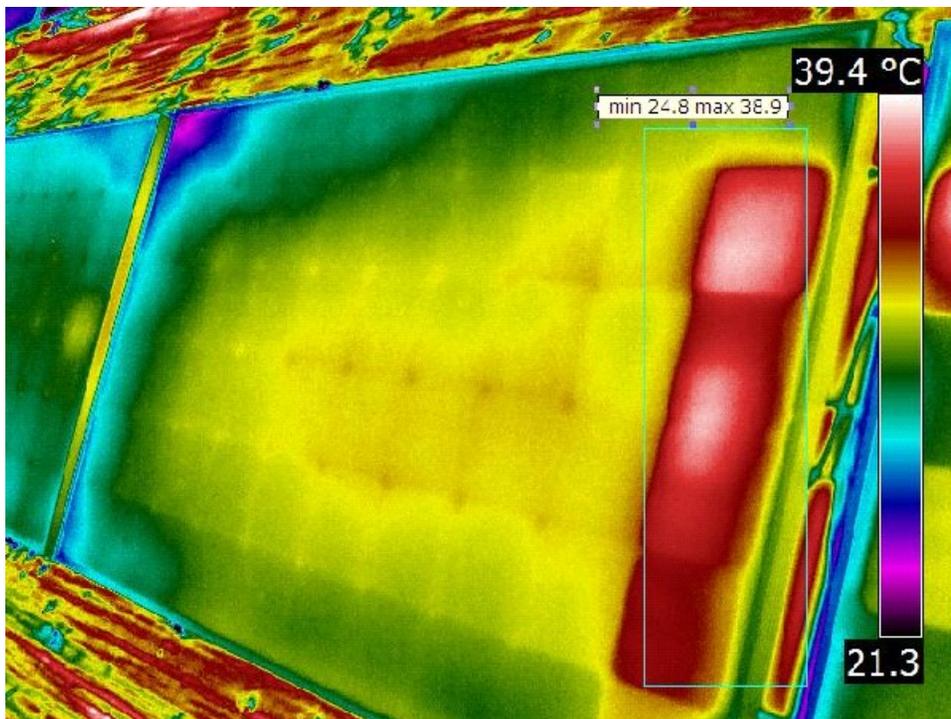
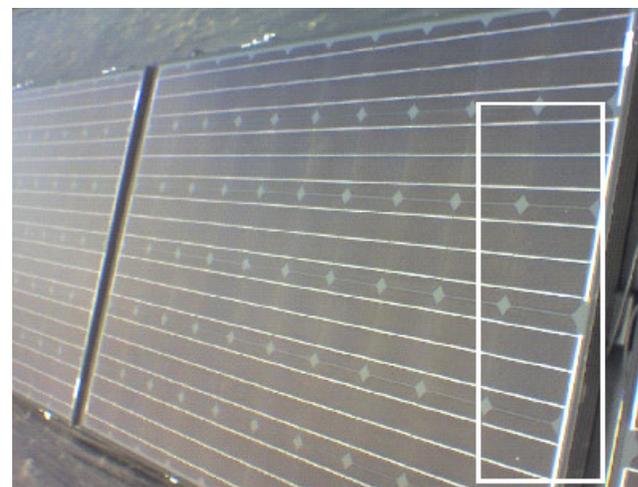
File: IR_11337A.jpg	Date: 15/09/2012	Time: 01:04 PM
File: DC_11338.jpg	Date: 15/09/2012	Time: 01:04 PM

Classification: Solar Panel
Observations: Elevated Surface Temperature at AR1
What is the Cause: Suspected Faulty Solar Cell(s)
Recommendations: Further investigation required

Repair Information		Loss to Production	
<p>PLEASE FAX BACK AFTER REPAIR TO: 0871 900 4978 OR INFO@THERMALIMAGING.CO.UK</p>		<input type="checkbox"/> Yes <input type="checkbox"/> No <input checked="" type="checkbox"/> Unknown	
		Repair Date: <input type="text"/>	Repaired By: <input type="text"/>
Consequences of Failure: <input type="text"/>	Root Cause: <input type="text"/>	Further investigation required	
Parts Req. Before Failure: <input type="text"/>	Repair Procedure: <input type="text"/>	Repair Notes: <input type="text"/>	
Parts Req. After Failure: <input type="text"/>			
Repair Recommendation: Further investigation required

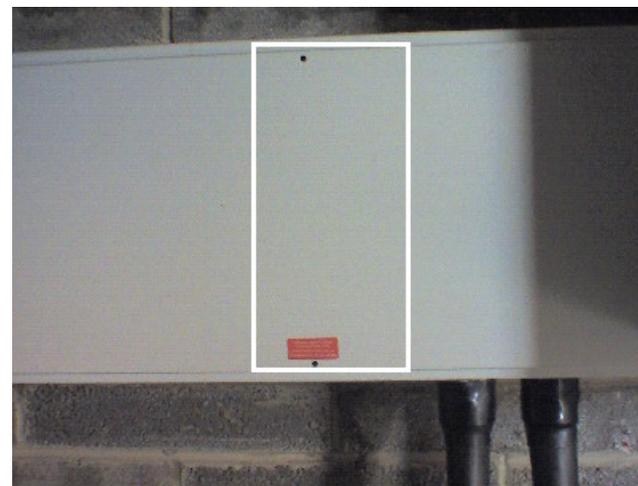
File:	Date:	Time:
File: DC_11447.jpg	Date: 15/09/2012	Time: 12:33 PM

Classification: Electrical
Observations: Missing panel fixings causing the panel to be secured insufficiently
What is the Cause: Panel fixings have not been replaced after previous removal
Recommendations: Add appropriate number of panel screws

Repair Information		PLEASE FAX BACK AFTER REPAIR TO: 0871 900 4978 OR INFO@THERMALIMAGING.CO.UK		Loss to Production	
Consequences of Failure:		Repair Date:		<input type="checkbox"/> Yes <input type="checkbox"/> No <input checked="" type="checkbox"/> Unknown	
<input type="text"/>		Repaired By:		<input type="text"/>	
Parts Req. Before Failure:		Root Cause:		<input type="text"/>	
<input type="text"/>		Repair Procedure:		Add appropriate number of panel screws	
Parts Req. After Failure:		Repair Notes:		<input type="text"/>	
<input type="text"/>					
Repair Recommendation:					
Add appropriate number of panel screws					
<input type="text"/>

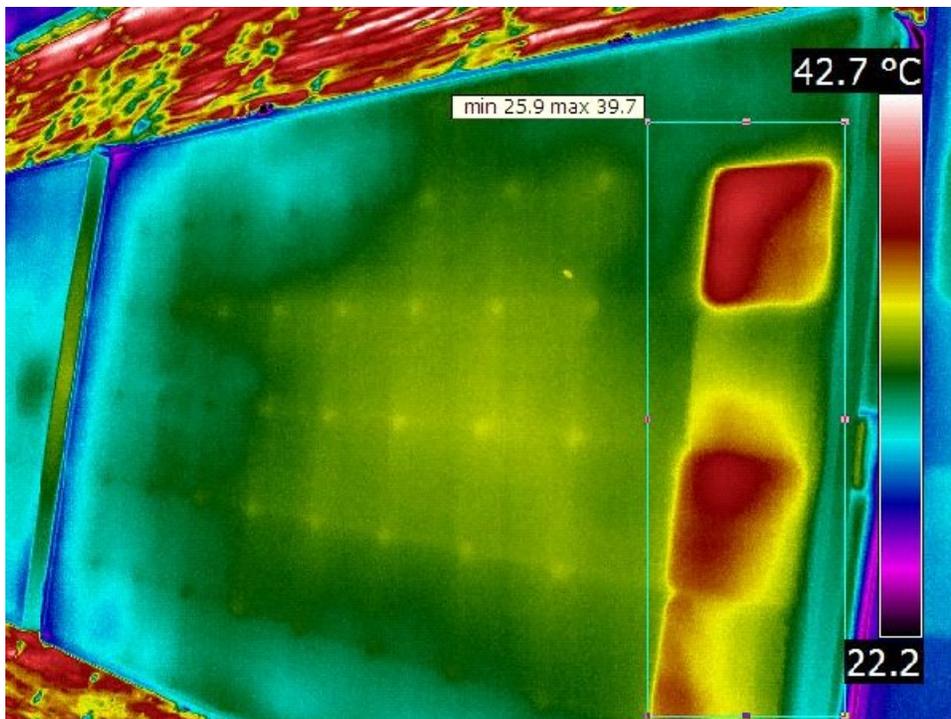
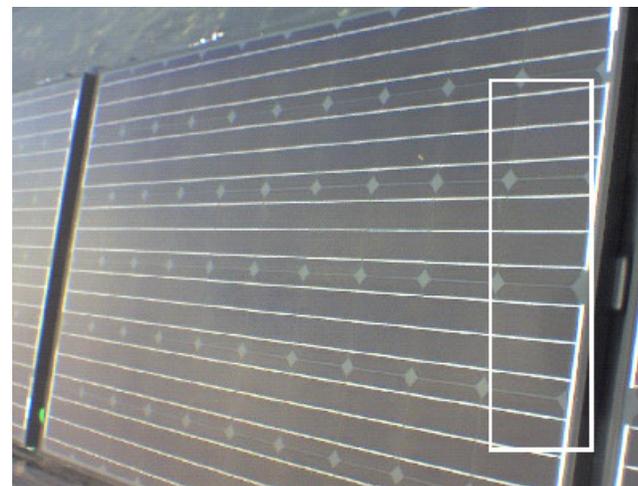
File: IR_11339A.jpg	Date: 15/09/2012	Time: 01:06 PM
File: DC_11340.jpg	Date: 15/09/2012	Time: 01:06 PM

Classification: Solar Panel
Observations: Elevated Surface Temperature at AR1
What is the Cause: Suspected Faulty Solar Cell(s)
Recommendations: Further investigation required

Repair Information		Loss to Production	
<p>PLEASE FAX BACK AFTER REPAIR TO: 0871 900 4978 OR INFO@THERMALIMAGING.CO.UK</p>		<input type="checkbox"/> Yes <input type="checkbox"/> No <input checked="" type="checkbox"/> Unknown	
		Repair Date: <input type="text"/>	Repaired By: <input type="text"/>
Consequences of Failure: <input type="text"/>	Root Cause: <input type="text"/>	Further investigation required	
Parts Req. Before Failure: <input type="text"/>	Repair Procedure: <input type="text"/>	Repair Notes: <input type="text"/>	
Parts Req. After Failure: <input type="text"/>			
Repair Recommendation: Further investigation required <input type="text"/>

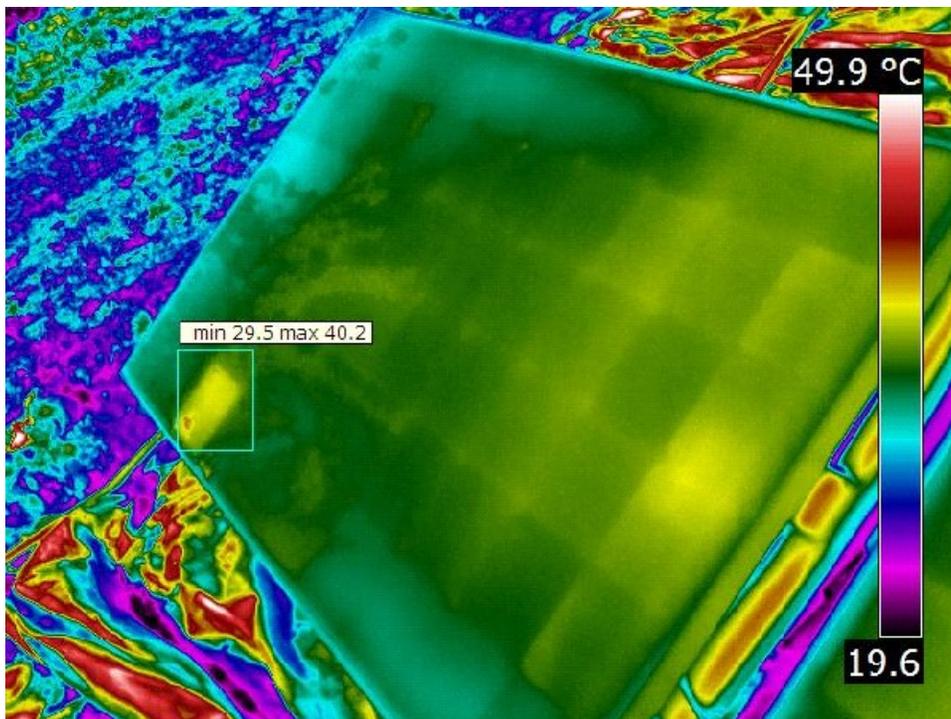
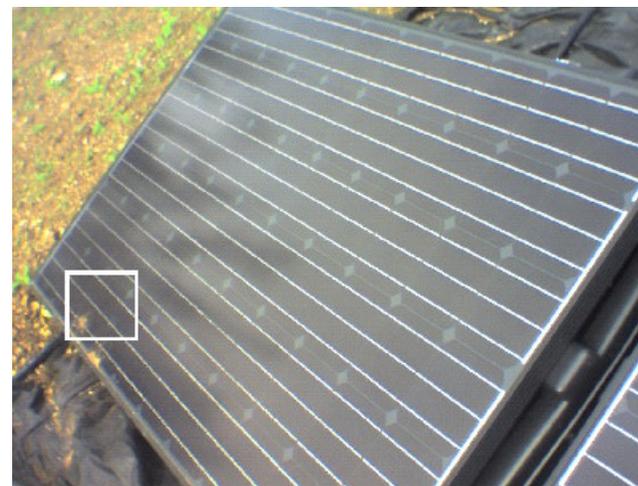
File: IR_11341A.jpg	Date: 15/09/2012	Time: 01:12 PM
File: DC_11342.jpg	Date: 15/09/2012	Time: 01:12 PM

Classification: Solar Panel
Observations: Elevated Surface Temperature at AR1
What is the Cause: Suspected Faulty Solar Cell(s)
Recommendations: Further investigation required

Repair Information		Loss to Production	
<p>PLEASE FAX BACK AFTER REPAIR TO: 0871 900 4978 OR INFO@THERMALIMAGING.CO.UK</p>		<input type="checkbox"/> Yes <input type="checkbox"/> No <input checked="" type="checkbox"/> Unknown	
		Repair Date: <input type="text"/>	Repaired By: <input type="text"/>
Consequences of Failure: <input type="text"/>	Root Cause: <input type="text"/>	Further investigation required	
Parts Req. Before Failure: <input type="text"/>	Repair Procedure: <input type="text"/>	Repair Notes: <input type="text"/>	
Parts Req. After Failure: <input type="text"/>			
Repair Recommendation: Further investigation required

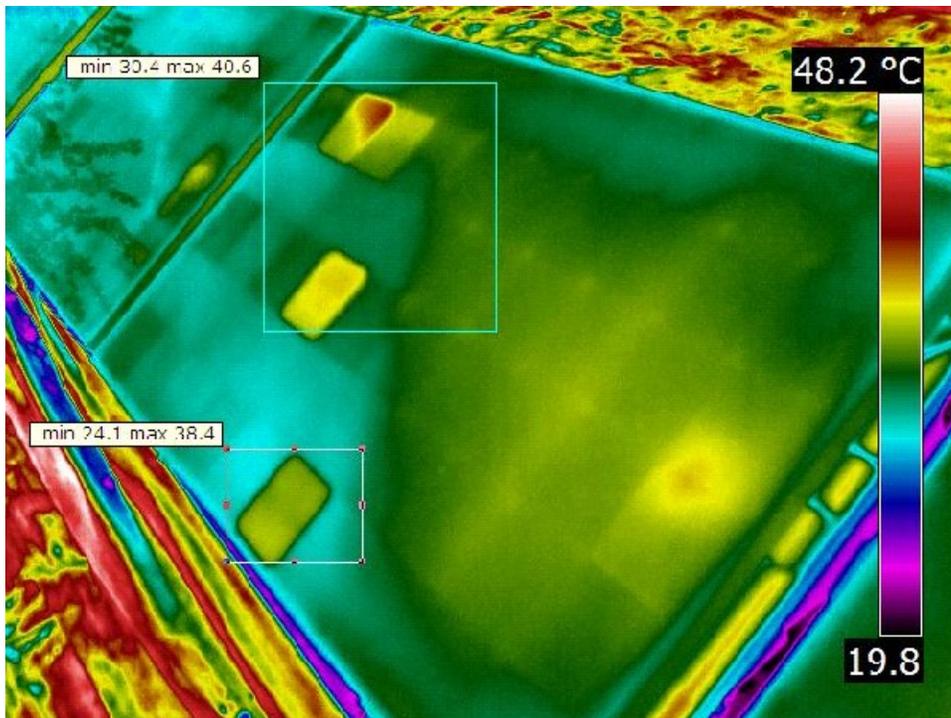
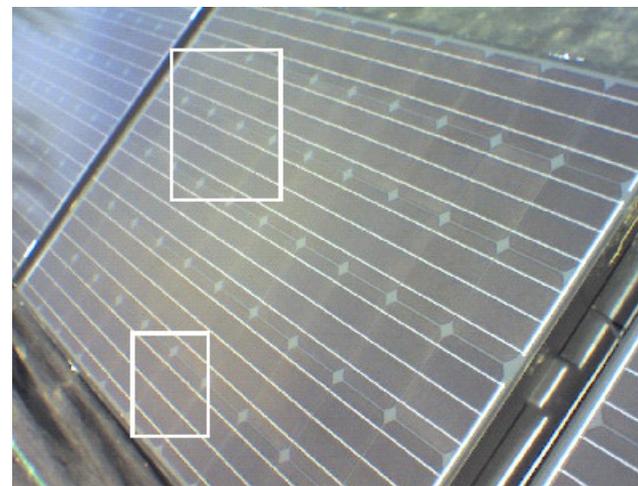
File: IR_11345A.jpg	Date: 15/09/2012	Time: 01:29 PM
File: DC_11346.jpg	Date: 15/09/2012	Time: 01:29 PM

- Classification:** Solar Panel
- Observations:** Elevated Surface Temperature at AR1 and AR2
- What is the Cause:** Suspected Faulty Solar Cell(s)
- Recommendations:** Further investigation required

Repair Information		Loss to Production	
<p>PLEASE FAX BACK AFTER REPAIR TO: 0871 900 4978 OR INFO@THERMALIMAGING.CO.UK</p>		<input type="checkbox"/> Yes <input type="checkbox"/> No <input checked="" type="checkbox"/> Unknown	
		Repair Date: <input type="text"/>	Repaired By: <input type="text"/>
Consequences of Failure: <input type="text"/>	Root Cause: <input type="text"/>	Further investigation required	
Parts Req. Before Failure: <input type="text"/>	Repair Procedure: <input type="text"/>		
Parts Req. After Failure: <input type="text"/>	Repair Notes: <input type="text"/>		
Repair Recommendation: Further investigation required <input type="text"/>

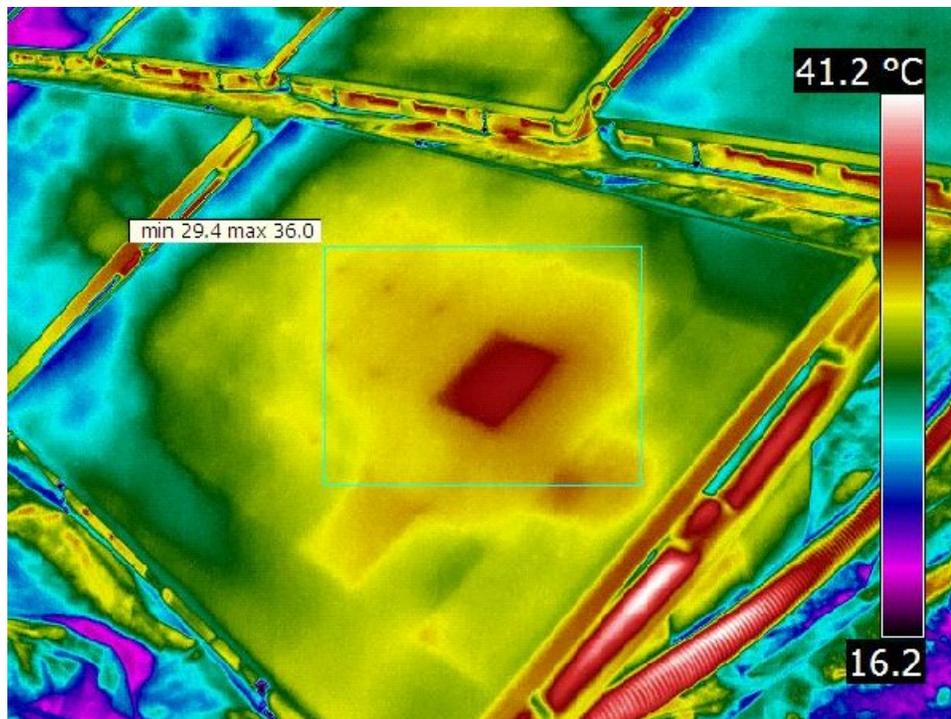
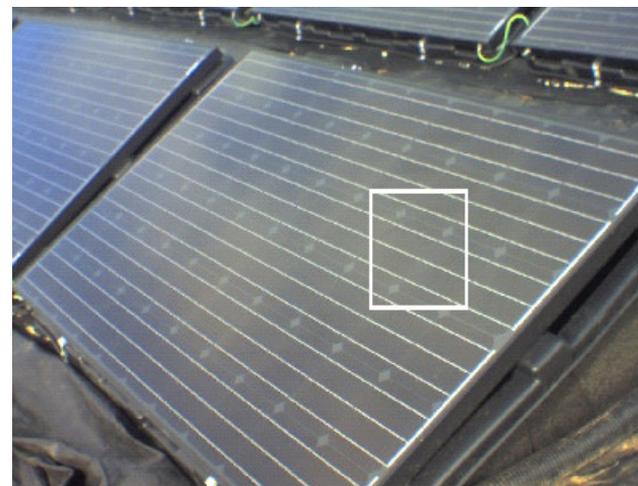
File: IR_11347A.jpg	Date: 15/09/2012	Time: 02:08 PM
File: DC_11348.jpg	Date: 15/09/2012	Time: 02:08 PM

Classification: Solar Panel
Observations: Elevated Surface Temperature at AR1
What is the Cause: Suspected Faulty Solar Cell(s)
Recommendations: Further investigation required

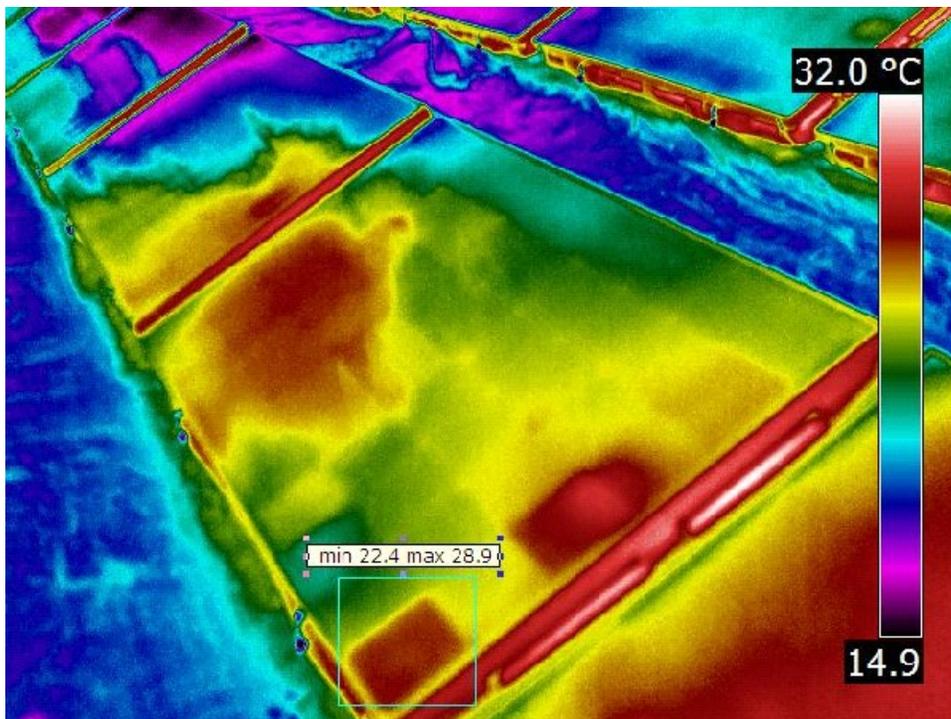
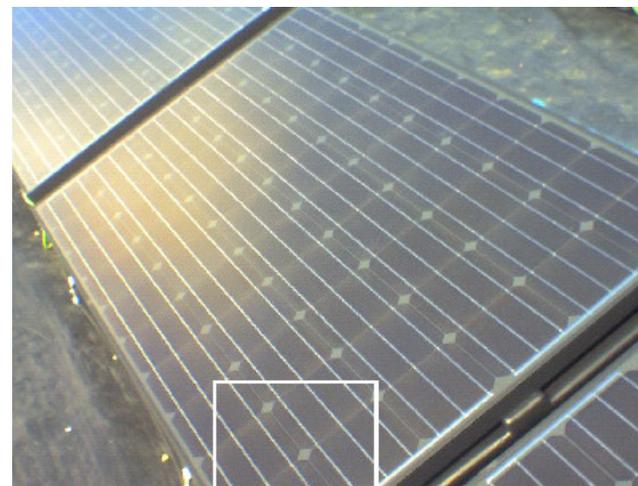
File: IR_11367a.jpg	Date: 15/09/2012	Time: 02:18 PM
File: DC_11368.jpg	Date: 15/09/2012	Time: 02:21 PM

Classification: Solar Panel
Observations: Elevated Surface Temperature at AR1
What is the Cause: Suspected Faulty Solar Cell(s)
Recommendations: Further investigation required

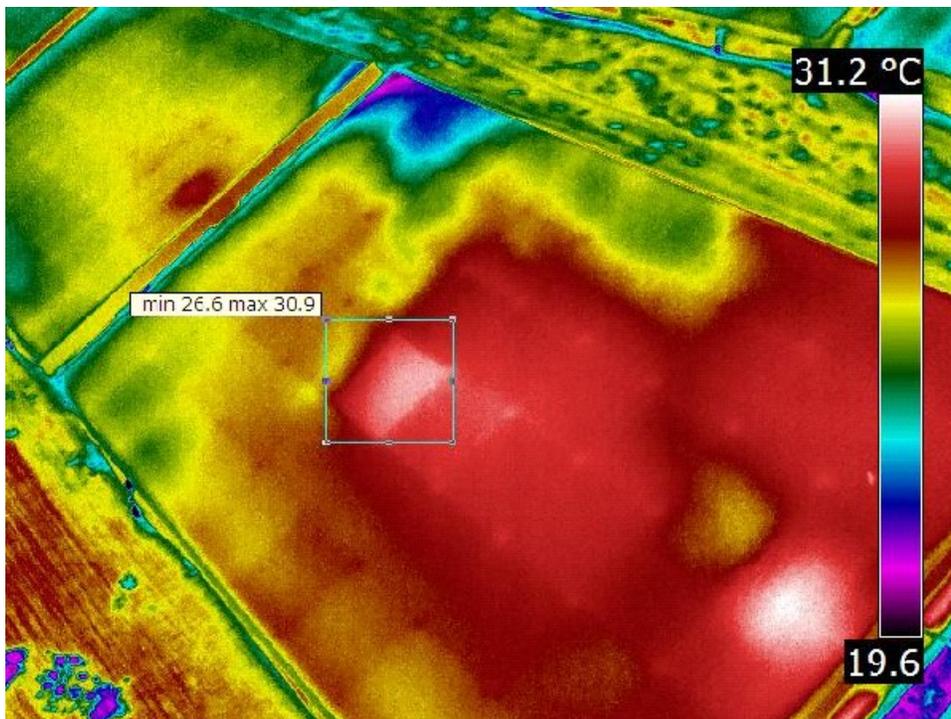
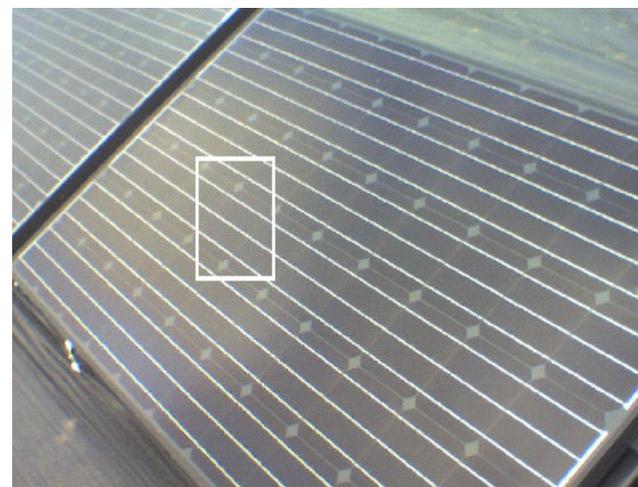
File: IR_11373A.jpg	Date: 15/09/2012	Time: 02:24 PM
File: DC_11374.jpg	Date: 15/09/2012	Time: 02:25 PM

Classification: Solar Panel
 Observations: Elevated Surface Temperature at AR1
 What is the Cause:
 Recommendations:

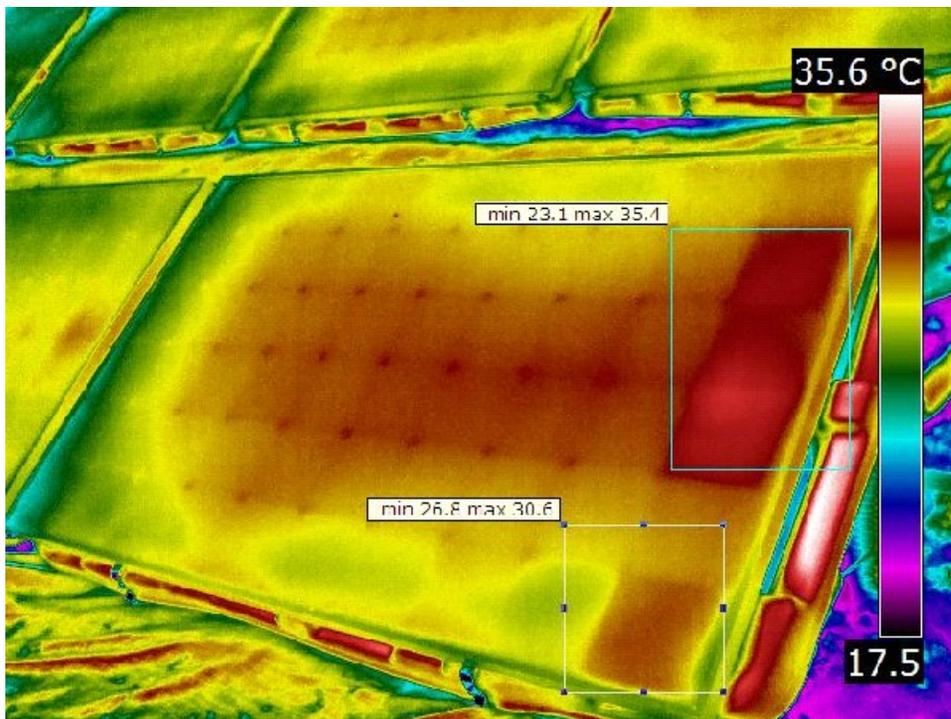
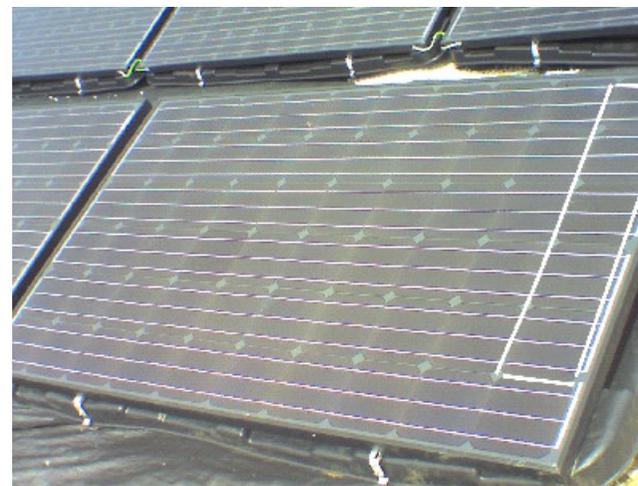
File: IR_11381A.jpg	Date: 15/09/2012	Time: 02:31 PM
File: DC_11382.jpg	Date: 15/09/2012	Time: 02:32 PM

Classification: Solar Panel
Observations: Elevated Surface Temperature at AR1 and AR2
What is the Cause: Suspected Faulty Solar Cell(s)
Recommendations: Further investigation required

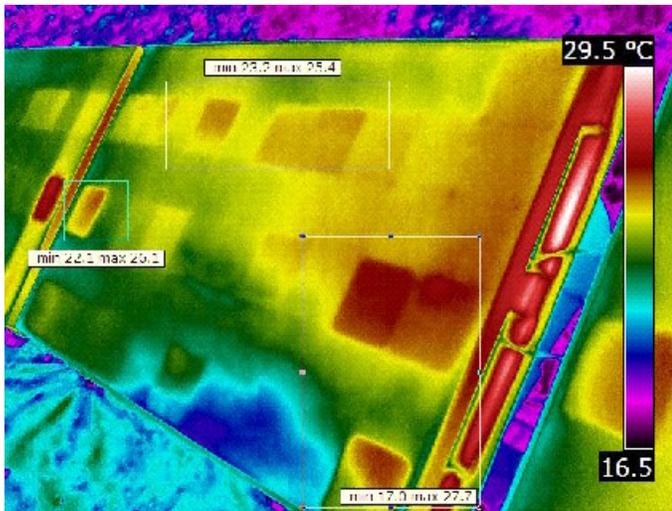
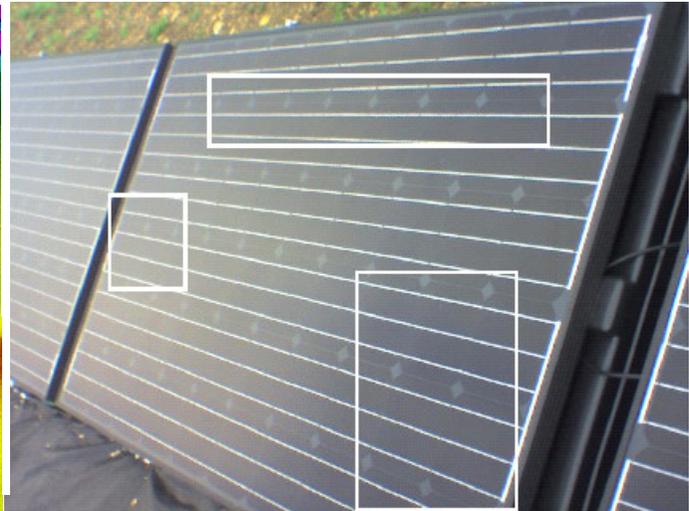
Photo File: IR_11329A.jpg

Operation Priority:	Critical to operation
Repair Priority:	3-Important
Hazard Type:	Visual
Hazard Classification:	Solar Panel
Hazard Group:	Elevated Surface Temperature
Hazard Issue:	at AR1, AR2 and AR3
Observations:	Elevated Surface Temperature at AR1, AR2 and AR3
What is the Cause:	Suspected Faulty Solar Cell(s)

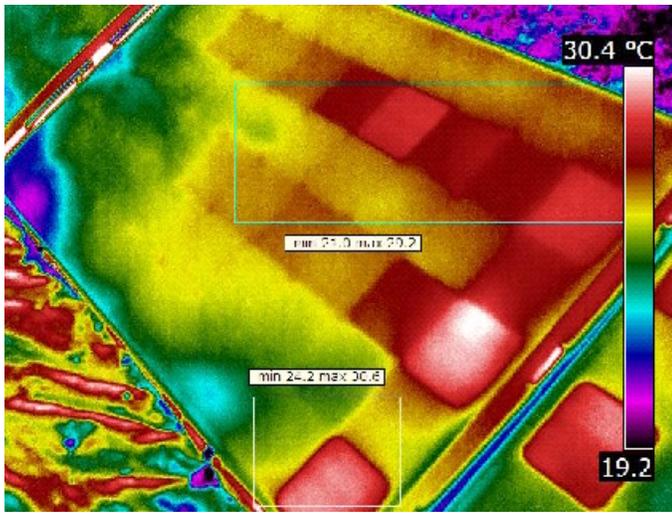
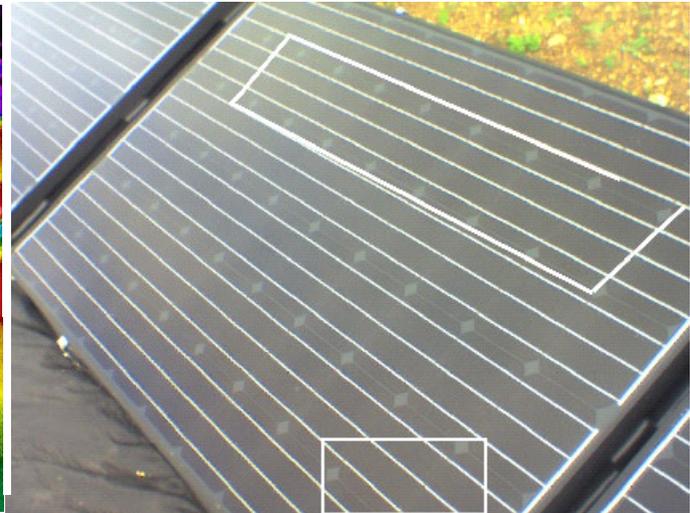
Photo File: IR_11331A.jpg

Operation Priority:	Critical to operation
Repair Priority:	3-Important
Hazard Type:	Visual
Hazard Classification:	Solar Panel
Hazard Group:	Elevated Surface Temperature
Hazard Issue:	at AR1 and AR2
Observations:	Elevated Surface Temperature at AR1 and AR2
What is the Cause:	Suspected Faulty Solar Cell(s)

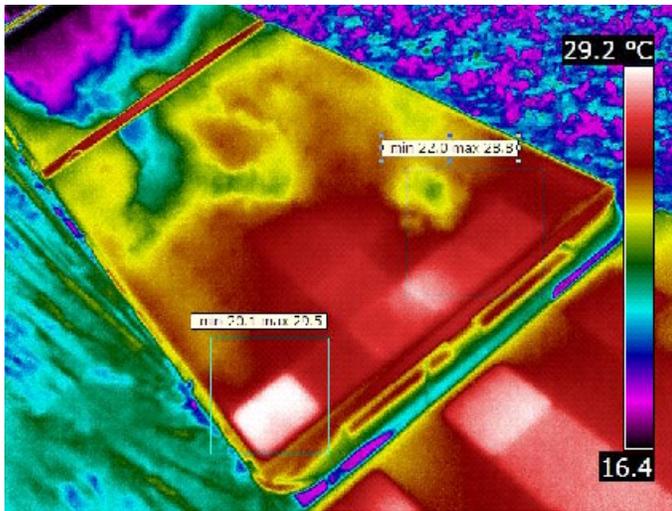
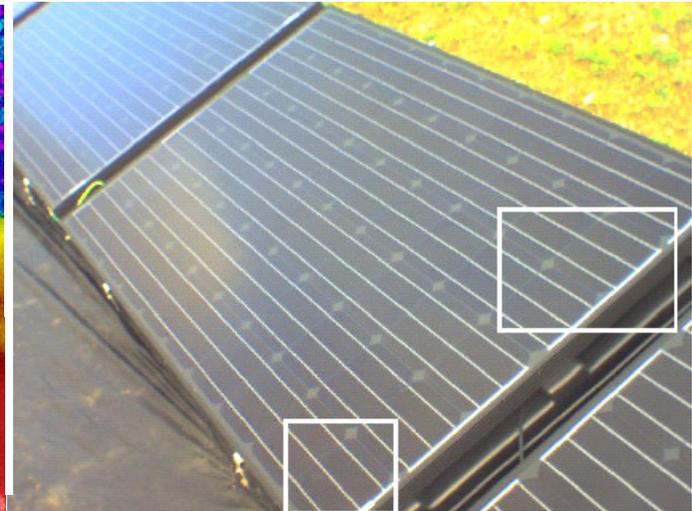
Photo File: IR_11333A.jpg

Operation Priority:	Critical to operation
Repair Priority:	2-Serious
Hazard Type:	Visual
Hazard Classification:	Solar Panel
Hazard Group:	Elevated Surface Temperature
Hazard Issue:	at AR1, AR2 and AR3
Observations:	Elevated Surface Temperature at AR1, AR2 and AR3
What is the Cause:	Suspected Faulty Solar Cell(s)

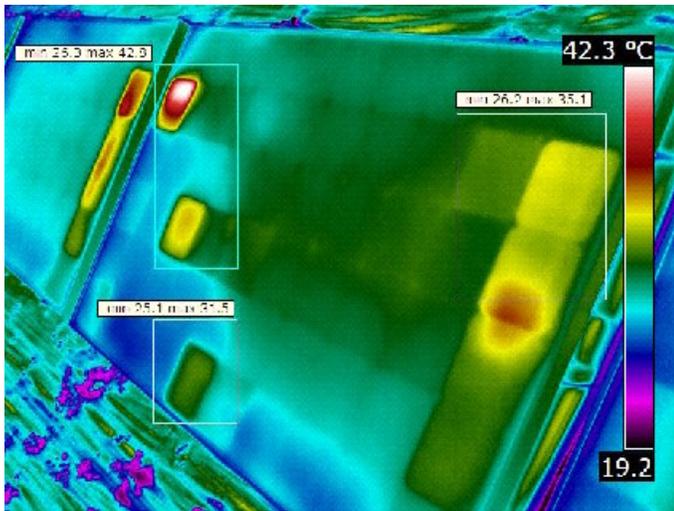
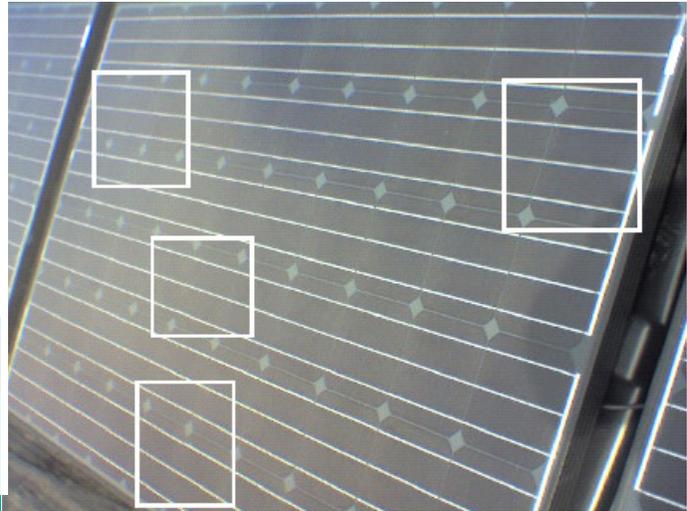
Photo File: IR_11335A.jpg

Operation Priority:	Critical to operation
Repair Priority:	2-Serious
Hazard Type:	Visual
Hazard Classification:	Solar Panel
Hazard Group:	Elevated Surface Temperature
Hazard Issue:	at AR1, AR2 and AR3
Observations:	Elevated Surface Temperature at AR1, AR2 and AR3
What is the Cause:	Suspected Faulty Solar Cell(s)

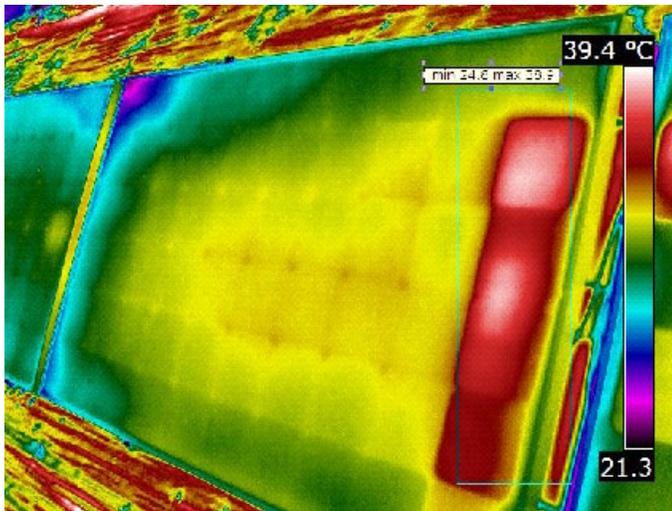
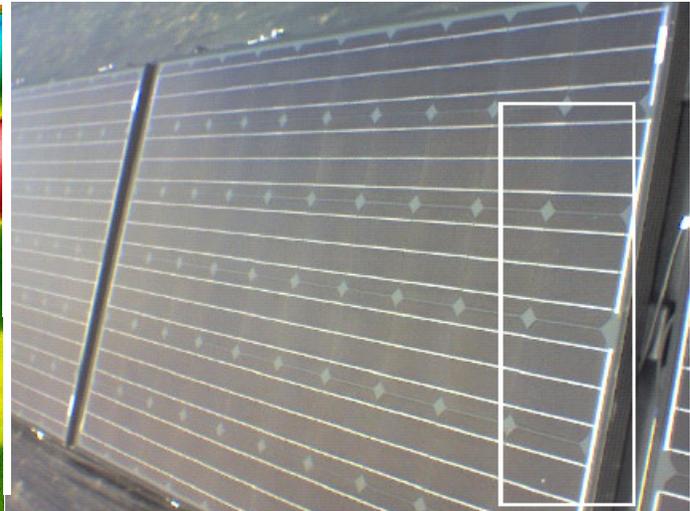
Photo File: IR_11337A.jpg

Operation Priority:	Critical to operation
Repair Priority:	3-Important
Hazard Type:	Visual
Hazard Classification:	Solar Panel
Hazard Group:	Elevated Surface Temperature
Hazard Issue:	at AR1
Observations:	Elevated Surface Temperature at AR1
What is the Cause:	Suspected Faulty Solar Cell(s)

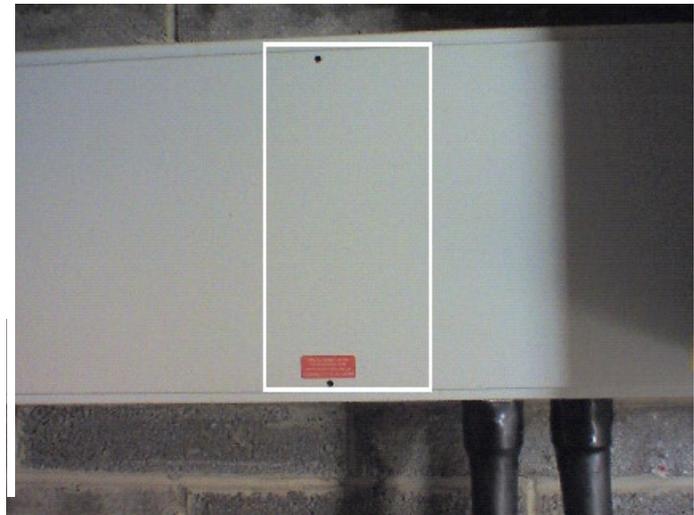
Operation Priority:	Critical to operation
Repair Priority:	4-Minor
Hazard Type:	Visual
Hazard Classification:	Electrical
Hazard Group:	Missing panel fixings
Hazard Issue:	causing the panel to be secured insufficiently
Observations:	Missing panel fixings causing the panel to be secured insufficiently
What is the Cause:	Panel fixings have not been replaced after previous removal

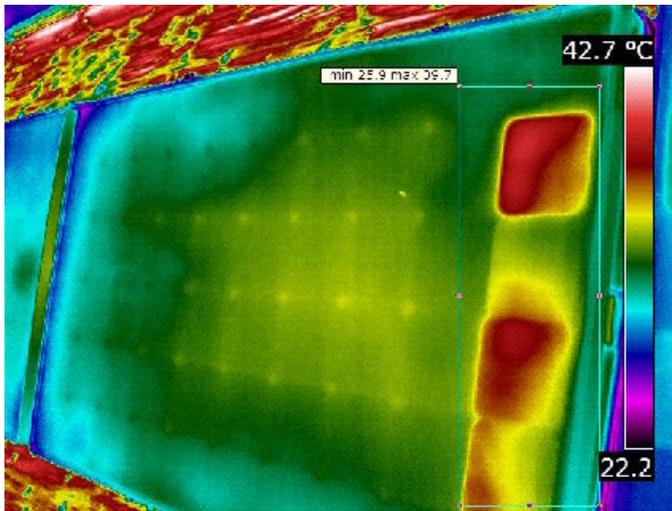
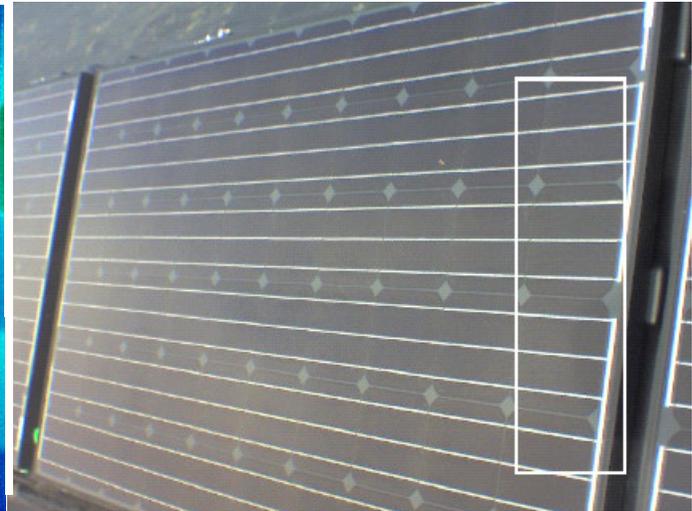
Photo File: IR_11339A.jpg

Operation Priority:	Critical to operation
Repair Priority:	3-Important
Hazard Type:	Visual
Hazard Classification:	Solar Panel
Hazard Group:	Elevated Surface Temperature
Hazard Issue:	at AR1
Observations:	Elevated Surface Temperature at AR1
What is the Cause:	Suspected Faulty Solar Cell(s)

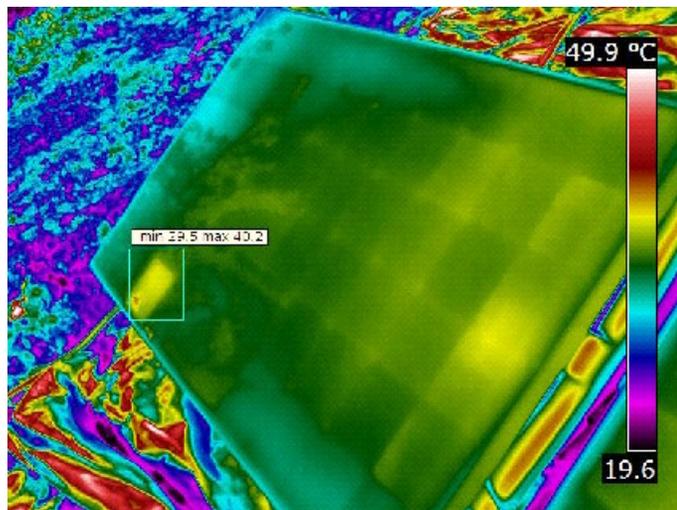
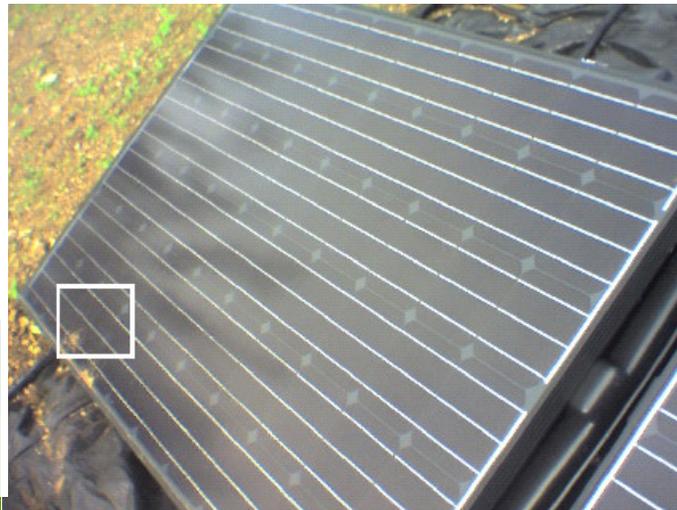
Photo File: IR_11341A.jpg

Operation Priority:	Critical to operation
Repair Priority:	3-Important
Hazard Type:	Visual
Hazard Classification:	Solar Panel
Hazard Group:	Elevated Surface Temperature
Hazard Issue:	at AR1
Observations:	Elevated Surface Temperature at AR1
What is the Cause:	Suspected Faulty Solar Cell(s)

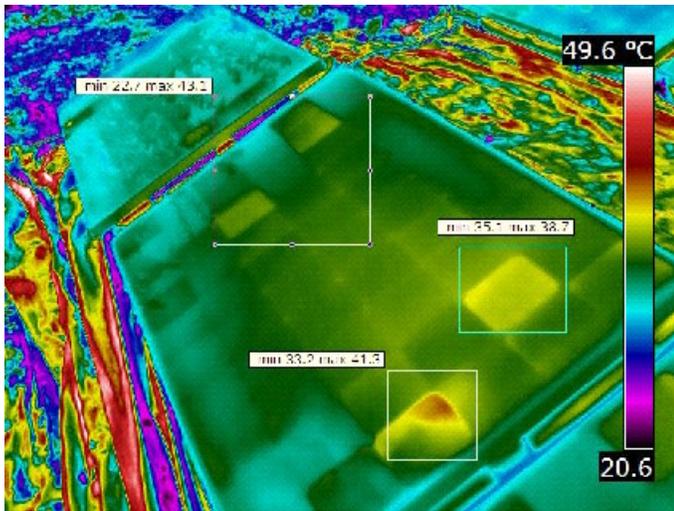
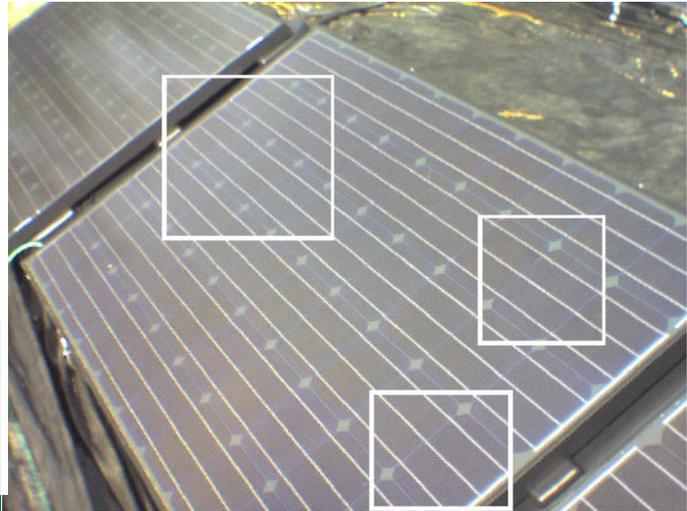
Photo File: IR_11343A.jpg

Operation Priority:	Critical to operation
Repair Priority:	3-Important
Hazard Type:	Visual
Hazard Classification:	Solar Panel
Hazard Group:	Elevated Surface Temperature
Hazard Issue:	at AR1, AR2 and AR3
Observations:	Elevated Surface Temperature at AR1, AR2 and AR3
What is the Cause:

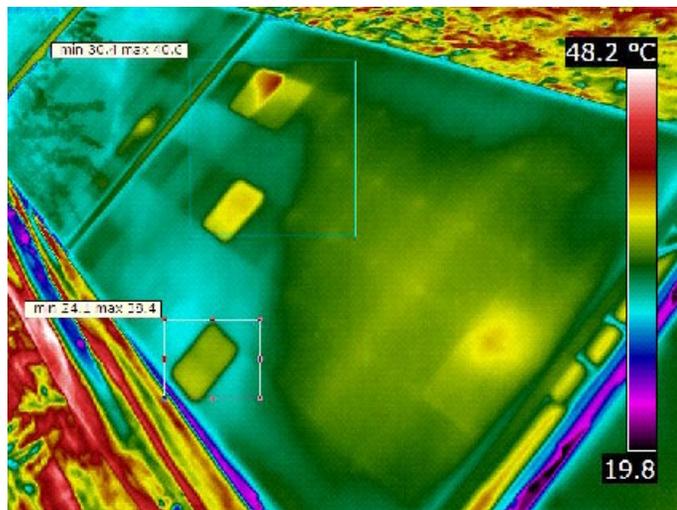
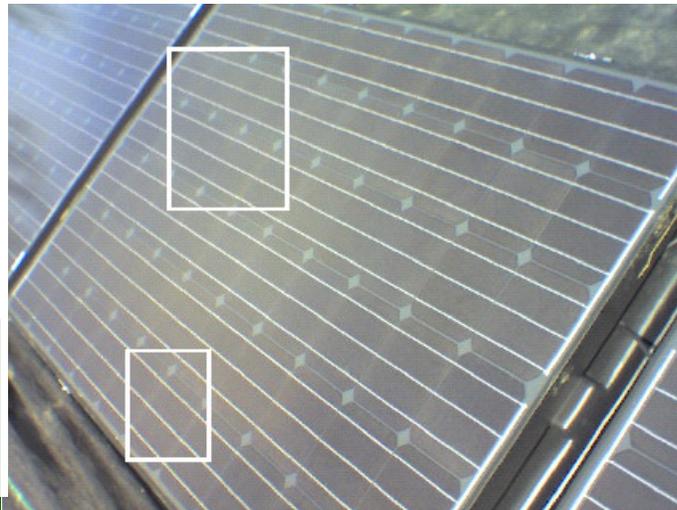
Photo File: IR_11345A.jpg

Operation Priority:	Critical to operation
Repair Priority:	3-Important
Hazard Type:	Visual
Hazard Classification:	Solar Panel
Hazard Group:	Elevated Surface Temperature
Hazard Issue:	at AR1 and AR2
Observations:	Elevated Surface Temperature at AR1 and AR2
What is the Cause:	Suspected Faulty Solar Cell(s)
