RISK MANAGEMENT SOLAR PANEL THERMOGRAPHIC INSPECTION FOR:

SAMPLE 2

TI-16078

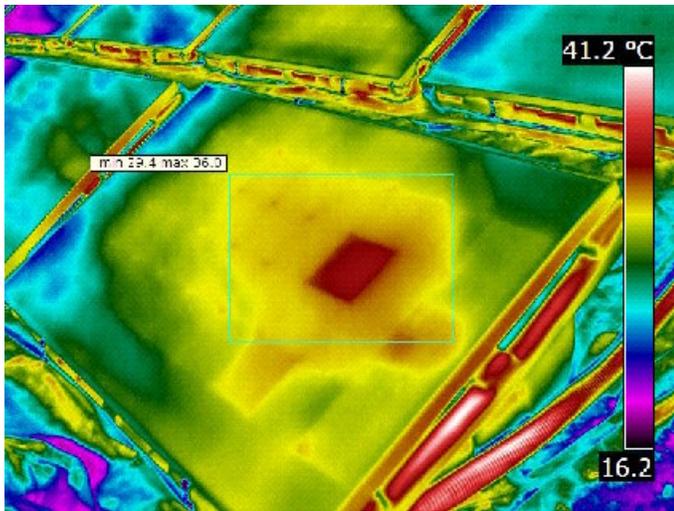
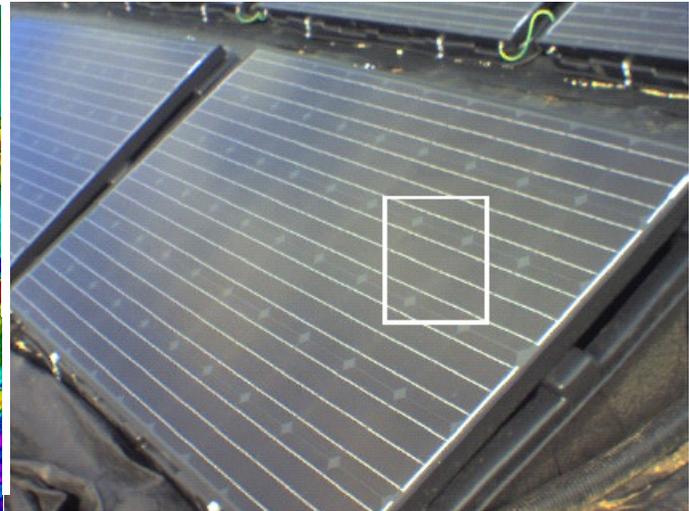
Photo File: IR_11347A.jpg

Operation Priority:	Critical to operation
Repair Priority:	3-Important
Hazard Type:	Visual
Hazard Classification:	Solar Panel
Hazard Group:	Elevated Surface Temperature
Hazard Issue:	at AR1
Observations:	Elevated Surface Temperature at AR1
What is the Cause:	Suspected Faulty Solar Cell(s)

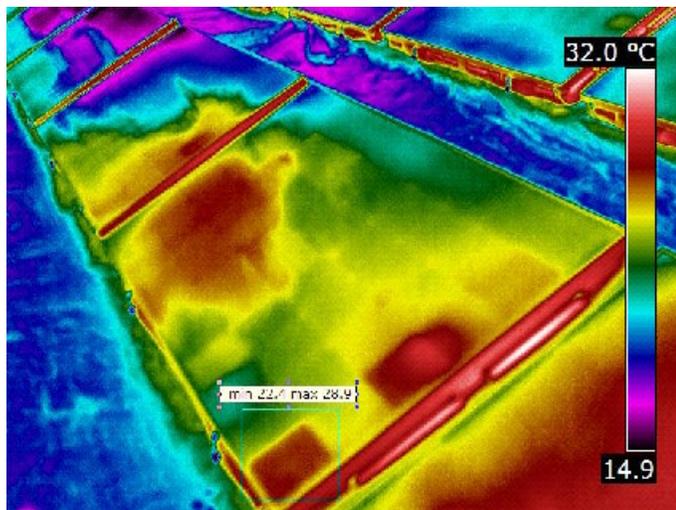
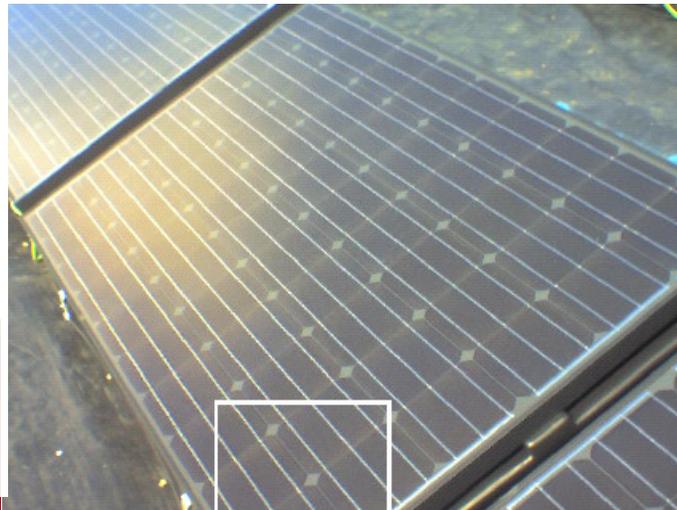
Photo File: IR_11367a.jpg

Operation Priority:	Critical to operation
Repair Priority:	4-Minor
Hazard Type:	Visual
Hazard Classification:	Solar Panel
Hazard Group:	Elevated Surface Temperature
Hazard Issue:	at AR1
Observations:	Elevated Surface Temperature at AR1
What is the Cause:	Suspected Faulty Solar Cell(s)

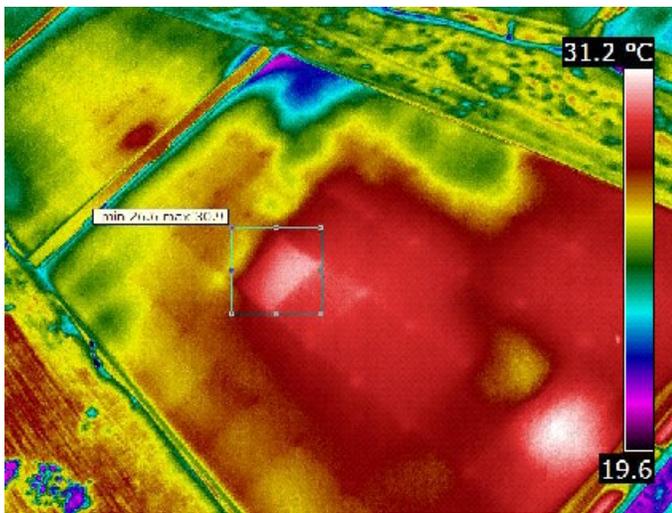
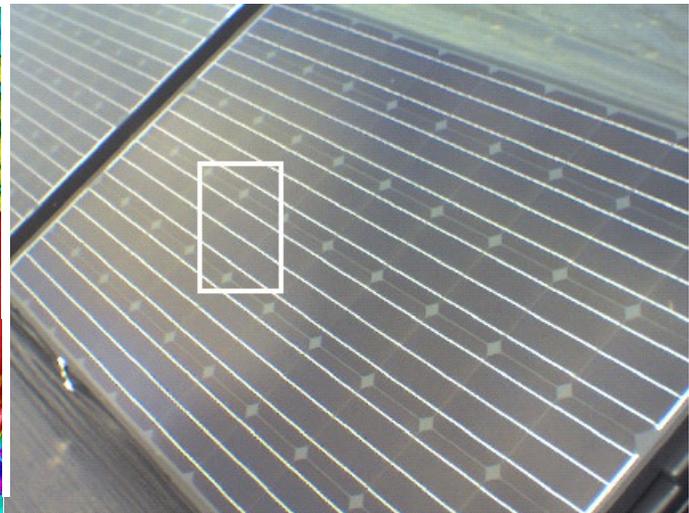
Photo File: IR_11373A.jpg

Operation Priority: Critical to operation
Repair Priority: 3-Important
Hazard Type: Visual
Hazard Classification: Solar Panel
Hazard Group: Elevated Surface Temperature
Hazard Issue: at AR1
Observations: [Elevated Surface Temperature at AR1](#)
What is the Cause:

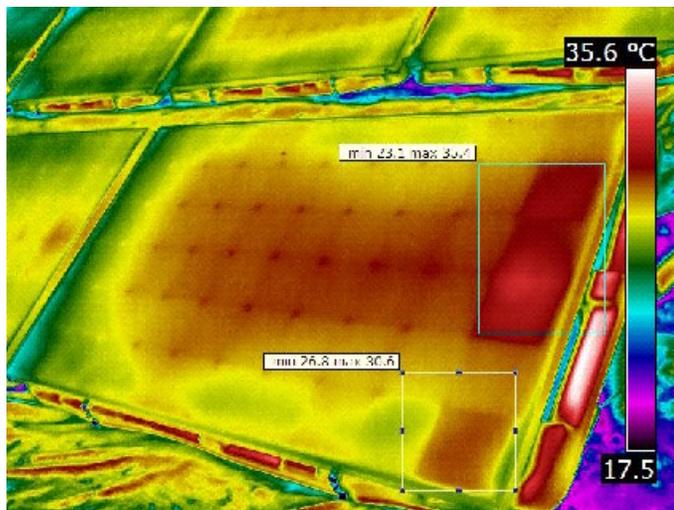
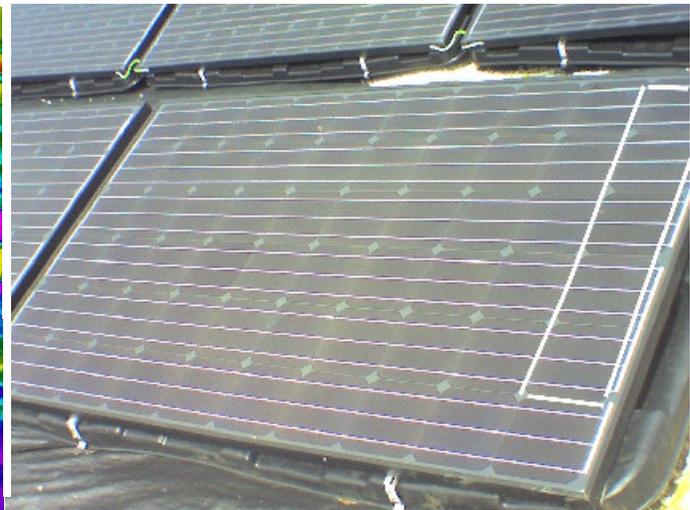
Photo File: IR_11381A.jpg

Operation Priority:	Critical to operation
Repair Priority:	3-Important
Hazard Type:	Visual
Hazard Classification:	Solar Panel
Hazard Group:	Elevated Surface Temperature
Hazard Issue:	at AR1 and AR2
Observations:	Elevated Surface Temperature at AR1 and AR2
What is the Cause:	Suspected Faulty Solar Cell(s)
