## RISK MANAGEMENT SOLAR PANEL THERMOGRAPHIC INSPECTION FOR:

### SAMPLE REPORT

**TI-16074**

INFRARED THERMOGRAPHIC INSPECTION  
OF  
TRANSMISSION / DISTRIBUTION  
ELECTRICAL INSPECTION

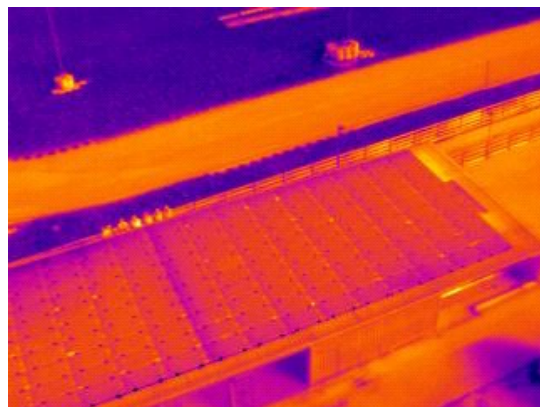
IR\_0004.jpg

### SOLAR PANELS \ GRID 3

Inspection No	Date Inspected	Test Status	Measured Temp	Threshold Temp	Ambient Temp	Status Note	Customer Notes
1898	14/09/2012	TESTED	20 C	30 C
