RISK MANAGEMENT THERMOGRAPHIC INSPECTION FOR:

TI THERMAL IMAGING LTD

**UNIT 8 WEYBRIDGE BUSINESS CENTRE
66 YORK ROAD
WEYBRIDGE
SURREY
KT13 9DY**

25/08/11

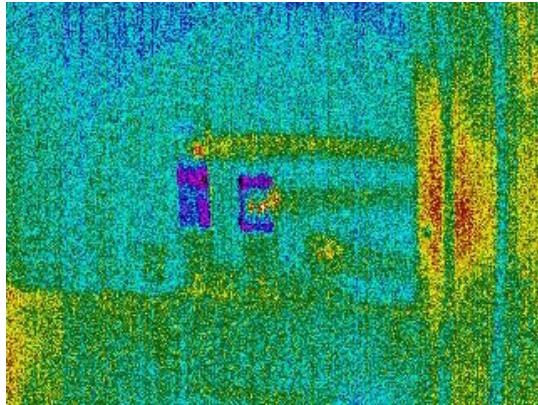
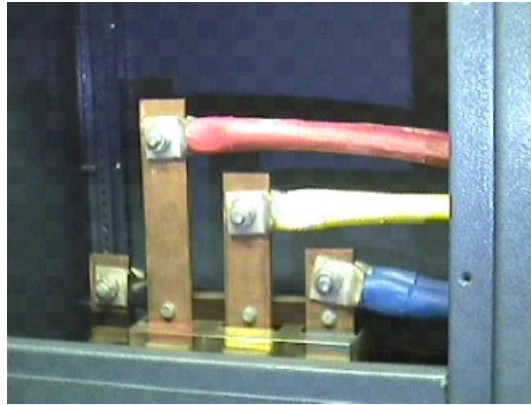
IR_0469.JPG

Inspection No	Date Inspected	Test Status	Measured Temp	Threshold Temp	Ambient Temp	Status Note	Customer Notes
25/08/2011		ESTED	-6 C	24 C	-7 C

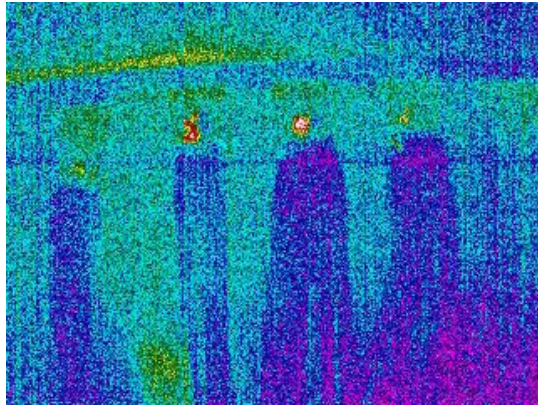
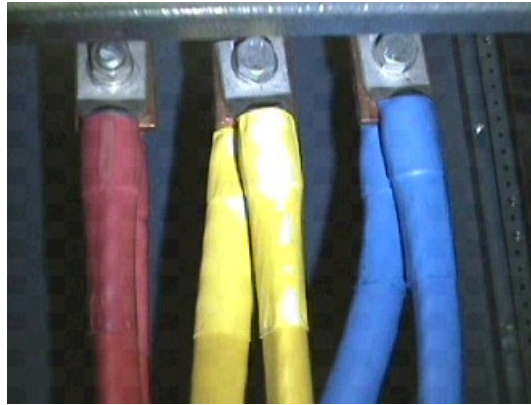
IR_0471.JPG

Inspection No	Date Inspected	Test Status	Measured Temp	Threshold Temp	Ambient Temp	Status Note	Customer Notes
25/08/2011		ESTED	-7 C	24 C	-7 C

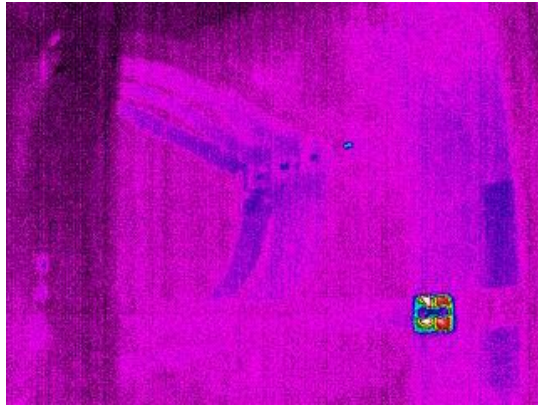
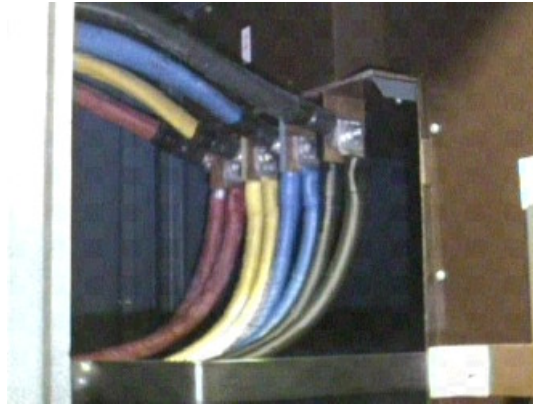
IR_0473.JPG

Inspection No	Date Inspected	Test Status	Measured Temp	Threshold Temp	Ambient Temp	Status Note	Customer Notes
25/08/2011		ESTED	20 C	75 C	18 C

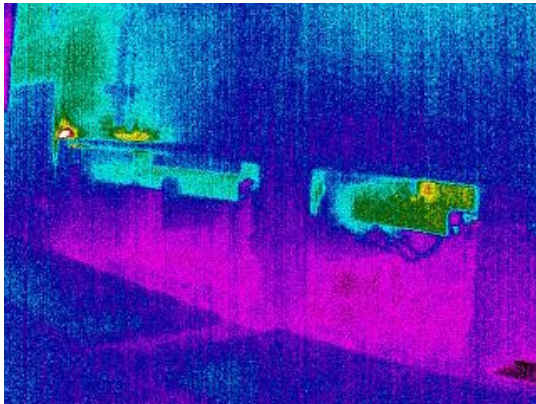
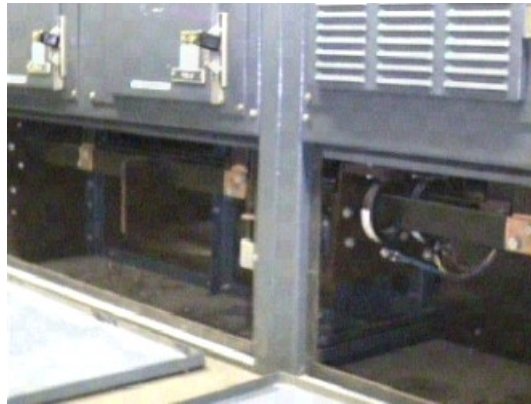
IR_0477.JPG

Inspection No	Date Inspected	Test Status	Measured Temp	Threshold Temp	Ambient Temp	Status Note	Customer Notes
25/08/2011		ESTED	20 C	75 C	18 C

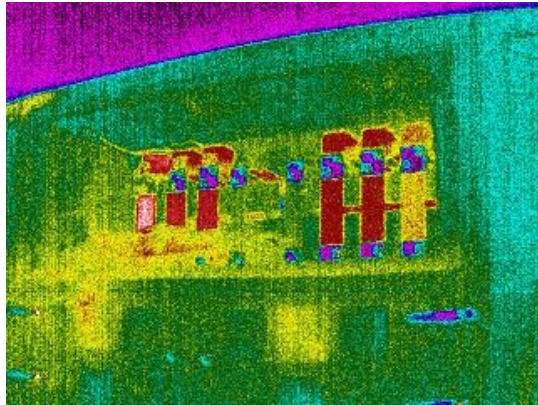
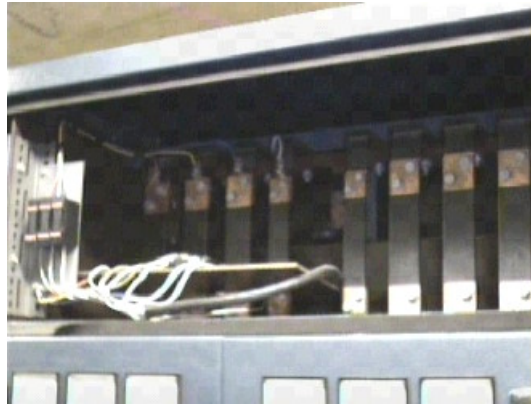
IR_0479.JPG

Inspection No	Date Inspected	Test Status	Measured Temp	Threshold Temp	Ambient Temp	Status Note	Customer Notes
25/08/2011		ESTED	21 C	75 C	19 C

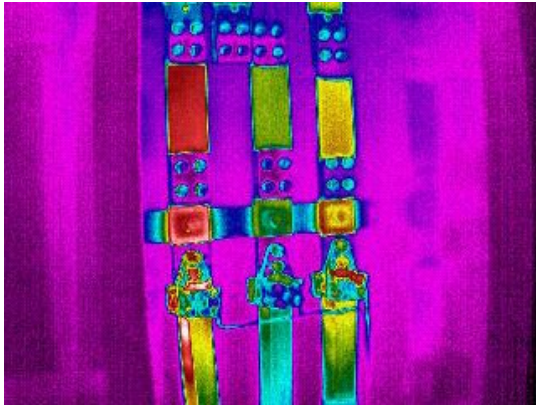
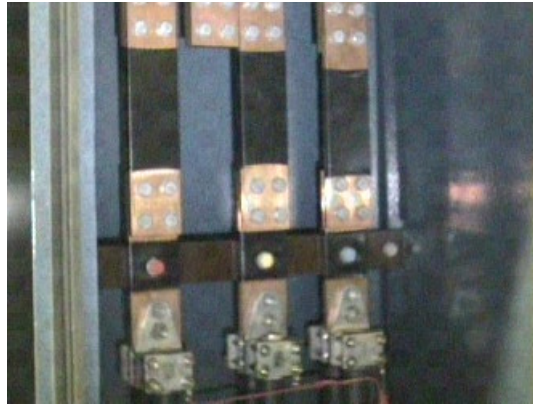
IR_0481.JPG

Inspection No	Date Inspected	Test Status	Measured Temp	Threshold Temp	Ambient Temp	Status Note	Customer Notes
25/08/2011		ESTED	20 C	75 C	32 C

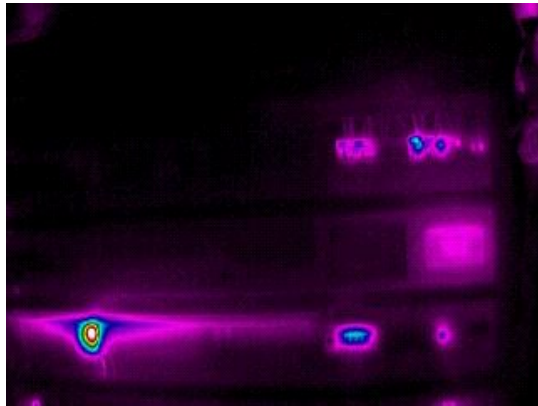
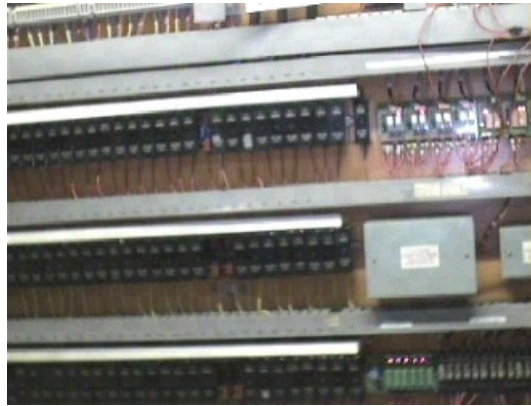
IR_0529.jpg

Inspection No	Date Inspected	Test Status	Measured Temp	Threshold Temp	Ambient Temp	Status Note	Customer Notes
25/08/2011		ESTED	38 C	75 C	22 C

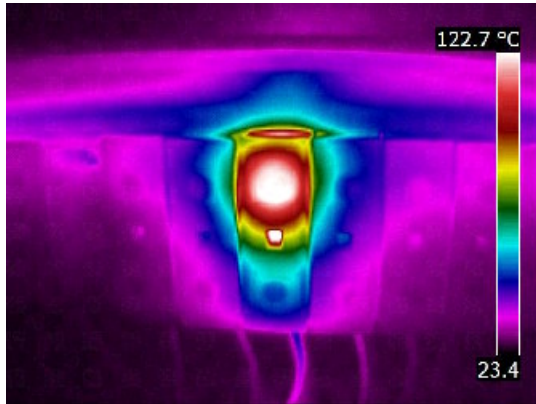
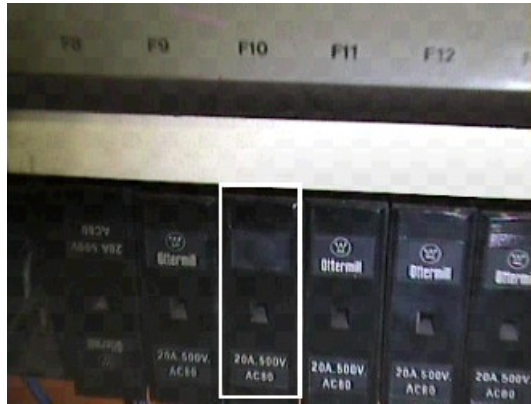
IR_0531.jpg

Inspection No	Date Inspected	Test Status	Measured Temp	Threshold Temp	Ambient Temp	Status Note	Customer Notes
25/08/2011		ESTED	159 C	75 C	23 C

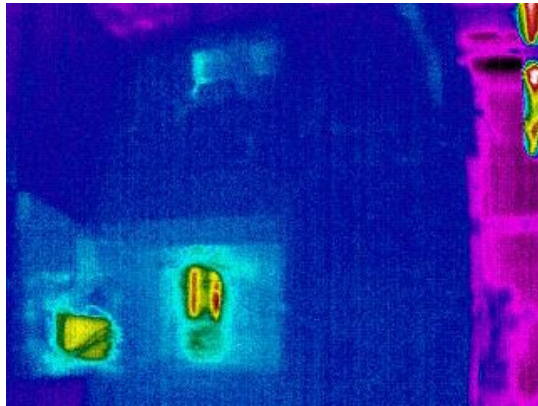
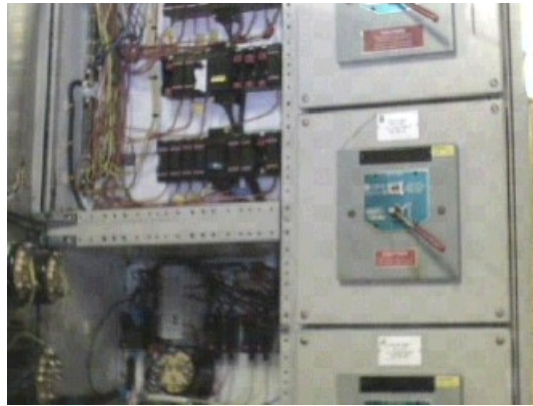
IR_0533.jpg

Inspection No	Date Inspected	Test Status	Measured Temp	Threshold Temp	Ambient Temp	Status Note	Customer Notes
25/08/2011		ESTED	28 C	75 C	18 C

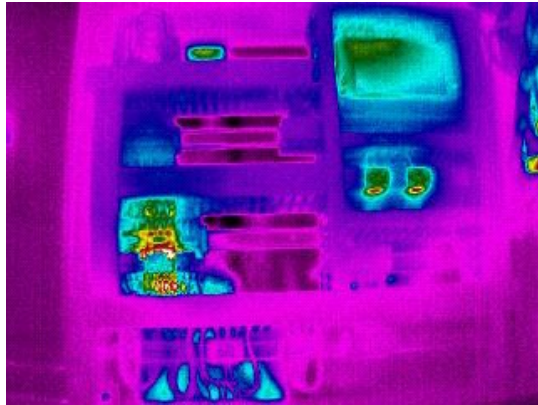
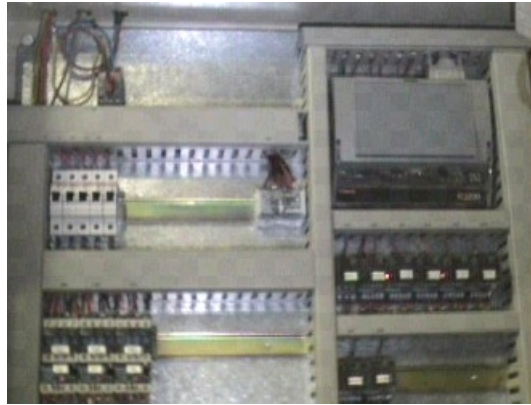
IR_0535.jpg

Inspection No	Date Inspected	Test Status	Measured Temp	Threshold Temp	Ambient Temp	Status Note	Customer Notes
25/08/2011		ESTED	51 C	75 C	21 C

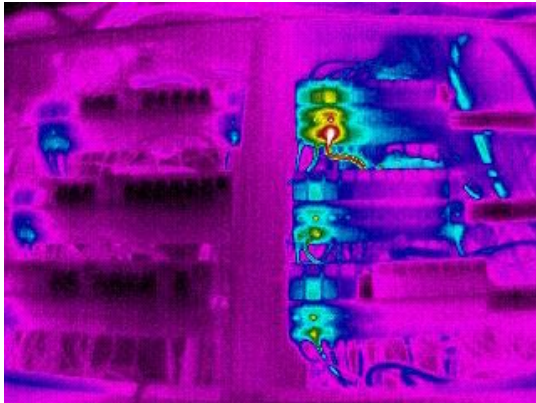
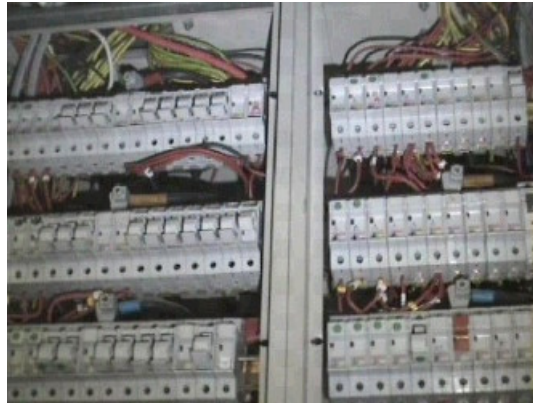
IR_0553.jpg

Inspection No	Date Inspected	Test Status	Measured Temp	Threshold Temp	Ambient Temp	Status Note	Customer Notes
25/08/2011		ESTED	45 C	75 C	23 C

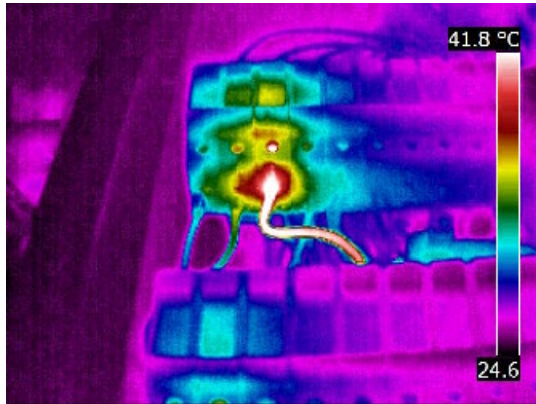
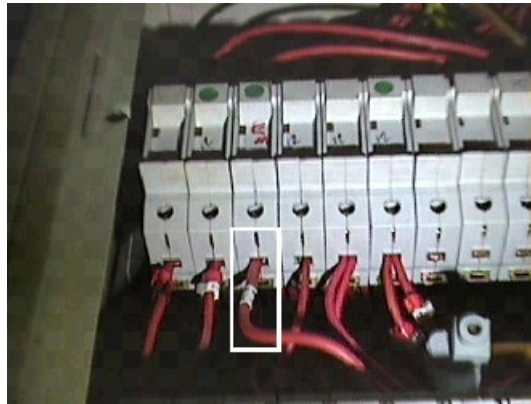
IR_0555.jpg

Inspection No	Date Inspected	Test Status	Measured Temp	Threshold Temp	Ambient Temp	Status Note	Customer Notes
25/08/2011		ESTED	47 C	75 C	25 C

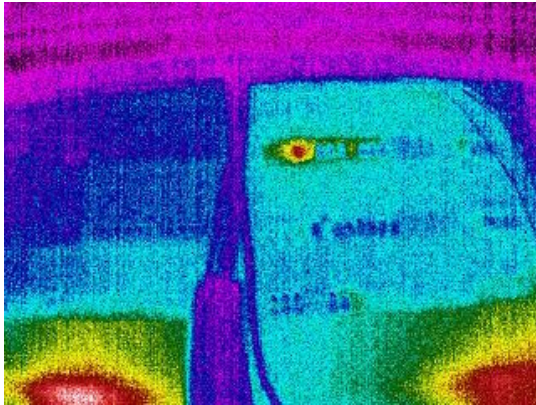
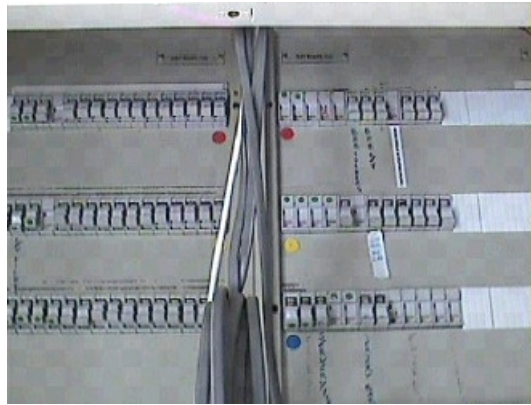
IR_0549.jpg

Inspection No	Date Inspected	Test Status	Measured Temp	Threshold Temp	Ambient Temp	Status Note	Customer Notes
25/08/2011		ESTED	24 C	75 C	20 C

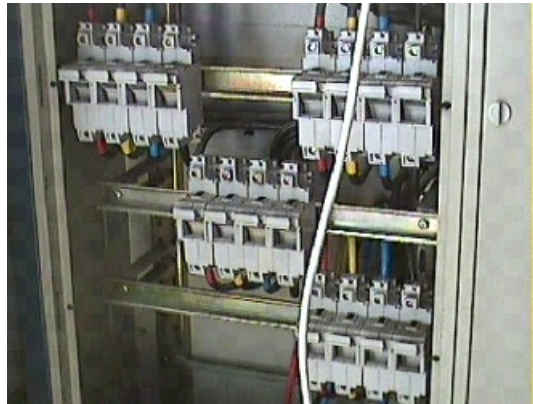
IR_0551.jpg

Inspection No	Date Inspected	Test Status	Measured Temp	Threshold Temp	Ambient Temp	Status Note	Customer Notes
25/08/2011		ESTED	22 C	75 C	19 C

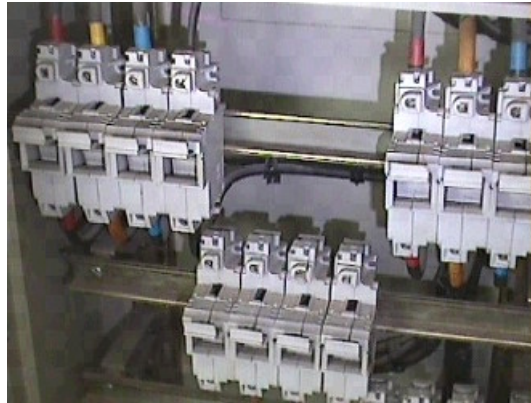
IR_0561.jpg

Inspection No	Date Inspected	Test Status	Measured Temp	Threshold Temp	Ambient Temp	Status Note	Customer Notes
25/08/2011		ESTED	34 C	75 C	18 C

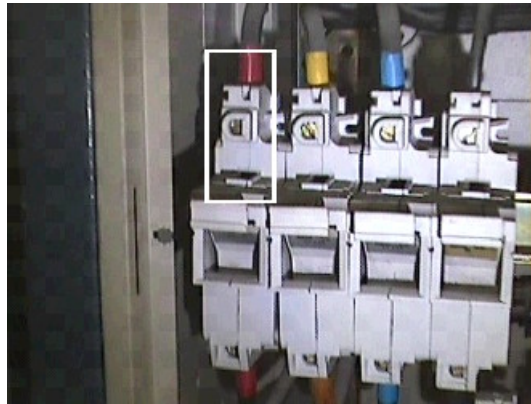
IR_0565.jpg

Inspection No	Date Inspected	Test Status	Measured Temp	Threshold Temp	Ambient Temp	Status Note	Customer Notes
25/08/2011		ESTED	32 C	75 C	19 C

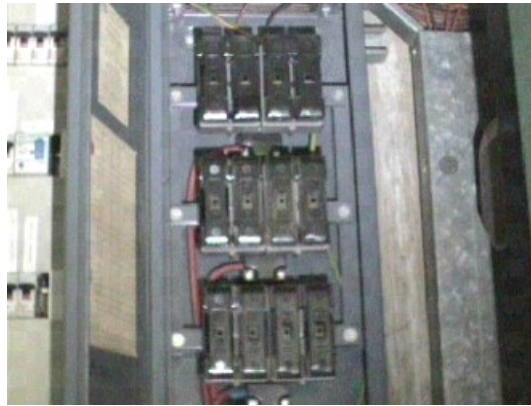
IR_0507.jpg

Inspection No	Date Inspected	Test Status	Measured Temp	Threshold Temp	Ambient Temp	Status Note	Customer Notes
25/08/2011		ESTED	20 C	75 C	17 C

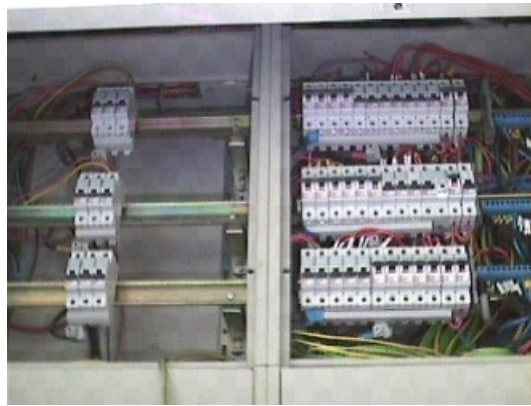
IR_0512.jpg

Inspection No	Date Inspected	Test Status	Measured Temp	Threshold Temp	Ambient Temp	Status Note	Customer Notes
25/08/2011		ESTED	26 C	75 C	20 C

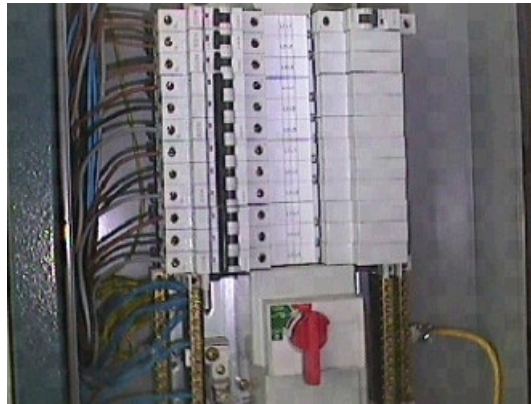
IR_0515.jpg

Inspection No	Date Inspected	Test Status	Measured Temp	Threshold Temp	Ambient Temp	Status Note	Customer Notes
25/08/2011		ESTED	28 C	75 C	24 C

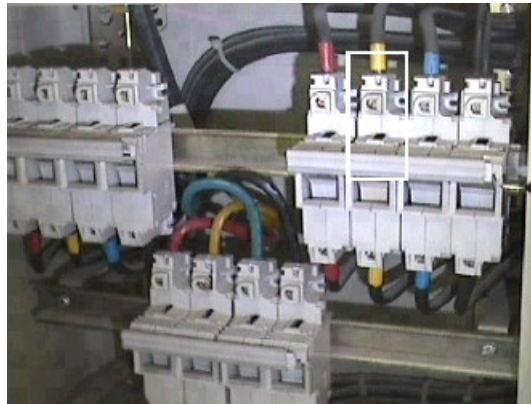
IR_0521.jpg

Inspection No	Date Inspected	Test Status	Measured Temp	Threshold Temp	Ambient Temp	Status Note	Customer Notes
25/08/2011		ESTED	42 C	75 C	21 C

Thermal Information	
Operation Priority:	Critical to operation
Repair Priority:	3-Important
Ambient:	21 C Enviroment: Indoors
Component Temperature On B phase line si	42 C
B phase load side Reference Temperature:	30 C
Temperature Rise Above Reference:	12 C
ANSI/EEE/NEMA Max Allowable Temp @ 100% Load:	75 C
Est Temp Rise over reference @ 50% Load:	24
Est Temp Rise over reference @ 100% Load:	98

Repair Information	PLEASE FAX BACK AFTER REPAIR TO:		Loss to Production	
	0871 900 4978 OR		<input type="checkbox"/> Yes	<input type="checkbox"/> No
	INFO@THERMALIMAGING.CO.UK		<input checked="" type="checkbox"/> Unknown	
	Consequences of Failure:	Repair Date:	Repaired By: <input type="text"/>	
	Loss of DB T41	Root Cause:	<input type="text"/>	
Parts Req. Before Failure:	Repair Procedure:	<input type="text"/>		
Parts Req. After Failure:	Repair Action:	<input type="text"/>		
Repair Recommendation:	Check, clean and re-make line side connection(s)
