## **THERMOGRAPHIC INSPECTION FOR:**

**FLOWLINE T-PIECES  
304/306**

**TI-14055**

**TI , TI Site 5 Process**

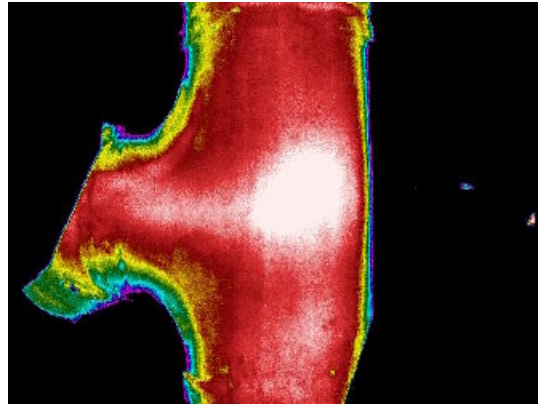
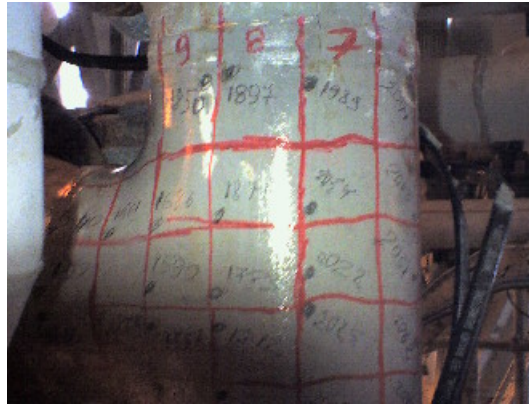
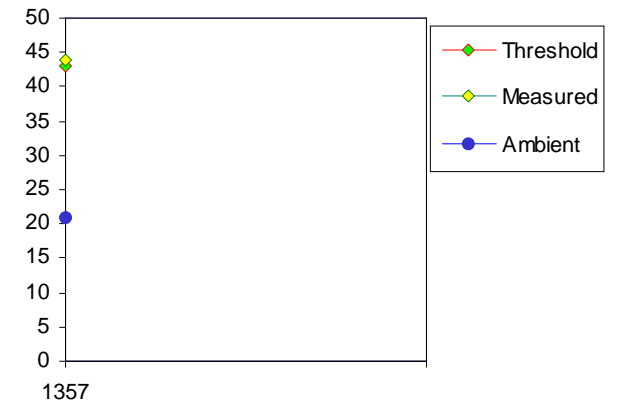
**WELL FLOWLINE T-PIECE \ 306 NORTH**

Inspection No	Date Inspected	Test Status	Measured Temp	Threshold Temp	Ambient Temp	Status Note	Customer Notes
1357	14/10/2010	TESTED	44 C	43 C	21 C

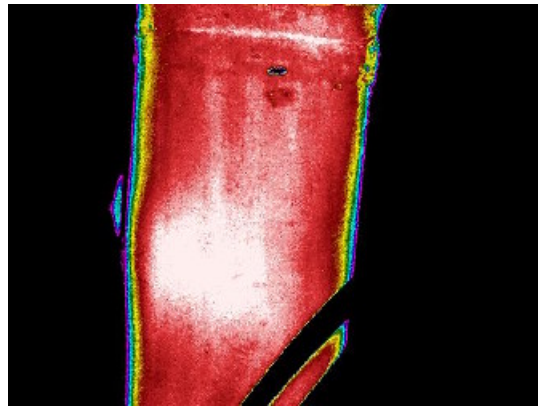
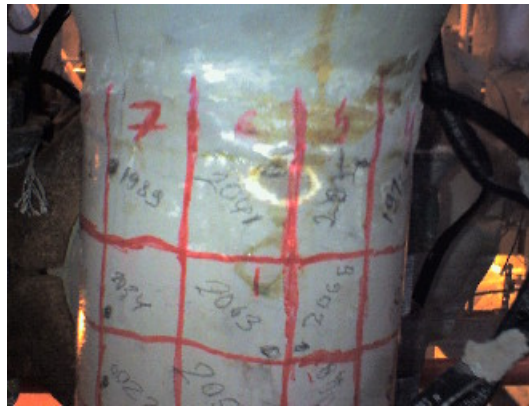
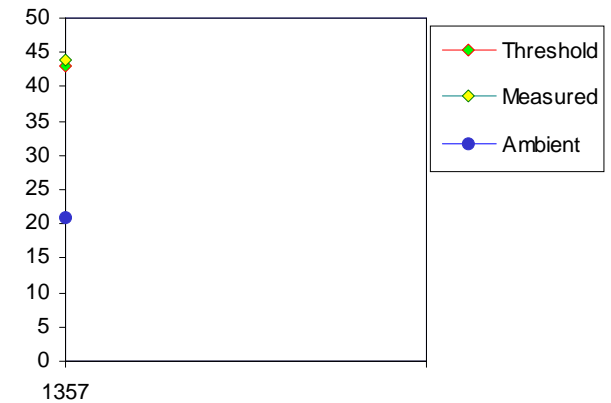
**WELL FLOWLINE T-PIECE \ 306 WEST**

Inspection No	Date Inspected	Test Status	Measured Temp	Threshold Temp	Ambient Temp	Status Note	Customer Notes
1357	14/10/2010	TESTED	44 C	43 C	21 C

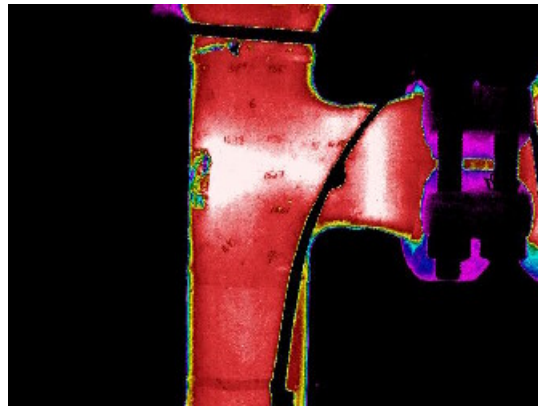
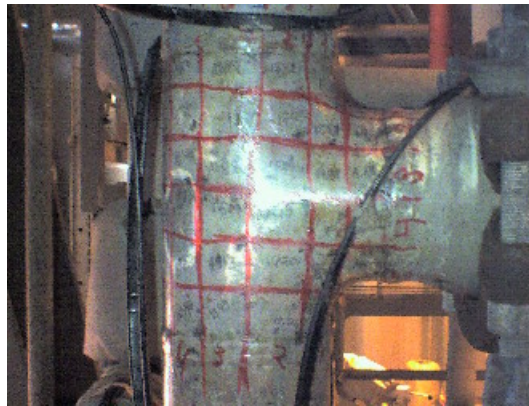
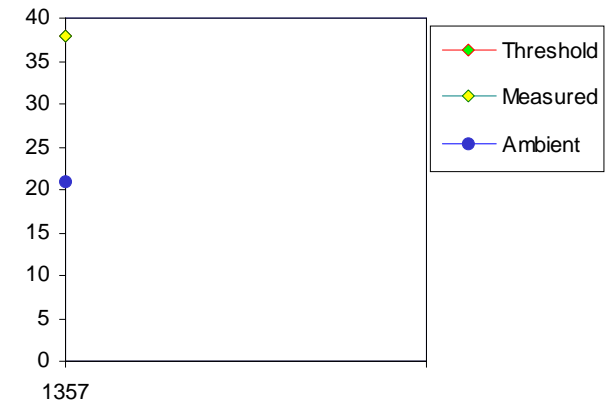
**WELL FLOWLINE T-PIECE \ 304 SOUTH**

Inspection No	Date Inspected	Test Status	Measured Temp	Threshold Temp	Ambient Temp	Status Note	Customer Notes
1357	14/10/2010	TESTED	38 C	38 C	21 C

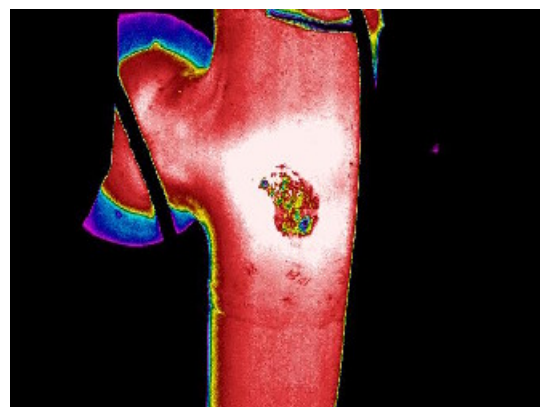
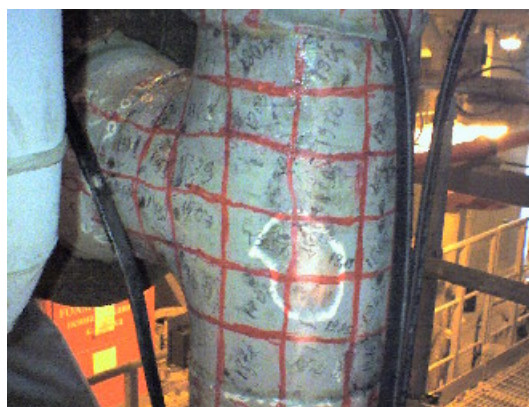
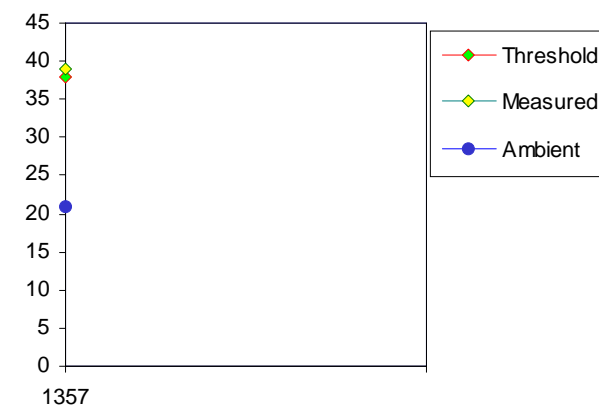
**WELL FLOWLINE T-PIECE \ 304 NORTH**

Inspection No	Date Inspected	Test Status	Measured Temp	Threshold Temp	Ambient Temp	Status Note	Customer Notes
1357	14/10/2010	TESTED	39 C	38 C	21 C
