RISK MANAGEMENT THERMOGRAPHIC MECHANICAL INSPECTION FOR:

SAMPLE

20/10/10

TI-13513

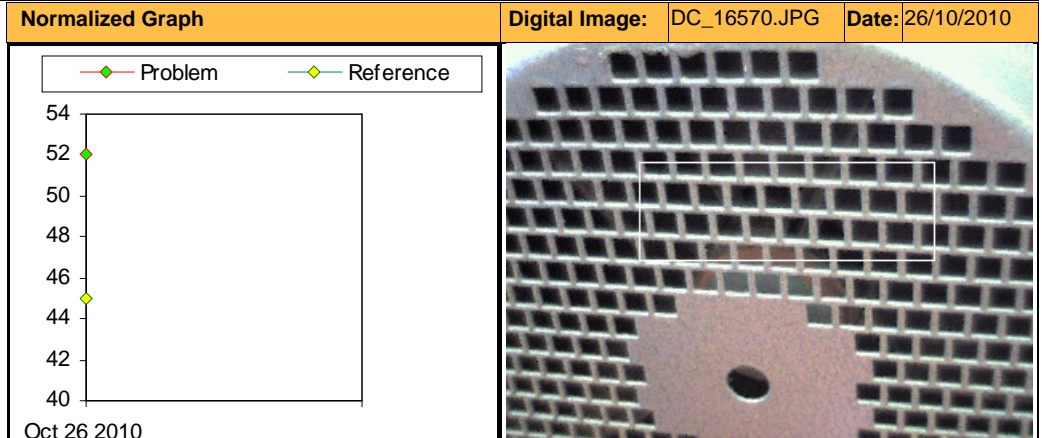
Location / Equipment Information	
Work Order	NOT ISSUED
Equipment ID	1K-P53202
Location	
Description	WATER PUMP NO. 2
Severity	4-Minor
Anomaly	Elevated bearing temperature on 22kwh 3 Phase Motor
Possible Root Cause	Deteriorated running bearing
Recommendation	Investigate bearing internals and either recondition or replace

Equipment Information	
Component:	PUMP MOTORS
Manufacturer:	Brook Compton
Model No:	Unavailable
Rated Amps:	40
Circuit Voltage:	415 Volts

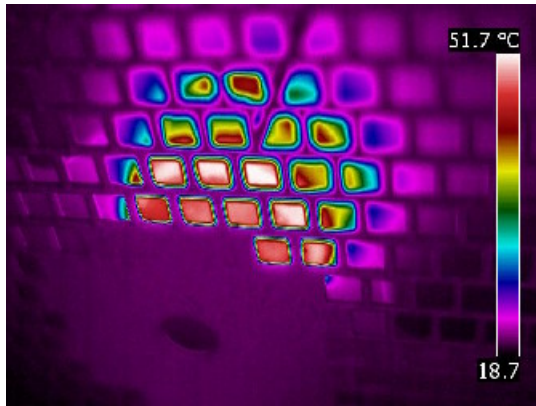
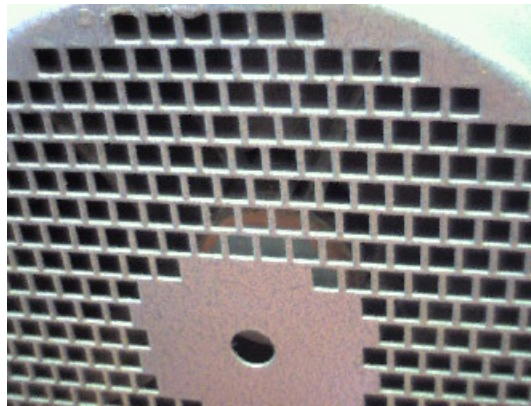
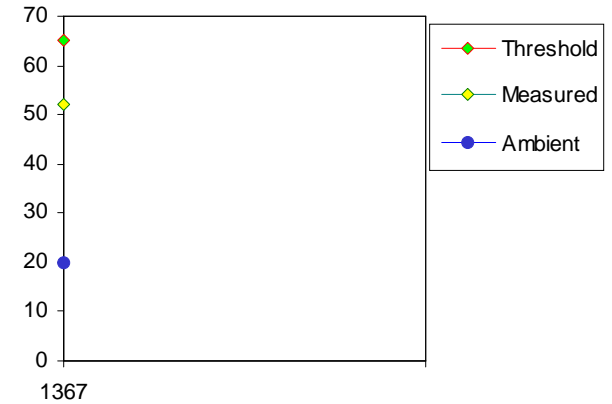
IR_16569.JPG

Inspection No	Date Inspected	Test Status	Measured Temp	Threshold Temp	Ambient Temp	Status Note	Customer Notes
1367	26/10/2010	TESTED	52 C	65 C	20 C

Operation Priority:	Critical to operation
Repair Priority:	4-Minor
Ambient:	21 C Enviroment: Indoors
Component Temperature:	52 C
Reference Temperature:	45 C
Temperature Rise Above Reference:	7 C
ANSI/EEE/NEMA Max Allowable Temp @ 100% Load:	65 C

Investigate bearing internals and either recondition or replace

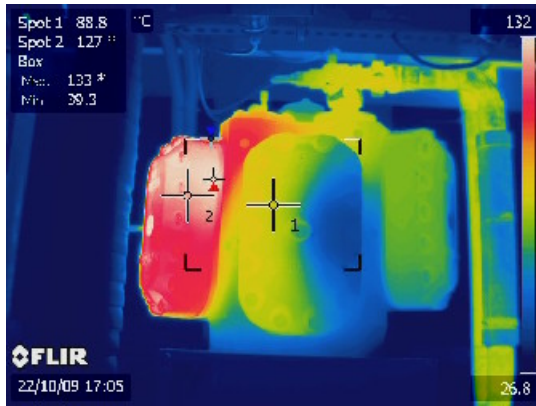
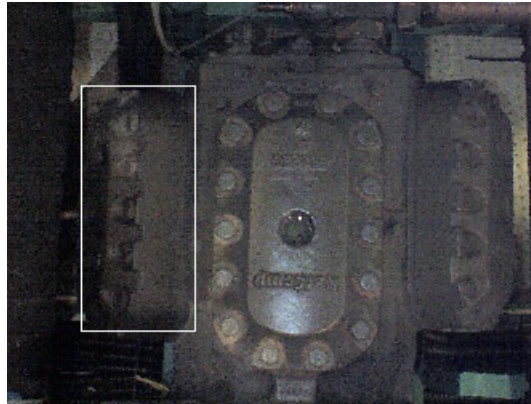
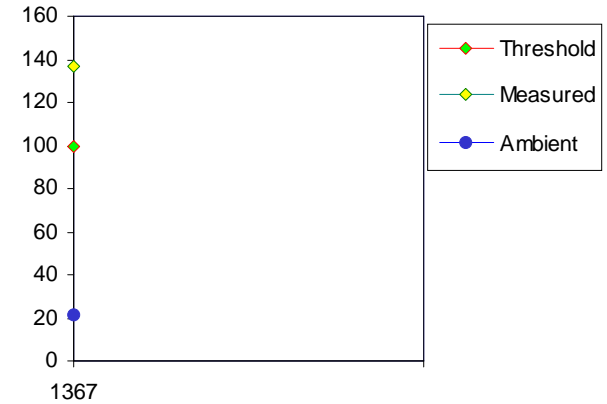
IR_7571.jpg

Location / Equipment Information	
Work Order	NOT ISSUED
Equipment ID	1S-HCOM7703
Location	
Description	COMPRESSOR 12
Severity	1-Critical
Anomaly	Overheated cylinder head on Compressor
Possible Root Cause	Unknown
Recommendation	Investigate and repair or replace

Inspection No	Date Inspected	Test Status	Measured Temp	Threshold Temp	Ambient Temp	Status Note	Customer Notes
1367	26/10/2010	TESTED	137 C	100 C	21 C

Operation Priority:	Critical to operation
Repair Priority:	1-Critical
Ambient:	21 C Enviroment: Indoors
Component Temperature:	137 C
Reference Temperature:	46 C
Temperature Rise Above Reference:	91 C
ANSI/EEE/NEMA Max Allowable Temp @ 100% Load:	100 C

Investigate and repair or replace

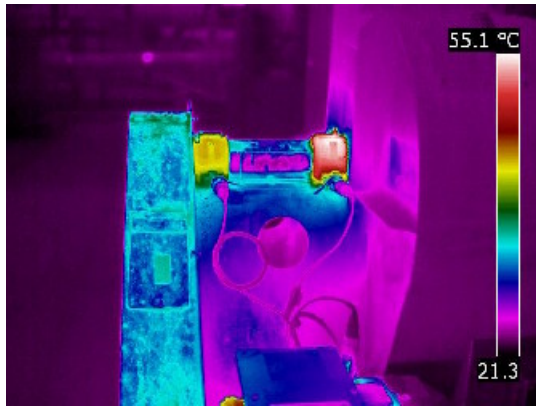
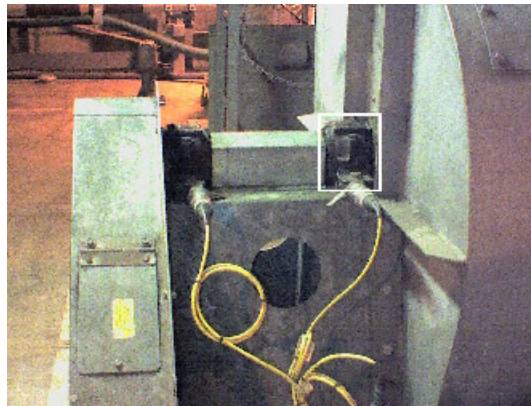
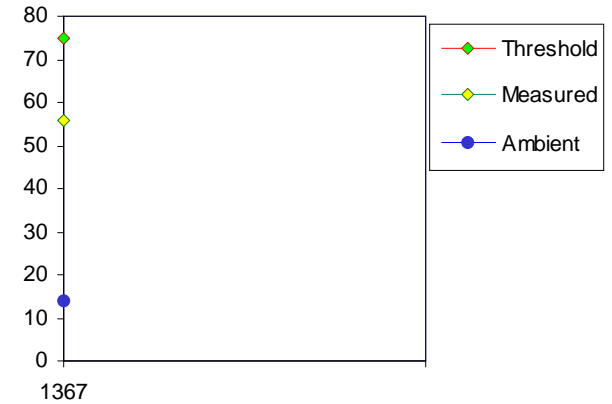
Equipment: EXTRACT FAN MOTOR RESERVE TANK CTO M3 14 C 3-Important
 Component: Elevated bearing temperature on 22KWH 3 PHASE MOTOR
 Failure of This Component Could Cause a Loss to Production: Yes No Unknown
 Consequences of Component Failure : Loss of EXTRACT FAN MOTOR RESERVE TANK

Inspection No	Date Inspected	Test Status	Measured Temp	Threshold Temp	Ambient Temp	Status Note	Customer Notes
1367	26/10/2010	TESTED	56 C	75 C	14 C

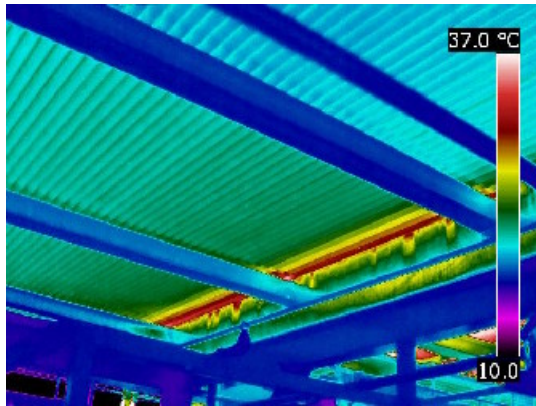
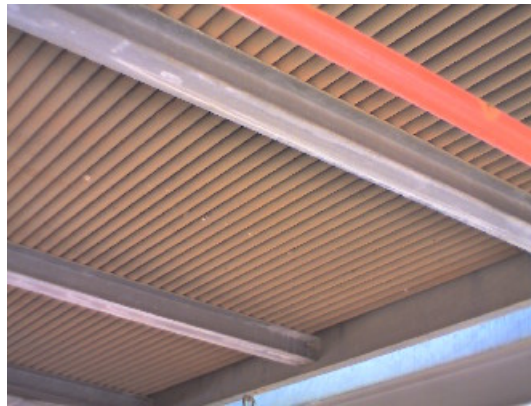
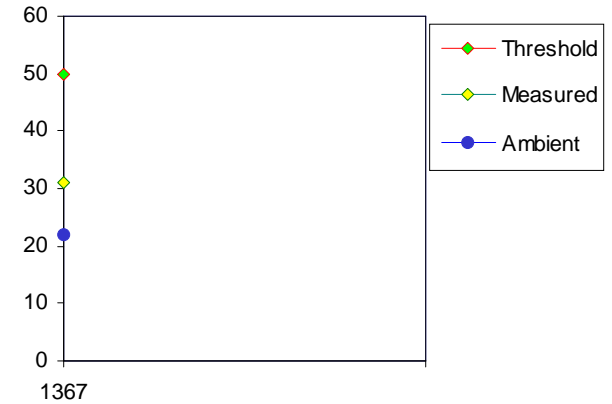
IR_1.jpg

Equipment: TRAIN 1 FIN FAN BANK CTO M4 12 C 3-Important
 Component: Elevated temperature on Fin Fan
 Failure of This Component Could Cause a Loss to Production: Yes No Unknown
 Consequences of Component Failure : Loss of TRAIN 1 FIN FAN BANK

Inspection No	Date Inspected	Test Status	Measured Temp	Threshold Temp	Ambient Temp	Status Note	Customer Notes
1367	26/10/2010	TESTED	31 C	50 C	22 C
