RISK MANAGEMENT ELECTRICAL THERMOGRAPHIC INSPECTION FOR:

TI UPS CELLS DISCHARGING SAMPLE

UNIT 8 66 YORK ROAD
WEYBRIDGE
SURREY
KT13 9DY

22/11/11

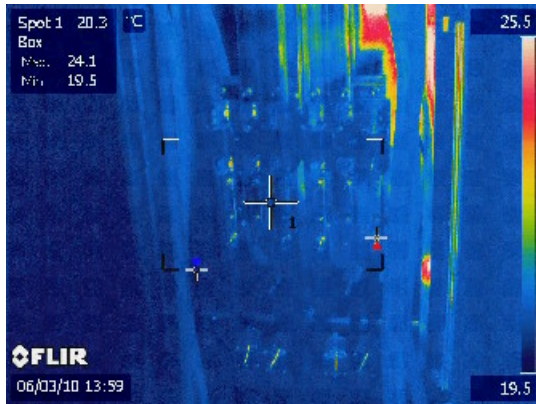
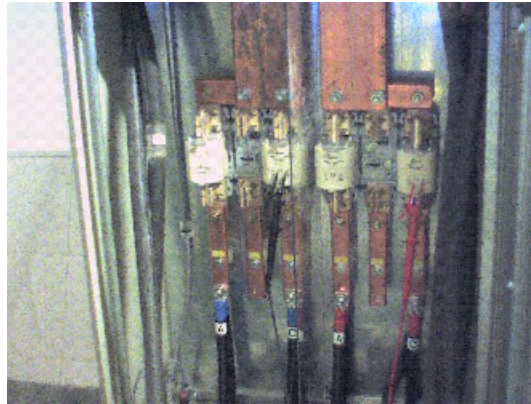
Inspection No	Date Inspected	Test Status	Measured Temp	Threshold Temp	Ambient Temp	Status Note	Customer Notes
1665	22/11/2011	TESTED	23 C	75 C	22 C

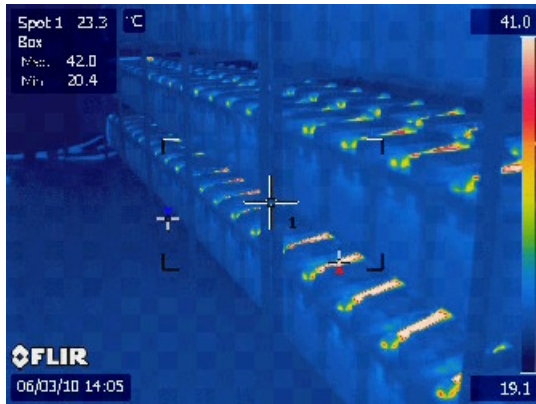
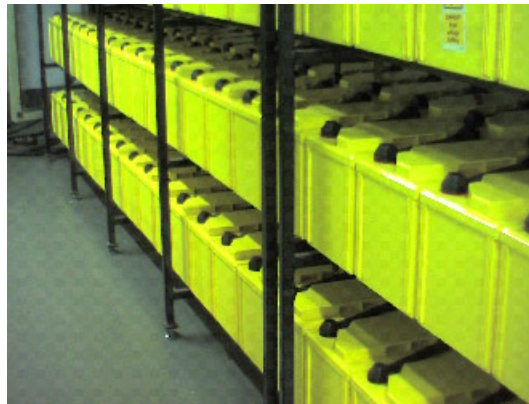
Inspection No	Date Inspected	Test Status	Measured Temp	Threshold Temp	Ambient Temp	Status Note	Customer Notes
1665	22/11/2011	TESTED	43 C	75 C	22 C

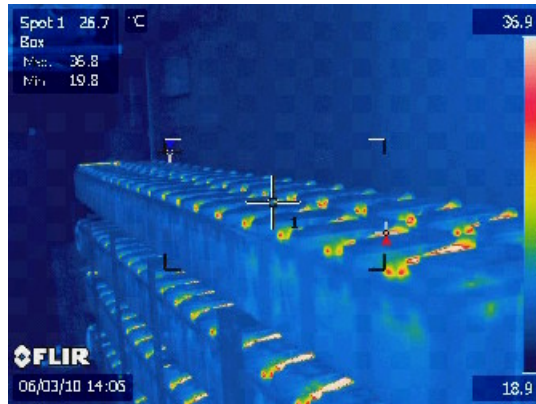
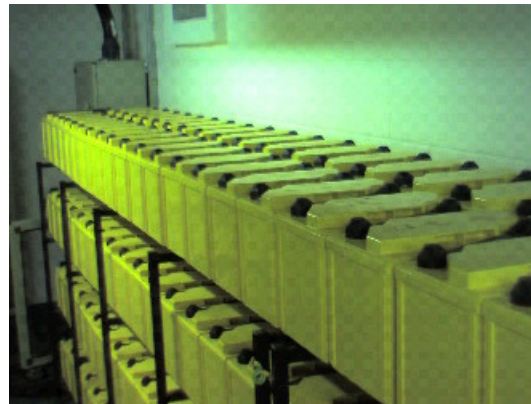
Inspection No	Date Inspected	Test Status	Measured Temp	Threshold Temp	Ambient Temp	Status Note	Customer Notes
1665	22/11/2011	TESTED	40 C	75 C	22 C

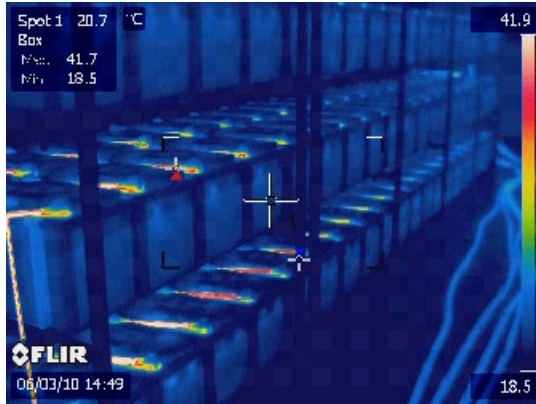
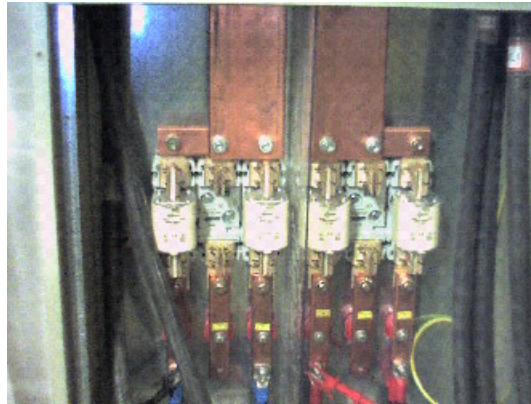
Inspection No	Date Inspected	Test Status	Measured Temp	Threshold Temp	Ambient Temp	Status Note	Customer Notes
1665	22/11/2011	TESTED	26 C	75 C	22 C

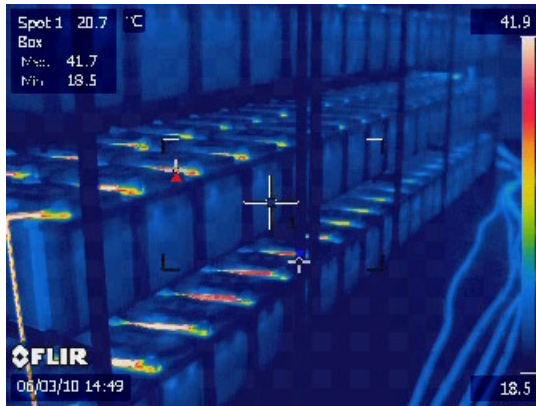
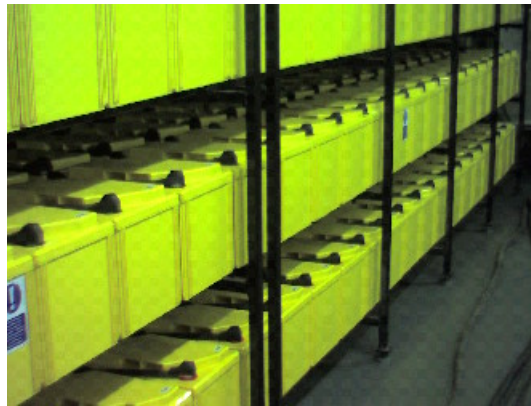
Inspection No	Date Inspected	Test Status	Measured Temp	Threshold Temp	Ambient Temp	Status Note	Customer Notes
1665	22/11/2011	TESTED	41 C	75 C	22 C

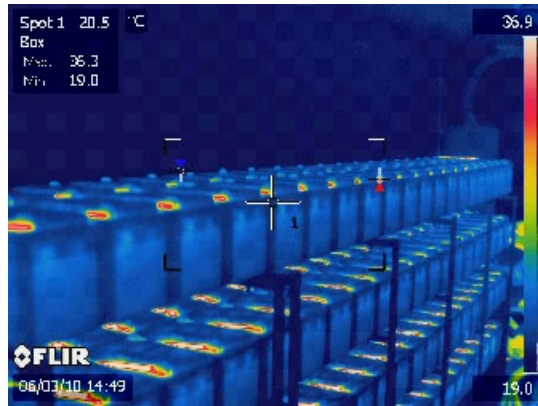
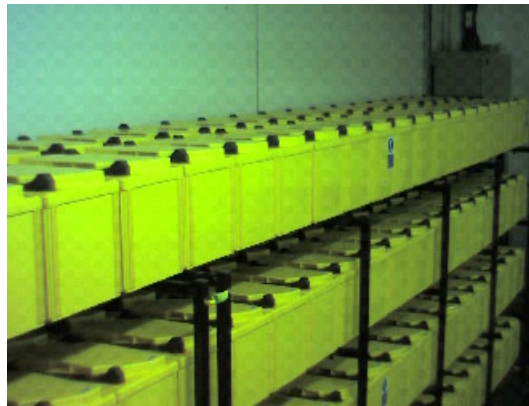
Inspection No	Date Inspected	Test Status	Measured Temp	Threshold Temp	Ambient Temp	Status Note	Customer Notes
1665	22/11/2011	TESTED	40 C	75 C	22 C

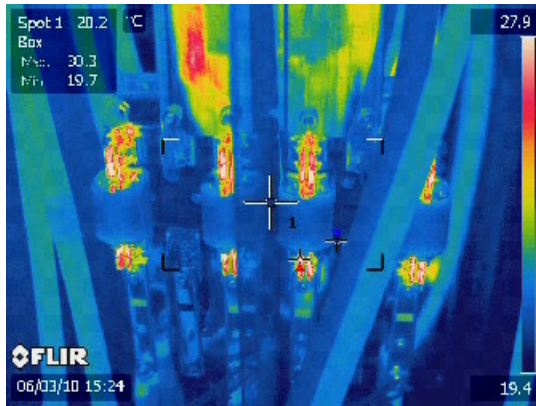
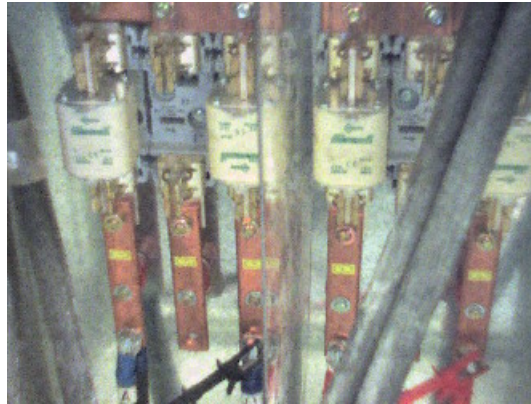
Inspection No	Date Inspected	Test Status	Measured Temp	Threshold Temp	Ambient Temp	Status Note	Customer Notes
1665	22/11/2011	TESTED	22 C	75 C	22 C

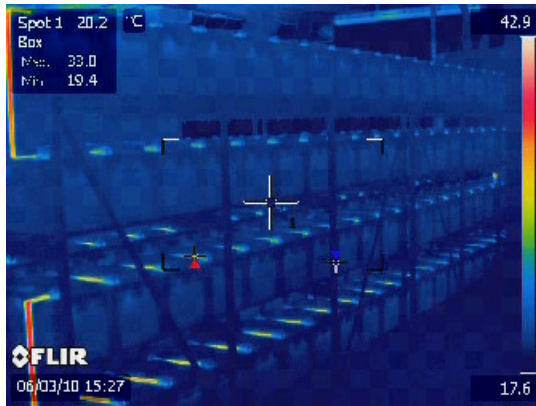
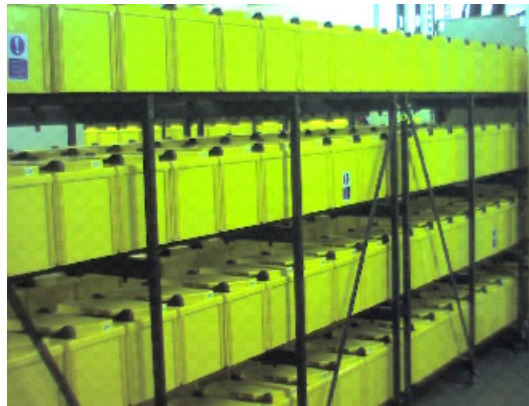
Inspection No	Date Inspected	Test Status	Measured Temp	Threshold Temp	Ambient Temp	Status Note	Customer Notes
1665	22/11/2011	TESTED	36 C	75 C	22 C

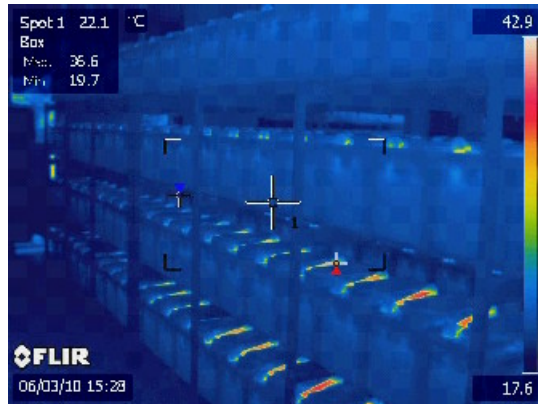
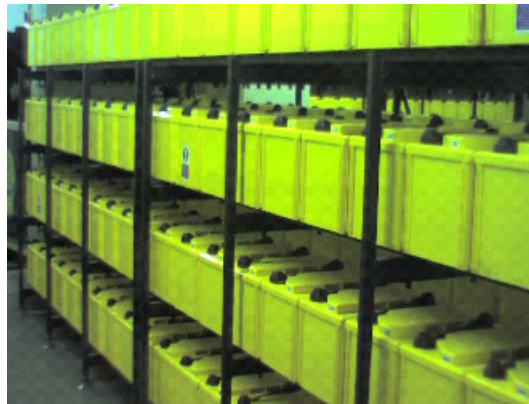
Inspection No	Date Inspected	Test Status	Measured Temp	Threshold Temp	Ambient Temp	Status Note	Customer Notes
1665	22/11/2011	TESTED	36 C	75 C	22 C

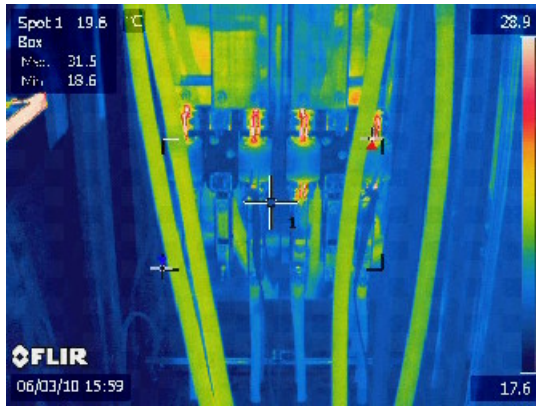
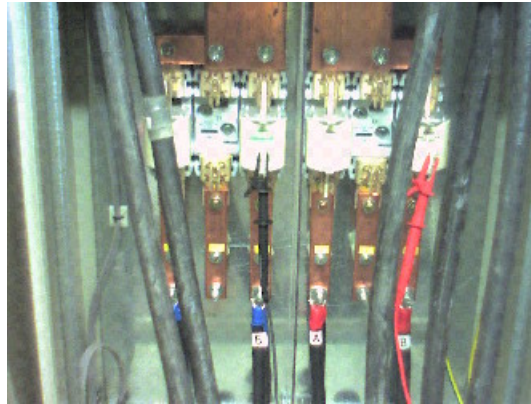
Inspection No	Date Inspected	Test Status	Measured Temp	Threshold Temp	Ambient Temp	Status Note	Customer Notes
1665	22/11/2011	TESTED	45 C	75 C	22 C

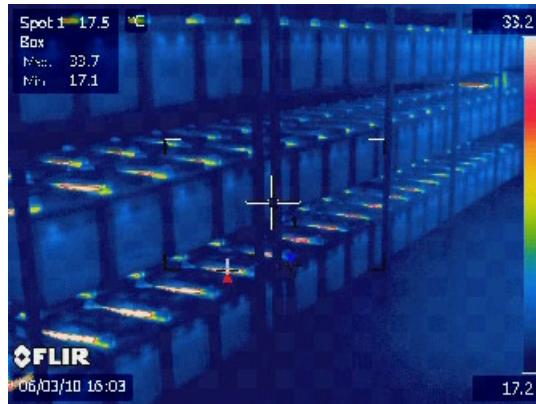
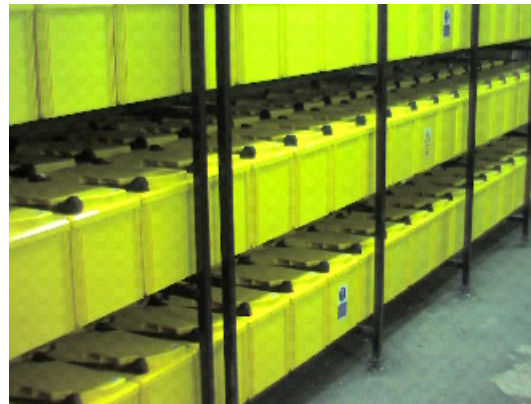
Inspection No	Date Inspected	Test Status	Measured Temp	Threshold Temp	Ambient Temp	Status Note	Customer Notes
1665	22/11/2011	TESTED	35 C	75 C	22 C

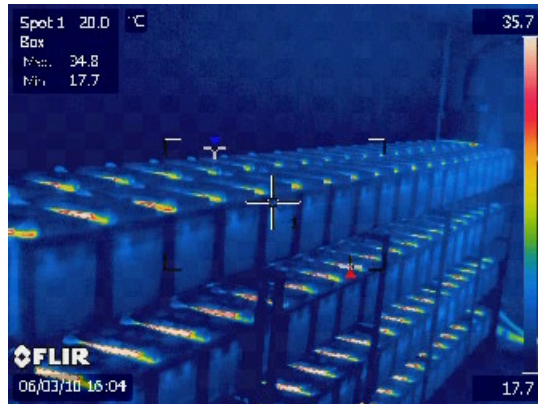
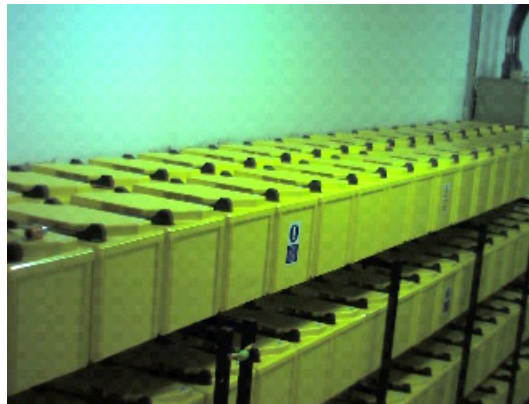
Inspection No	Date Inspected	Test Status	Measured Temp	Threshold Temp	Ambient Temp	Status Note	Customer Notes
1665	22/11/2011	TESTED	35 C	75 C	22 C
