**Thermographic inspection of:
V21110 HP1**

**TI Job No:
TI_16442**

9 March 2013

Executive Summary – V21110 HP1

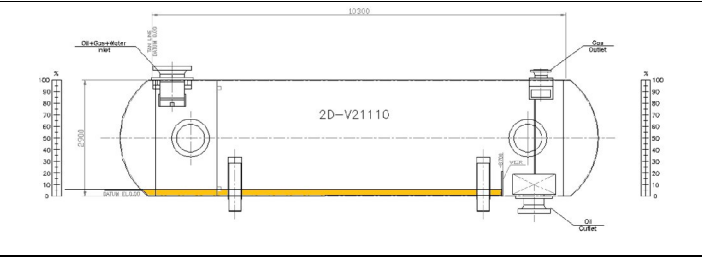
Inspection 5 Sediment Level – 21/02/09

Inlet	Centre	Weir	Outlet
Meters	0.1	0.2	0.2	0
Suspected sediment level (cm)				
West Elevation				
Suspected sediment level (cm)

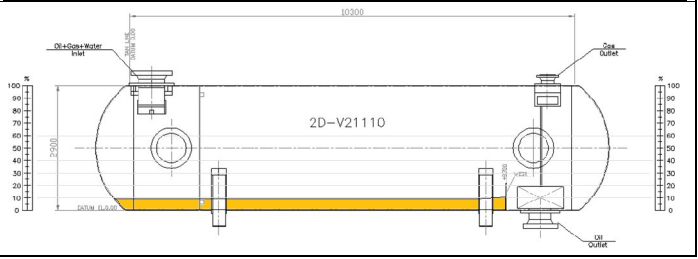
Inspection 6 Sediment Level -03/05/09

East Elevation	Inlet	Inlet saddle - Centre	Centre	Outlet saddle - Centre	Weir
Suspected sediment level (cm)	28	26	27	26	28
West Elevation					
Suspected sediment level (cm)	31	30	29	27	32

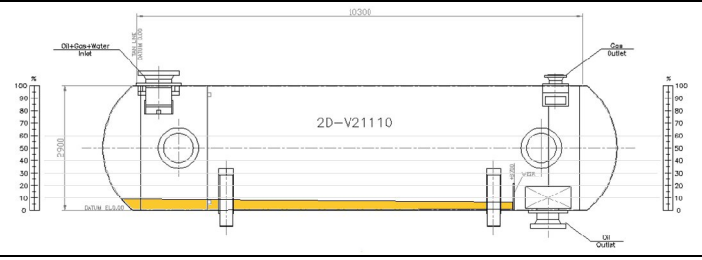
Inspection 7 Sediment Level – 04/11/09

East Elevation	Inlet	Inlet saddle - Centre	Centre	Outlet saddle - Centre	Weir
Suspected sediment level (cm)	21	24	19	22	21
West Elevation					
Suspected sediment level (cm)	18	23	20	20	19

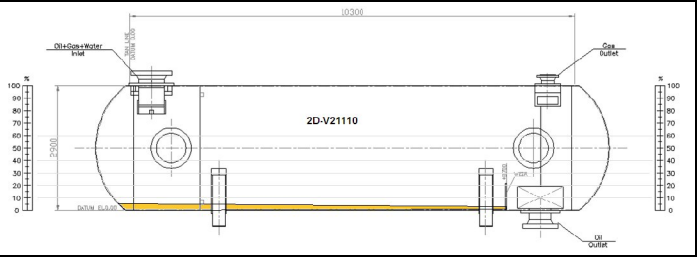
Inspection 8 Sediment Level – 20/01/10

East Elevation	Inlet	Inlet saddle - Centre	Centre	Outlet saddle - Centre	Weir
Suspected sediment level (cm)	17	16	14	14	9
West Elevation					
Suspected sediment level (cm)	15	13	9	11	8

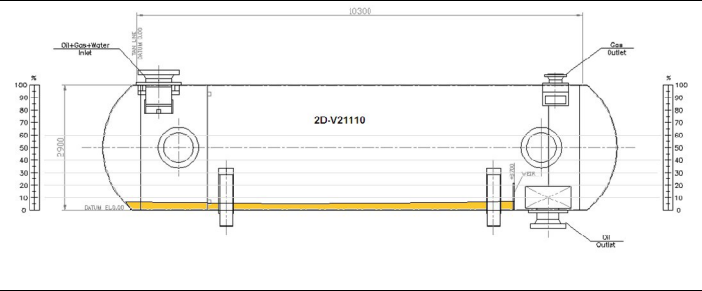
Inspection 9 Sediment Level – 02/03/10

East Elevation	Inlet	Inlet saddle - Centre	Centre	Outlet saddle - Centre	Weir
Suspected sediment level (cm)	18	15	15	18	19
West Elevation					
Suspected sediment level (cm)	18	15	15	18	19

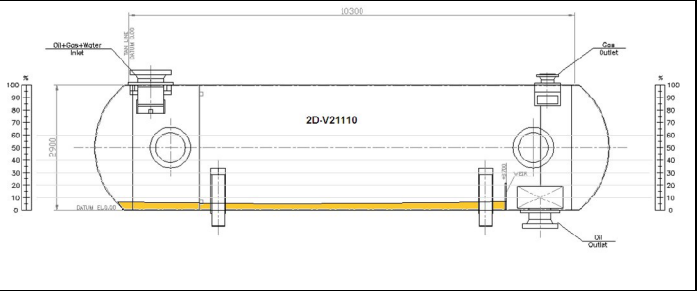
Inspection 10 Sediment Level – 12/05/10

East Elevation	Inlet	Inlet saddle - Centre	Centre	Outlet saddle - Centre	Weir
Suspected sediment level (cm)	18-21	15-18	21-18	16-18	18
West Elevation					
Suspected sediment level (cm)	17	17-18	17	14-15	14

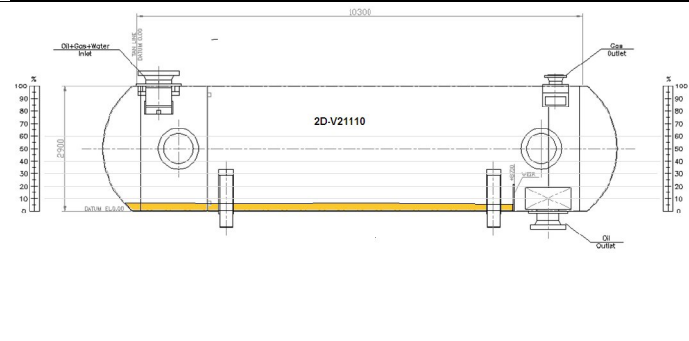
Inspection 11 Sediment Level – 11/08/10

East Elevation	Inlet	Inlet saddle - Centre	Centre	Outlet saddle - Centre	Weir
Suspected sediment level (cm)	19	14	18	18	14
West Elevation	Inlet	Inlet saddle - Centre	Centre	Outlet saddle - Centre	Weir
Suspected sediment level (cm)	14	13	13-16	21	14

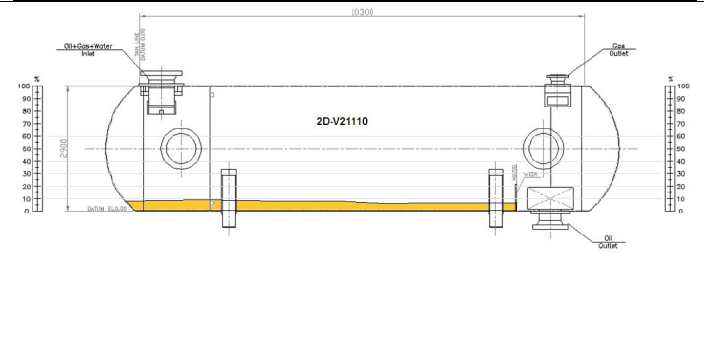
Inspection 12 Sediment Level - 27/11/10

East Elevation	Inlet	Inlet saddle - Centre	Centre	Outlet saddle - Centre	Weir
Suspected sediment level (cm)	22-25	24-22	20	20-24	20
West Elevation	Inlet	Inlet saddle - Centre	Centre	Outlet saddle - Centre	Weir
Suspected sediment level (cm)	22-20	20	19-17	17-19	14

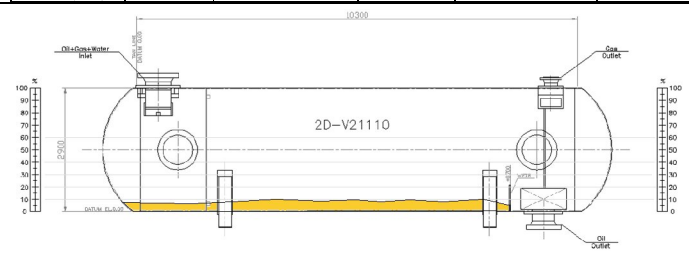
Inspection 13 Sediment Level – 08/03/11

East Elevation	Inlet	Inlet saddle - Centre	Centre	Outlet saddle - Centre	Weir
Suspected sediment level (cm)	23-20	26-29	29-23	25-23	18
West Elevation	Inlet	Inlet saddle - Centre	Centre	Outlet saddle - Centre	Weir
Suspected sediment level (cm)	23-20	21-22	23-25	22-21	22

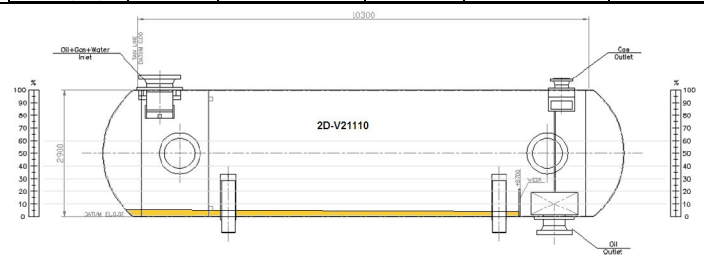
Inspection 14 Sediment Level – 01/06/11

East Elevation	Inlet	Inlet saddle - Centre	Centre	Outlet saddle - Centre	Weir
Suspected sediment level (cm)	18-8-17	17-17-15	17-15-19	15-14-12	12
West Elevation	Inlet	Inlet saddle - Centre	Centre	Outlet saddle - Centre	Weir
Suspected sediment level (cm)	17-15-14	11-10-11	11-11-13	14-10-16	16

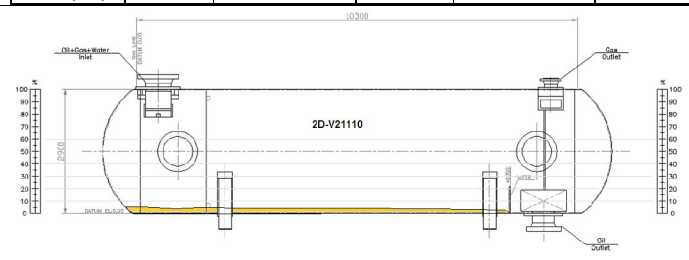
Inspection 15 Sediment Level – 15/09/11

East Elevation	Inlet	Inlet saddle - Centre	Centre	Outlet saddle - Centre	Weir
Suspected sediment level (cm)	14-10-10	13-10-10	10-11	9	9
West Elevation	Inlet	Inlet saddle - Centre	Centre	Outlet saddle - Centre	Weir
Suspected sediment level (cm)	14-14-13	11-11-12	12-13-12	12-12-14	11

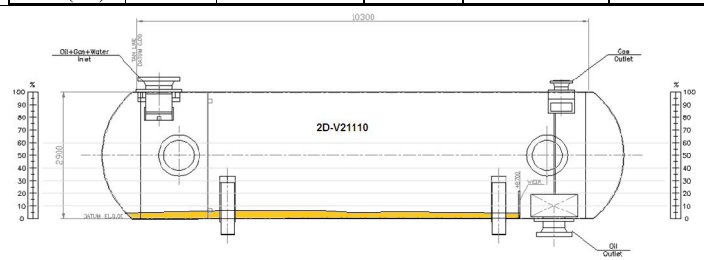
Inspection 16 Sediment Level – 13/12/11

East Elevation	Inlet	Inlet saddle - Centre	Centre	Outlet saddle - Centre	Weir
Suspected sediment level (cm)	15-19-22	22-22	20-21	20-24	18
West Elevation	Inlet	Inlet saddle - Centre	Centre	Outlet saddle - Centre	Weir
Suspected sediment level (cm)	21-21-19	21-19-20	16-16-22	18-16-16	16

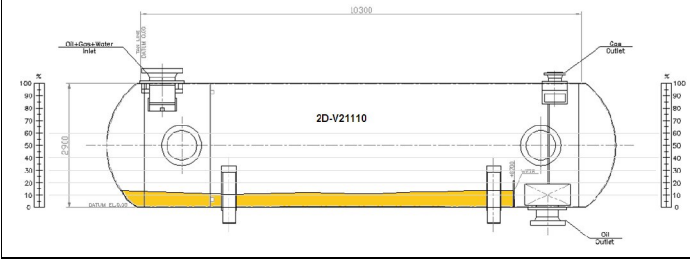
Inspection 17 Sediment Level – 15/09/11					
East Elevation	Inlet	Inlet saddle - Centre	Centre	Outlet saddle - Centre	Weir
Suspected sediment level (cm)	48-49-48	45-49	47-38	39-43	12
West Elevation	Inlet	Inlet saddle - Centre	Centre	Outlet saddle - Centre	Weir
Suspected sediment level (cm)	30-33-34	35-36-38	32-33-35	35-34-39	42

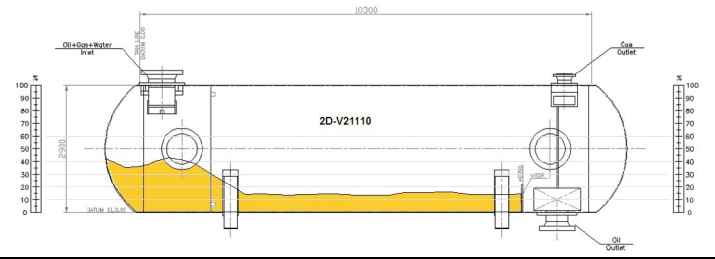
Inspection 18 Sediment Level – 08/03/12					
East Elevation	Inlet	Inlet saddle - Centre	Centre	Outlet saddle - Centre	Weir
Suspected sediment level (cm)	126-92-28	43-36-38	28-31-29	24-24-24	41
West Elevation	Inlet	Inlet saddle - Centre	Centre	Outlet saddle - Centre	Weir
Suspected sediment level (cm)	118-105-115	45-41-45	48-48-48	48-46	46

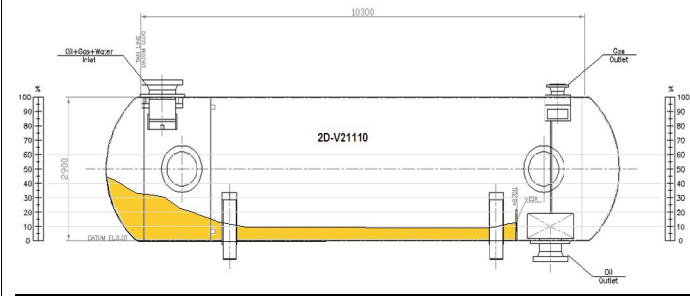
Inspection 19 Sediment Level – 01/06/12					
East Elevation	Inlet	Inlet saddle - Centre	Centre	Outlet saddle - Centre	Weir
Suspected sediment level (cm)	0	22 - 25 - 28	27 - 28 - 28	25 - 28 - 28	0
West Elevation	Inlet	Inlet saddle - Centre	Centre	Outlet saddle - Centre	Weir
Suspected sediment level (cm)	0	130 - 91 - 64	32 - 37 - 35	30 - 29 - 23	43

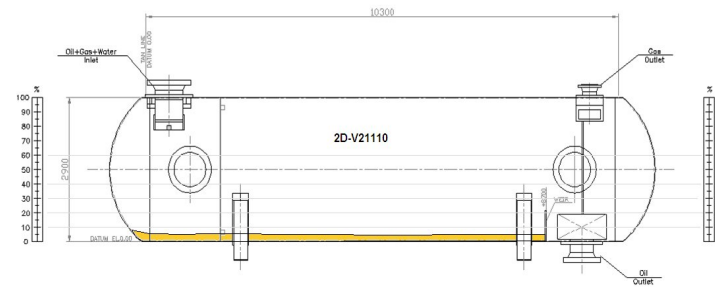
Inspection 20 Sediment Level – 21/09/12					
East Elevation	Inlet	Inlet saddle - Centre	Centre	Outlet saddle - Centre	Weir
Suspected sediment level (cm)	0	13 - 13 - 14	15 - 17 - 19	14 - 14 - 14	0
West Elevation	Inlet	Inlet saddle - Centre	Centre	Outlet saddle - Centre	Weir
Suspected sediment level (cm)	0	14 - 14 - 15	16 - 17 - 17	16 - 17 - 17	0

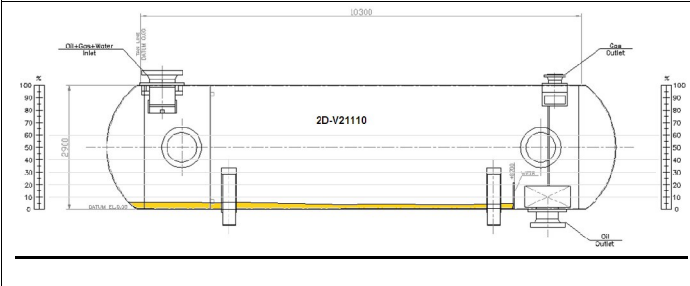
Inspection 21 Sediment Level – 10/12/12					
East Elevation	Inlet	Inlet saddle - Centre	Centre	Outlet saddle - Centre	Weir
Suspected sediment level (cm)	25-18-16	17-18	18-19	24-25	11
West Elevation	Inlet	Inlet saddle - Centre	Centre	Outlet saddle - Centre	Weir
Suspected sediment level (cm)	6-5-6	5-4-4	18-12-10	13-12-12	16

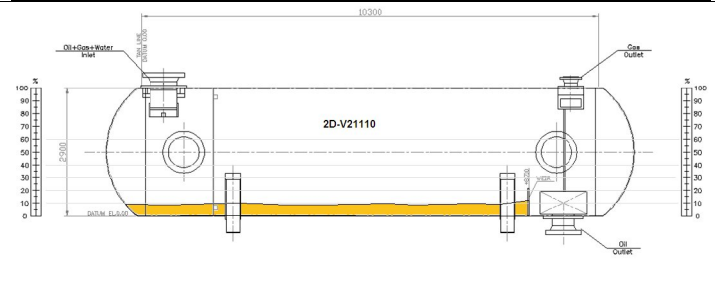
Inspection 22 Sediment Level – 08/03/13					
East Elevation	Inlet	Inlet saddle - Centre	Centre	Outlet saddle - Centre	Weir
Suspected sediment level (cm)	27-26-22	25-25	27-19	19-19	21
West Elevation	Inlet	Inlet saddle - Centre	Centre	Outlet saddle - Centre	Weir
Suspected sediment level (cm)	27-24-26	30-26-27	27-26-30	25-27-25	37

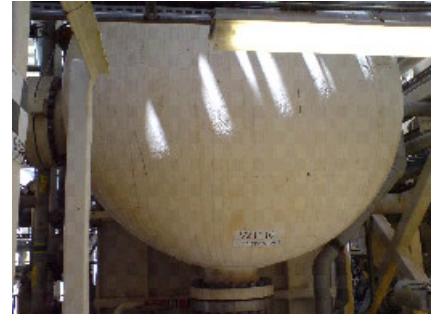
V21110 HP1 \ SOUTH \ OUTLET DOME

Inspection No	Date Inspected	Sp1-Sp2	Sp3-Sp4	Sp5-Sp6	Sand Level %		
1744	28/01/2012	0 cm	0 cm	0 cm	Sp1-2 % = 0	Sp3-4 % = 0	Sp5-6 % = 0
1777	08/03/2012	0 cm	0 cm	0 cm	Sp1-2 % = 0	Sp3-4 % = 0	Sp5-6 % = 0
1839	02/06/2012	0 cm	0 cm	0 cm	Sp1-2 % = 0	Sp3-4 % = 0	Sp5-6 % = 0
1850	22/09/2012	0 cm	0 cm	0 cm	Sp1-2 % = 1	Sp3-4 % = 1	Sp5-6 % = 1
1861	10/12/2012	0 cm	0 cm	0 cm	Sp1-2 % = 0	Sp3-4 % = 0	Sp5-6 % = 0
1877	09/03/2013	0 cm	0 cm	0 cm	Sp1-2 % = 0	Sp3-4 % = 0	Sp5-6 % = 0

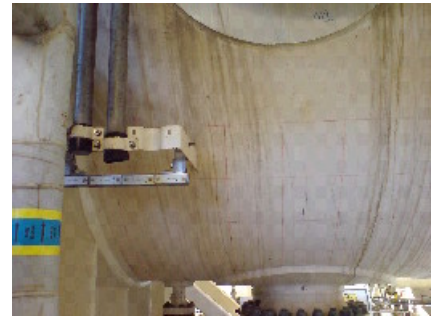
EQUIPMENT LOCATION:
V21110 HP1 \ WEST \ OUTLET DOME - SADDLE

Inspection No	Date Inspected	Sp1-Sp2	Sp3-Sp4	Sp5-Sp6	Sand Level %		
1744	28/01/2012	0 cm	0 cm	42 cm	Sp1-2 % = 0	Sp3-4 % = 0	Sp5-6 % = 14
1777	08/03/2012	0 cm	1 cm	41 cm	Sp1-2 % = 0	Sp3-4 % = 0	Sp5-6 % = 14
1839	02/06/2012	0 cm	34 cm	38 cm	Sp1-2 % = 0	Sp3-4 % = 12	Sp5-6 % = 13
1850	22/09/2012	0 cm	0 cm	0 cm	Sp1-2 % = 0	Sp3-4 % = 0	Sp5-6 % = 0
1861	10/12/2012	0 cm	0 cm	16 cm	Sp1-2 % = 0	Sp3-4 % = 0	Sp5-6 % = 6
1877	09/03/2013	0 cm	22 cm	37 cm	Sp1-2 % = 0	Sp3-4 % = 8	Sp5-6 % = 13

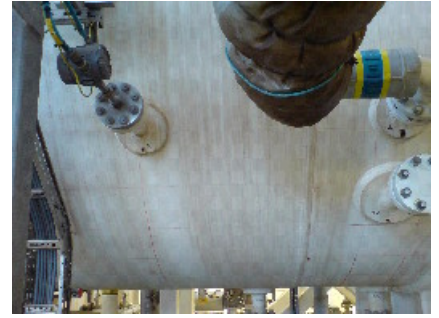
V21110 HP1 \ WEST \ OUTLET SADDLE - CENTER

Inspection No	Date Inspected	Sp1-Sp2	Sp3-Sp4	Sp5-Sp6	Sand Level %		
1744	28/01/2012	39 cm	34 cm	35 cm	Sp1-2 % = 14	Sp3-4 % = 12	Sp5-6 % = 12
1777	08/03/2012	24 cm	24 cm	24 cm	Sp1-2 % = 8	Sp3-4 % = 8	Sp5-6 % = 8
1839	02/06/2012	28 cm	26 cm	27 cm	Sp1-2 % = 10	Sp3-4 % = 9	Sp5-6 % = 9
1850	22/09/2012	14 cm	13 cm	14 cm	Sp1-2 % = 5	Sp3-4 % = 5	Sp5-6 % = 5
1861	10/12/2012	12 cm	12 cm	13 cm	Sp1-2 % = 4	Sp3-4 % = 4	Sp5-6 % = 4
1877	09/03/2013	25 cm	27 cm	25 cm	Sp1-2 % = 9	Sp3-4 % = 9	Sp5-6 % = 8

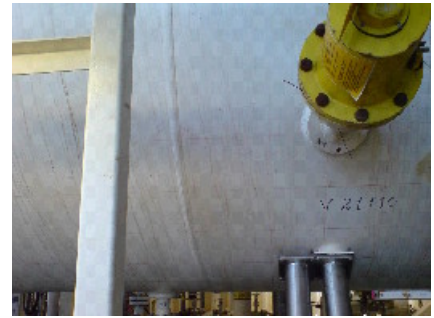
EQUIPMENT LOCATION:
V21110 HP1 \ WEST \ CENTER

Inspection No	Date Inspected	Sp1-Sp2	Sp3-Sp4	Sp5-Sp6	Sand Level %		
1744	28/01/2012	35 cm	33 cm	32 cm	Sp1-2 % = 12	Sp3-4 % = 11	Sp5-6 % = 11
1777	08/03/2012	28 cm	31 cm	29 cm	Sp1-2 % = 10	Sp3-4 % = 11	Sp5-6 % = 10
1839	02/06/2012	27 cm	28 cm	28 cm	Sp1-2 % = 9	Sp3-4 % = 10	Sp5-6 % = 10
1850	22/09/2012	14 cm	14 cm	14 cm	Sp1-2 % = 5	Sp3-4 % = 5	Sp5-6 % = 5
1861	10/12/2012	10 cm	12 cm	18 cm	Sp1-2 % = 4	Sp3-4 % = 4	Sp5-6 % = 6
1877	09/03/2013	30 cm	26 cm	27 cm	Sp1-2 % = 10	Sp3-4 % = 9	Sp5-6 % = 9

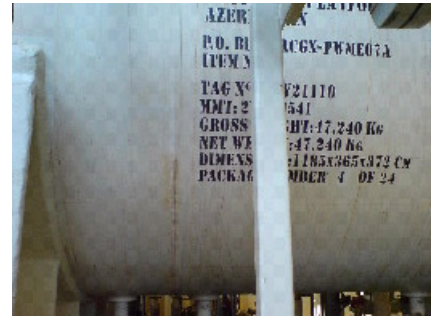
EQUIPMENT LOCATION:
V21110 HP1 \ WEST \ CENTER - INLET SADDLE

Inspection No	Date Inspected	Sp1-Sp2	Sp3-Sp4	Sp5-Sp6	Sand Level %		
1744	28/01/2012	35 cm	36 cm	38 cm	Sp1-2 % = 12	Sp3-4 % = 13	Sp5-6 % = 13
1777	08/03/2012	35 cm	36 cm	43 cm	Sp1-2 % = 12	Sp3-4 % = 12	Sp5-6 % = 15
1839	02/06/2012	25 cm	27 cm	28 cm	Sp1-2 % = 9	Sp3-4 % = 9	Sp5-6 % = 10
1850	22/09/2012	15 cm	17 cm	19 cm	Sp1-2 % = 5	Sp3-4 % = 6	Sp5-6 % = 6
1861	10/12/2012	11 cm	13 cm	13 cm	Sp1-2 % = 4	Sp3-4 % = 4	Sp5-6 % = 5
1877	09/03/2013	27 cm	26 cm	30 cm	Sp1-2 % = 9	Sp3-4 % = 9	Sp5-6 % = 10

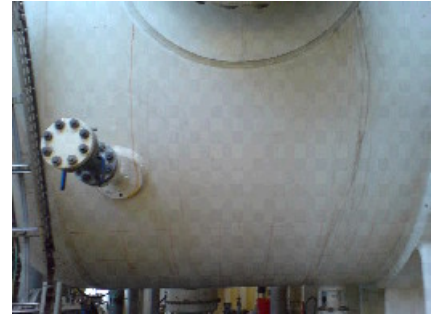
EQUIPMENT LOCATION:
V21110 HP1 \ WEST \ INLET SADDLE - DOME

Inspection No	Date Inspected	Sp1-Sp2	Sp3-Sp4	Sp5-Sp6	Sand Level %		
1744	28/01/2012	30 cm	33 cm	34 cm	Sp1-2 % = 10	Sp3-4 % = 11	Sp5-6 % = 12
1777	08/03/2012	28 cm	31 cm	92 cm	Sp1-2 % = 10	Sp3-4 % = 11	Sp5-6 % = 32
1839	02/06/2012	22 cm	25 cm	28 cm	Sp1-2 % = 8	Sp3-4 % = 8	Sp5-6 % = 10
1850	22/09/2012	13 cm	13 cm	14 cm	Sp1-2 % = 5	Sp3-4 % = 4	Sp5-6 % = 5
1861	10/12/2012	16 cm	15 cm	18 cm	Sp1-2 % = 6	Sp3-4 % = 5	Sp5-6 % = 6
1877	09/03/2013	26 cm	24 cm	27 cm	Sp1-2 % = 9	Sp3-4 % = 8	Sp5-6 % = 9

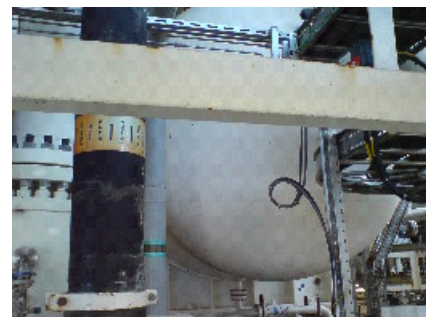
EQUIPMENT LOCATION:
V21110 HP1 \ NORTH \ INLET DOME

Inspection No	Date Inspected	Sp1-Sp2	Sp3-Sp4	Sp5-Sp6	Sand Level %		
1744	28/01/2012	25 cm	25 cm	24 cm	Sp1-2 % = 9	Sp3-4 % = 9	Sp5-6 % = 8
1777	09/03/2012	116 cm	126 cm	120 cm	Sp1-2 % = 40	Sp3-4 % = 44	Sp5-6 % = 42
1839	02/06/2012	0 cm	0 cm	0 cm	Sp1-2 % = 0	Sp3-4 % = 1	Sp5-6 % = 1
1850	22/09/2012	0 cm	0 cm	0 cm	Sp1-2 % = 2	Sp3-4 % = 1	Sp5-6 % = 1
1861	10/12/2012	1 cm	15 cm	1 cm	Sp1-2 % = 0	Sp3-4 % = 5	Sp5-6 % = 0
1877	09/03/2013	11 cm	11 cm	6 cm	Sp1-2 % = 4	Sp3-4 % = 4	Sp5-6 % = 2

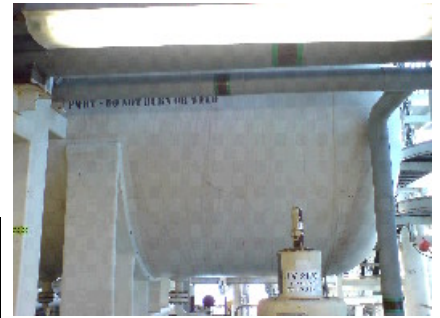
EQUIPMENT LOCATION:
V21110 HP1 \ EAST \ INLET DOME - SADDLE

Inspection No	Date Inspected	Sp1-Sp2	Sp3-Sp4	Sp5-Sp6	Sand Level %		
1744	28/01/2012	48 cm	49 cm	48 cm	Sp1-2 % = 17	Sp3-4 % = 17	Sp5-6 % = 17
1777	09/03/2012	118 cm	105 cm	115 cm	Sp1-2 % = 41	Sp3-4 % = 36	Sp5-6 % = 40
1839	02/06/2012	130 cm	91 cm	64 cm	Sp1-2 % = 45	Sp3-4 % = 31	Sp5-6 % = 22
1850	22/09/2012	14 cm	15 cm	15 cm	Sp1-2 % = 5	Sp3-4 % = 5	Sp5-6 % = 5
1861	10/12/2012	25 cm	18 cm	16 cm	Sp1-2 % = 9	Sp3-4 % = 6	Sp5-6 % = 6
1877	09/03/2013	27 cm	26 cm	22 cm	Sp1-2 % = 9	Sp3-4 % = 9	Sp5-6 % = 8

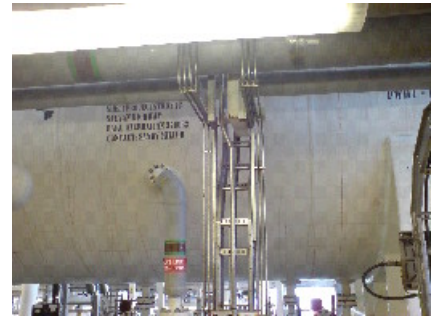
EQUIPMENT LOCATION:
V21110 HP1 \ EAST \ INLET SADDLE - CENTER

Inspection No	Date Inspected	Sp1-Sp2	Sp3-Sp4	Sp5-Sp6	Sand Level %		
1744	28/01/2012	45 cm	49 cm	47 cm	Sp1-2 % = 15	Sp3-4 % = 17	Sp5-6 % = 16
1777	08/03/2012	45 cm	41 cm	39 cm	Sp1-2 % = 15	Sp3-4 % = 14	Sp5-6 % = 14
1839	02/06/2012	32 cm	37 cm	35 cm	Sp1-2 % = 11	Sp3-4 % = 13	Sp5-6 % = 12
1850	22/09/2012	16 cm	17 cm	17 cm	Sp1-2 % = 6	Sp3-4 % = 6	Sp5-6 % = 6
1861	10/12/2012	17 cm	18 cm	18 cm	Sp1-2 % = 6	Sp3-4 % = 6	Sp5-6 % = 6
1877	09/03/2013	25 cm	25 cm	27 cm	Sp1-2 % = 9	Sp3-4 % = 9	Sp5-6 % = 9

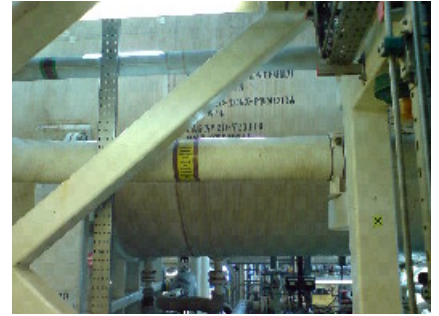
V21110 HP1 \ EAST \ CENTER - OUTLET SADDLE

Inspection No	Date Inspected	Sp1-Sp2	Sp3-Sp4	Sp5-Sp6	Sand Level %		
1744	28/01/2012	38 cm	39 cm	43 cm	Sp1-2 % = 13	Sp3-4 % = 13	Sp5-6 % = 15
1777	08/03/2012	48 cm	48 cm	48 cm	Sp1-2 % = 17	Sp3-4 % = 17	Sp5-6 % = 16
1839	02/06/2012	30 cm	29 cm	23 cm	Sp1-2 % = 10	Sp3-4 % = 10	Sp5-6 % = 11
1850	22/09/2012	16 cm	17 cm	18 cm	Sp1-2 % = 6	Sp3-4 % = 6	Sp5-6 % = 6
1861	10/12/2012	19 cm	24 cm	25 cm	Sp1-2 % = 7	Sp3-4 % = 8	Sp5-6 % = 9
1877	09/03/2013	19 cm	19 cm	19 cm	Sp1-2 % = 7	Sp3-4 % = 6	Sp5-6 % = 7
