THERMOGRAPHIC INSPECTION FOR:

UNDERFLOOR HEATING PIPEWORK

TI SITE 7 SAMPLE REPORT

TI , TI Site 7 Hot Water Pipe Leakage

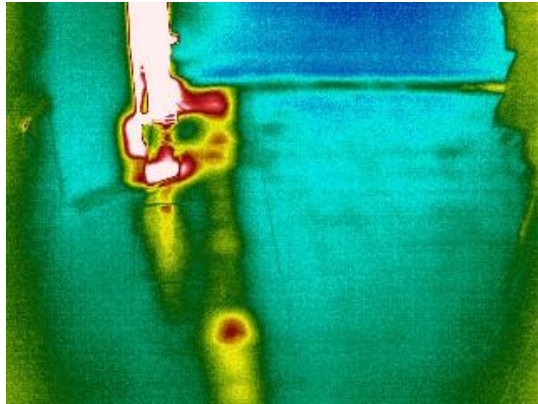
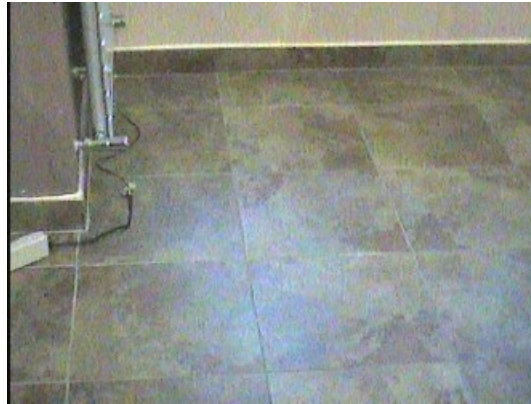
Inspection No	Date Inspected	Test Status	Measured Temp	Threshold Temp	Ambient Temp	Status Note	Customer Notes
1417	22/11/2010	TESTED	28 C	32 C	20 C

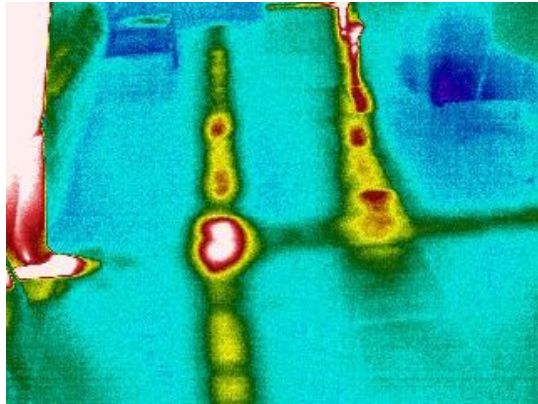
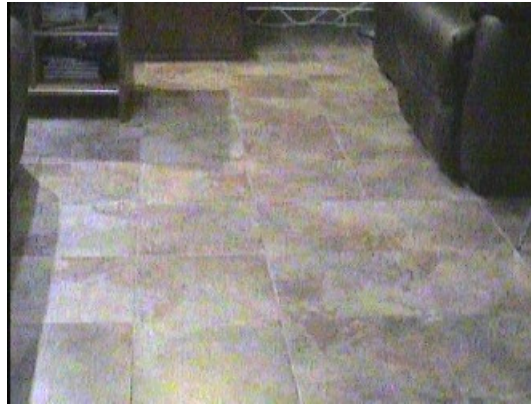
LIVING ROOM \ TOWARDS REAR RADIATOR

Inspection No	Date Inspected	Test Status	Measured Temp	Threshold Temp	Ambient Temp	Status Note	Customer Notes
1417	22/11/2010	TESTED	29 C	32 C	20 C

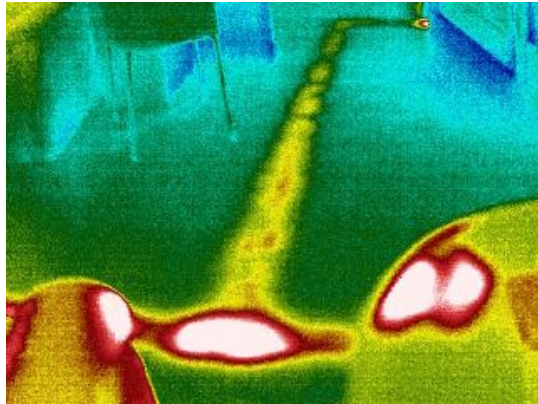
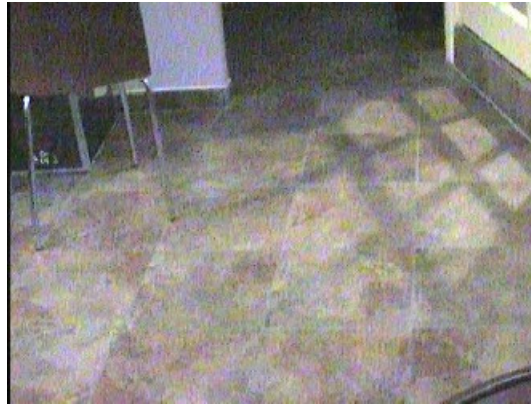
LIVING ROOM \ T-PIECE TO KITCHEN

Inspection No	Date Inspected	Test Status	Measured Temp	Threshold Temp	Ambient Temp	Status Note	Customer Notes
1417	22/11/2010	TESTED	26 C	32 C	20 C

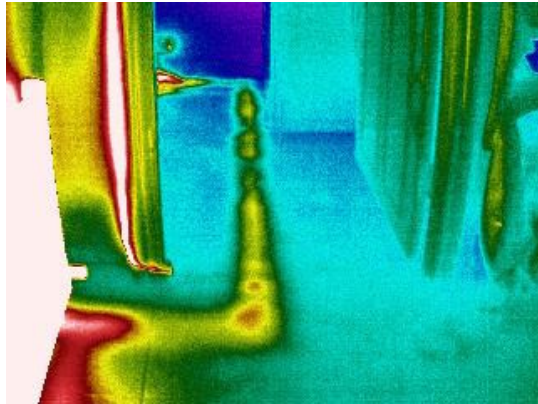
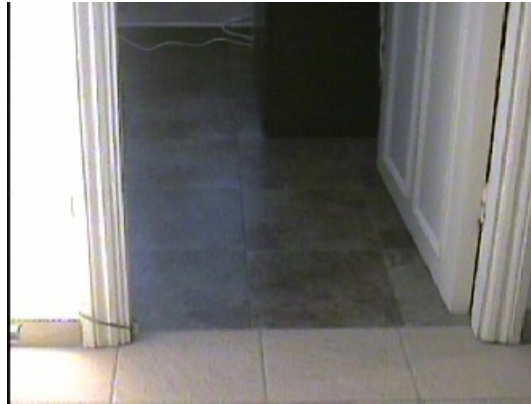
Inspection No	Date Inspected	Test Status	Measured Temp	Threshold Temp	Ambient Temp	Status Note	Customer Notes
1417	22/11/2010	TESTED	23 C	32 C	20 C

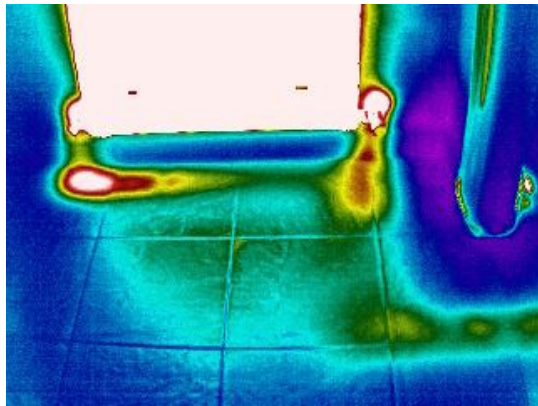
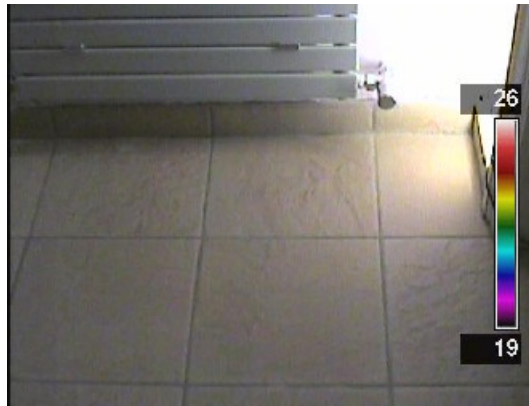
Inspection No	Date Inspected	Test Status	Measured Temp	Threshold Temp	Ambient Temp	Status Note	Customer Notes
1417	22/11/2010	TESTED	31 C	32 C	20 C

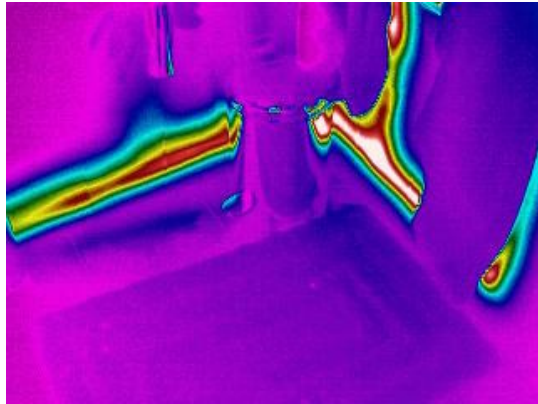
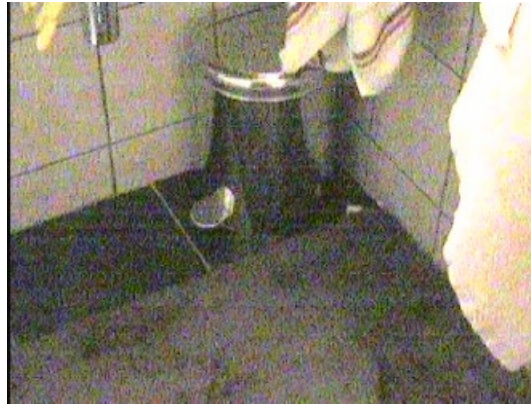
Inspection No	Date Inspected	Test Status	Measured Temp	Threshold Temp	Ambient Temp	Status Note	Customer Notes
1417	22/11/2010	TESTED	32 C	32 C	20 C
