Thermal Imaging Report

Inspection Ref. TI WATER LEAK DEMO (PIPE WORK)

TI LTD / TI WATER LEAK DEMO

10th Mar 2014

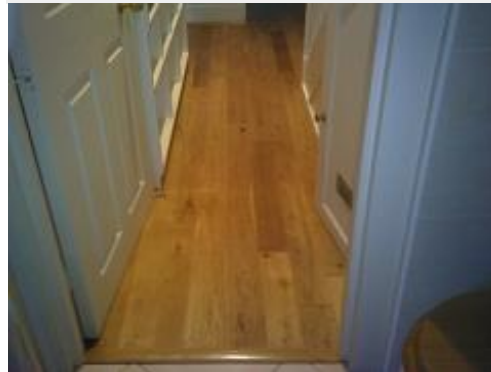
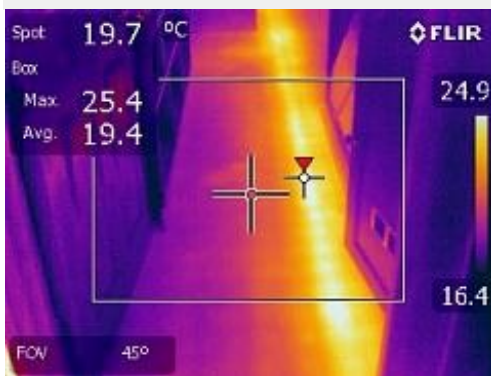
HALLWAY - FROM BATHROOM

Inspection Reference	Date Inspected	Pipework temp.	Min temp	Max temp	Moisture meter reading - Top (%)
TI WATER LEAK DEMO	10 th Mar 2014	75	19	25	N/A

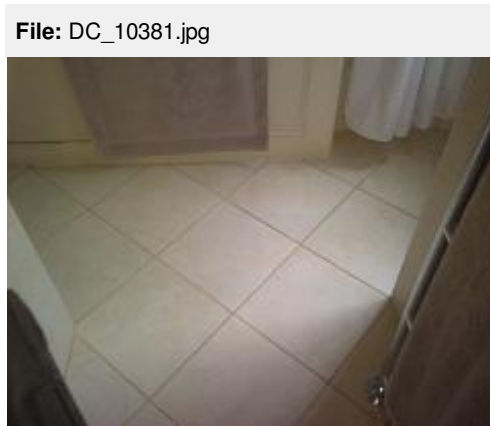
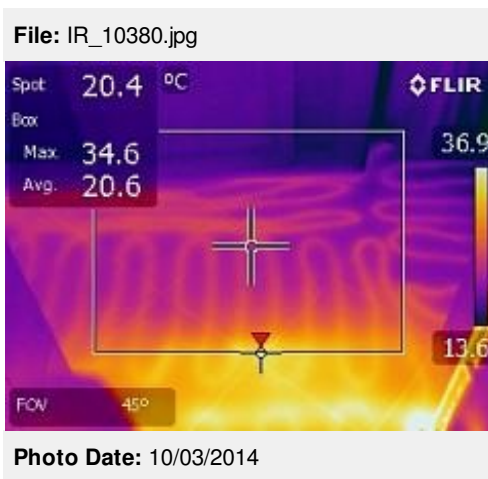
BATHROOM - ADJACENT REAR DOOR

Inspection Reference	Date Inspected	Pipework temp.	Min temp	Max temp	Moisture meter reading - Top (%)
TI WATER LEAK DEMO	10 th Mar 2014	75	20	25	N/A

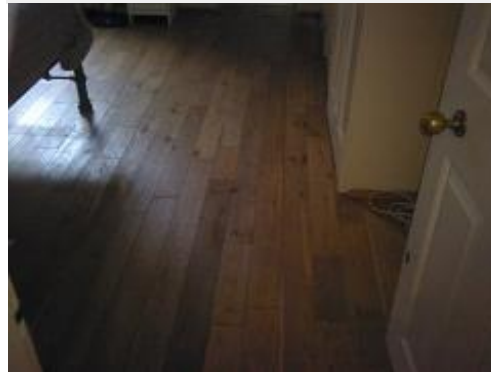
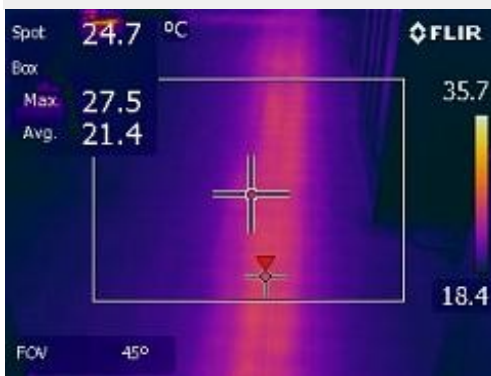
MASTER BEDROOM - FROM HALLWAY TO EN SUITE

Inspection Reference	Date Inspected	Pipework temp.	Min temp	Max temp	Moisture meter reading - Top (%)
TI WATER LEAK DEMO	10 th Mar 2014	70	21	25	N/A

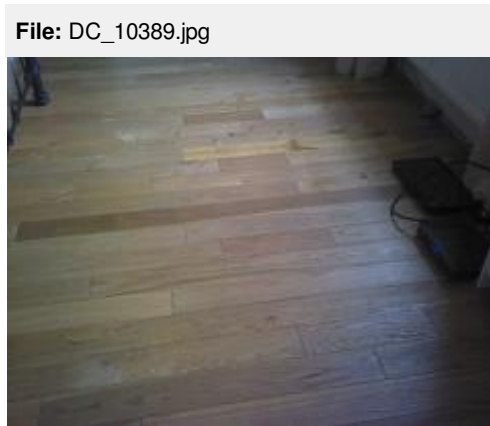
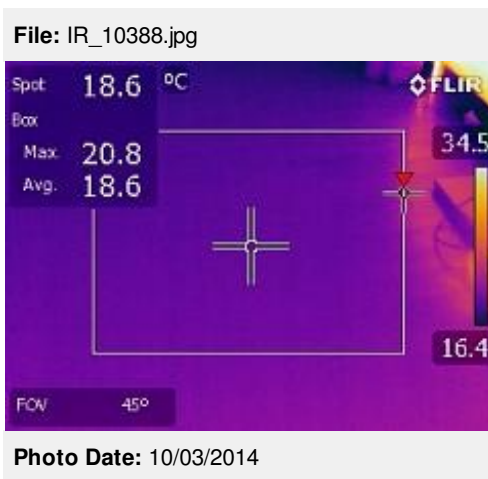
MASTER BEDROOM - ADJACENT WINDOW

Inspection Reference	Date Inspected	Pipework temp.	Min temp	Max temp	Moisture meter reading - Top (%)
TI WATER LEAK DEMO	10 th Mar 2014	75	18	25	N/A

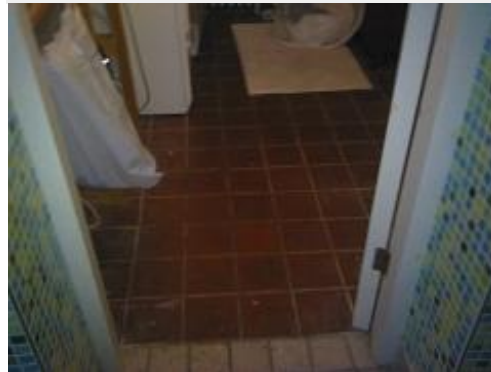
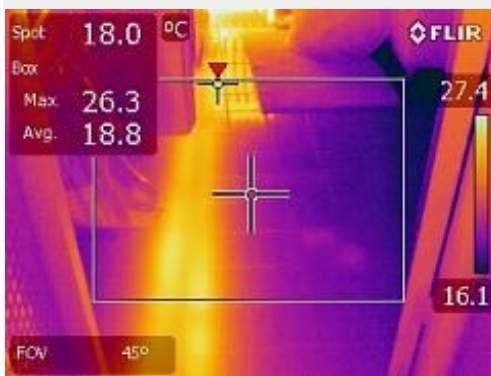
UTILITY ROOM - FROM DOORWAY

Inspection Reference	Date Inspected	Pipework temp.	Min temp	Max temp	Moisture meter reading - Top (%)
TI WATER LEAK DEMO	10 th Mar 2014	75	17	20	N/A

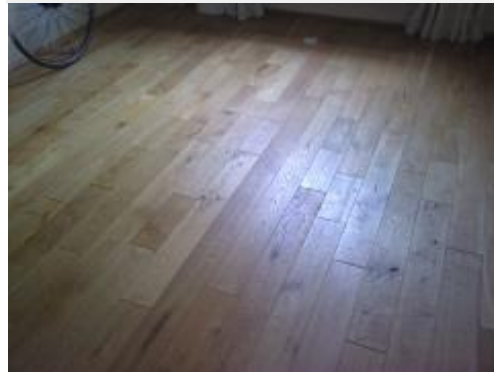
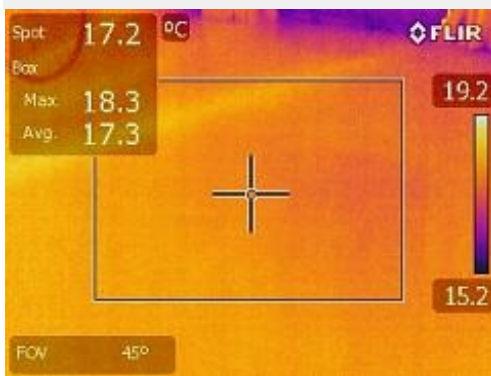
SECOND BEDROOM - TOWARDS WINDOW

Inspection Reference	Date Inspected	Pipework temp.	Min temp	Max temp	Moisture meter reading - Top (%)
TI WATER LEAK DEMO	10 th Mar 2014	75	17	18	N/A

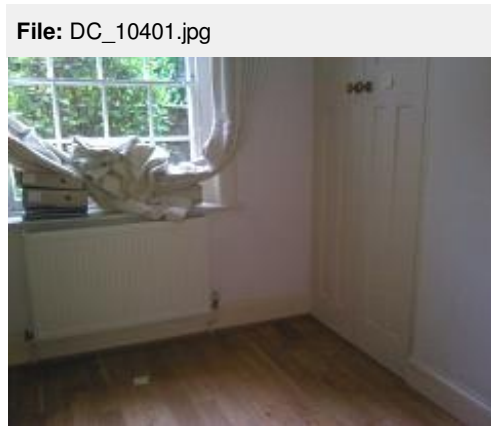
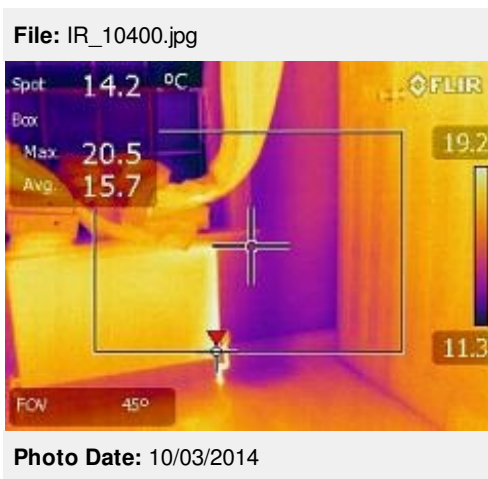
SECOND BEDROOM - RIGHT CORNER FROM WINDOW

Inspection Reference	Date Inspected	Pipework temp.	Min temp	Max temp	Moisture meter reading - Top (%)
TI WATER LEAK DEMO	10 th Mar 2014	75	16	15	N/A
