Stroma Technology Ltd

InspectionNo: 2075 Report Date: 11/04/2013

CARE HOME COURTYARD SOUTH

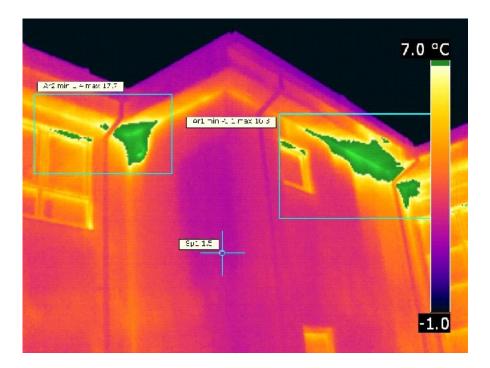
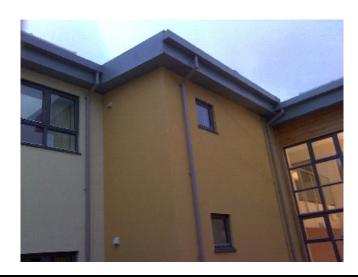
File: IR_2523A.jpg File: DC_2524.jpg

Elevated temperature at AR1 and AR2

Suspected air leakage

Check seals and repair or replace where necessary
